From: official information
Sent: Friday, 9 July 2021 15:52
To: [REDACTED]
Cc: official information
Subject: Response - LGOIMA 21195 - [REDACTED] - Taitua Arboretum Additional Fluoride Free Water Supply
Attachments: Attachment A_Taitua Water Supply Diagrams and Photo.pdf

Taitua Arboretum Non-Fluoridated Drinking Water Supply System

Attachment A_Taitua Arboretum Additional Water Supply Diagrams and Photos

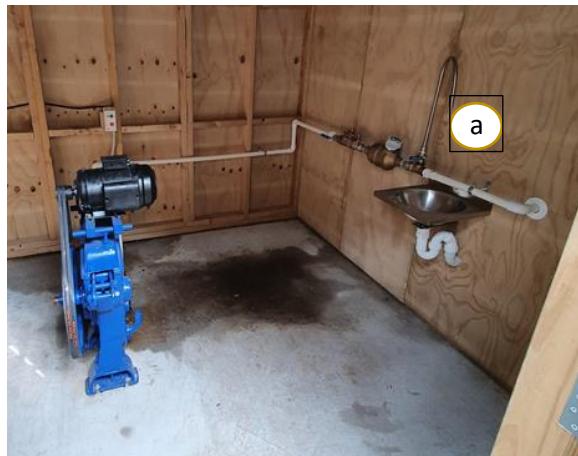
Bore Shed

- a Bore sample point – only operable while pump running

1. Bore shed – replaced existing smaller shed for increased bore security
2. Bore pump – refurbished to improve bore head protection and pump operation
3. Pre-treatment storage reservoir (35,0000 Litres) – refurbished Timbertank with new lining and roof to exclude environmental contamination

- 1 New bore shed
- Refurbished bore pump
- New pipe work

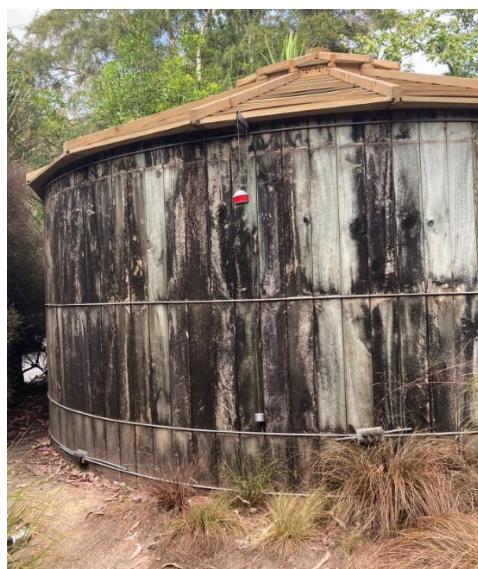
Pre-Treatment Reservoir

- Sample tap spouts were truncated shortly after installation to improve sterilisation of sample point and reduce risk of biofilm development;
- Reservoir inspection identified some re-accumulation of sediment however UV transmittance and turbidity have been at levels that would not impact UV performance;

- 2 Inspected and cleaned
- New liners
- New roof
