Council OPEN AGENDA

Victoria on the River

Summary of Engineering and Contamination Assessments

VOTR Site Assessment
Victoria on the River

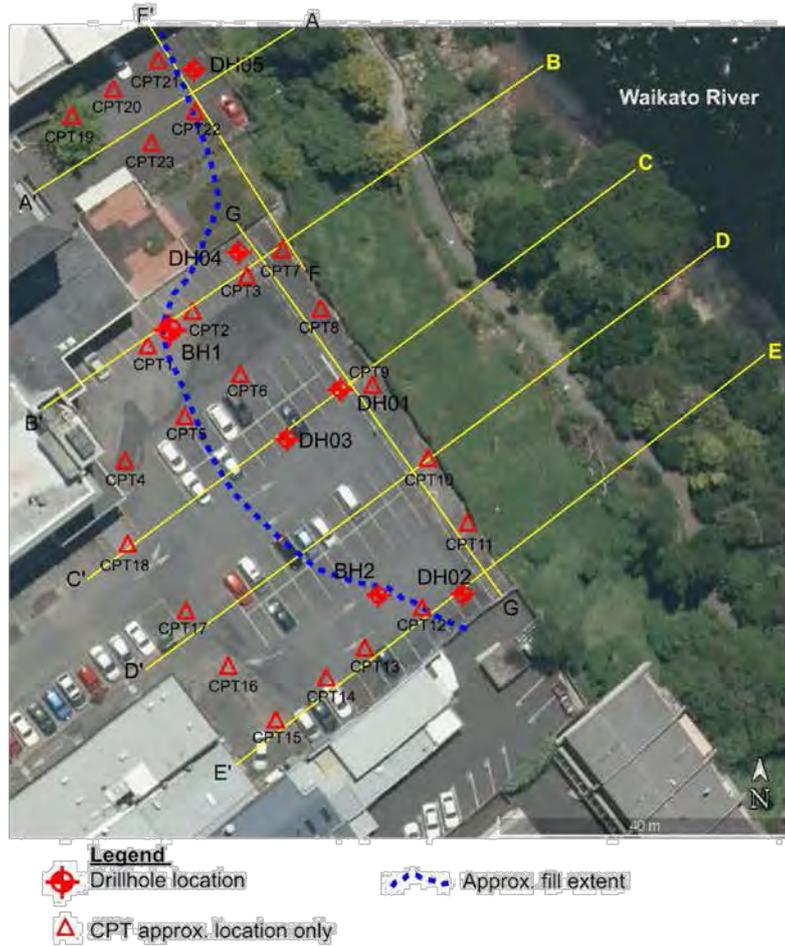
Figure 1 - Site Investigations

The information from the drillhole logs has been used to develop a series of geological sections through the site and derive an approximate location for the extent of the fill. The geological sections are presented in the full assessment report. The approximate extent of the fill is shown on Figure 1 below.

AECOM undertook a geotechnical investigation consisting of a cored drillhole near the slope crest. Loose sandy fill with traces of refuse was found in the drillhole to a depth of 11 m. Underlying the fill was very loose sensitive fine sand. Medium dense and dense sands were located from 18 metres below ground level and continued to the base of the 30 m deep drillhole.

Supplementary hand augerholes were undertaken in the northern part of the slope. In this location the fill does not appear to be as deep (approx. 1.5 m), however it should be noted that deep drilling may recover material that is fill which would mean that a revision of the interpretation of ground conditions in this area would be required.

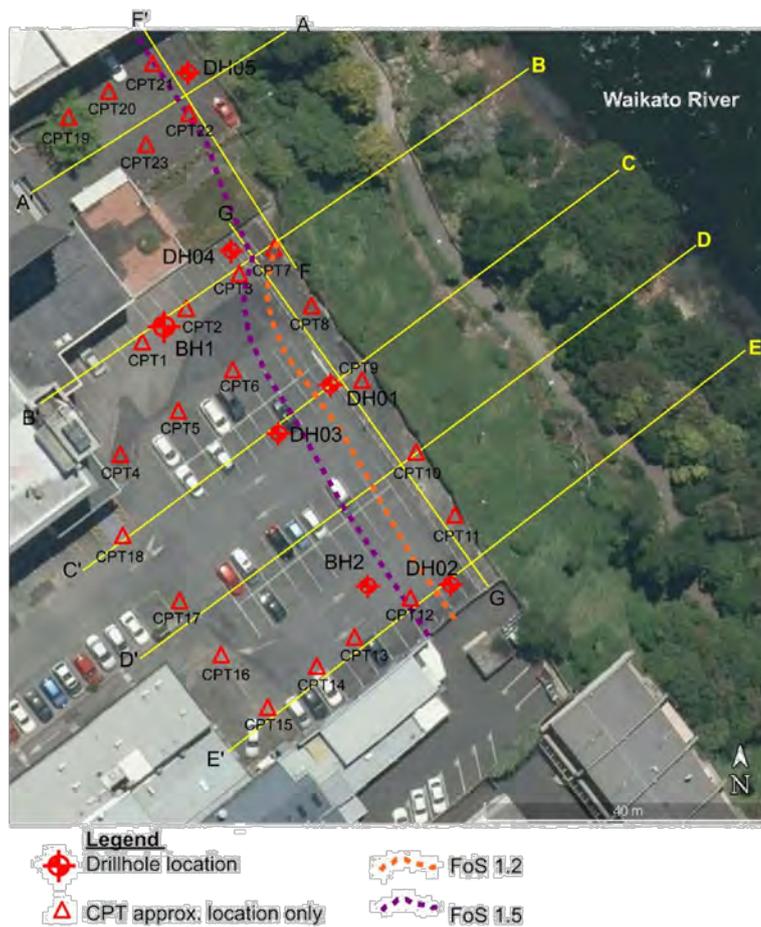
Figure 2 - Slope setbacks

We consider that a slope stability factor of safety of 1.2 is adequate for an at-grade re-seal of the carpark, though minor slope creep deformation may continue and periodic maintenance of the carpark surface (crack repairs, etc.), could be required.

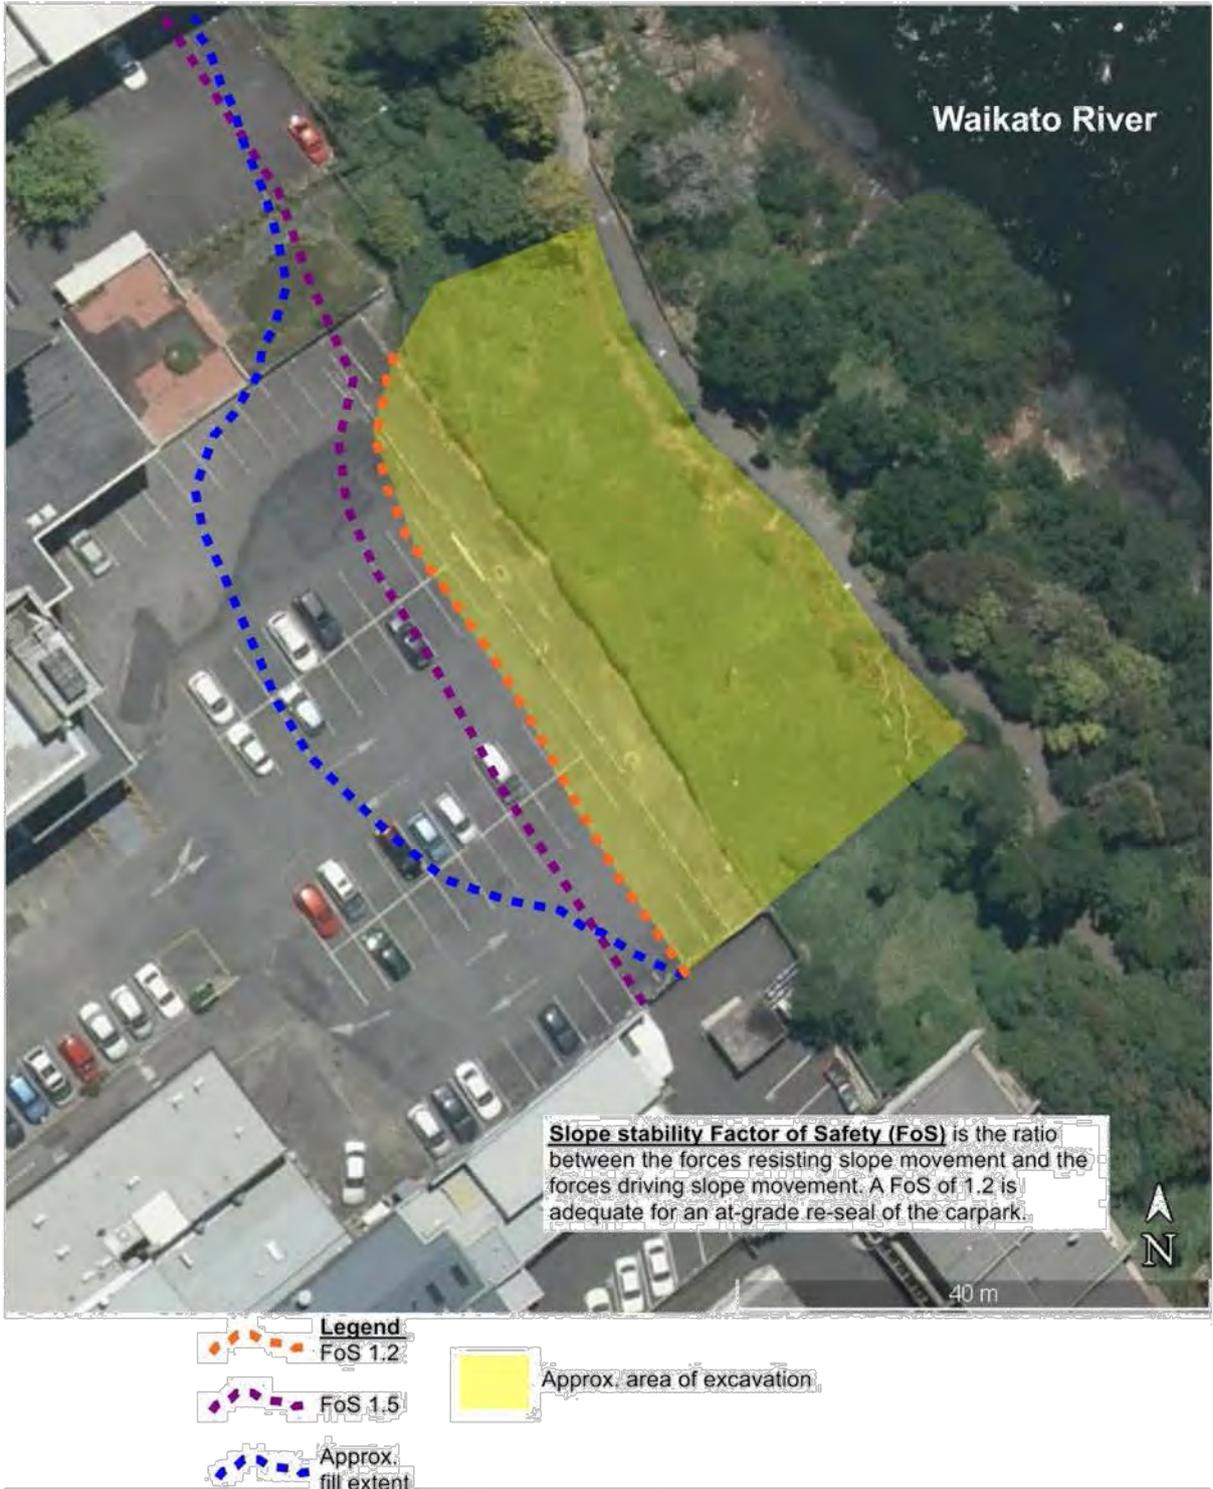
VOTR Aerial Photograph: AECOM- extent of excavation

- Lots 1, 6, 7 and 8 (area currently used exclusively as carparking) are affected in the following ways (shown on the aerial photograph appended as Attachment 4):
 - Unstable loose fill – requires excavation and removal - 150 truck and trailer loads
 - Some contamination requiring excavation and specialised disposal
 - Site unsafe from the boundary of northern boundary of Lot 1 to the southern boundary of Lot 8 and up to 15 metres back from the existing slope edge.
 - River path below site unsafe over the same length as the land immediately above it (comparable in scale to the Bryce Street walkway)
 - River at risk of contamination should the VOTR land subside
 - Stormwater network within the site is faulty, contributing to the problem.
- Lot 2 (area immediately adjoining Skycity Casino) is largely unaffected and does not need to be considered for remediation.
