Project Report

Ruakiwi Road – Pedestrian Safety Improvement near Lake Domain Drive intersection

Te Rapa Road/Garnett Avenue/Vardon Road Intersection Improvements – 2025/26

Ulster Street/Maeroa Road Safety Improvement Project 2025/26

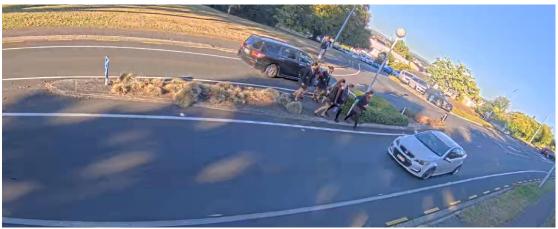
Figure 3 Students crossing in groups captured in the survey camera

The existing uncontrolled crossing has a narrow refuge island which does not provide a safe place to wait while crossing the road. The narrow refuge island can only accommodate 2 to 3 pedestrians safely, and its width does not allow for pedestrians with prams or mobility scooters, forcing children and other vulnerable road users to stand in the traffic lane or at the front and back of the island's kerbs while attempting to cross between gaps in traffic.

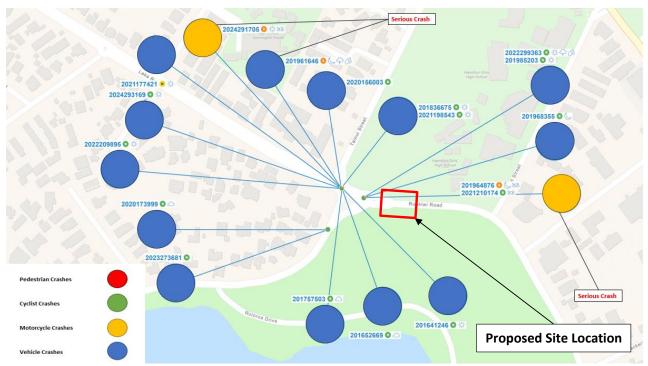
At this location due to Failed to give way or stop, poor judgement resulting in loss of control/Head on and Crossing/turning crashes. Since 2014 the social cost of crashes has been \$4.04M. No crashes identified at the existing refuge island and no pedestrian involved crashes.

Figure 5 CAS Data – Showing Crashes (since 2014)

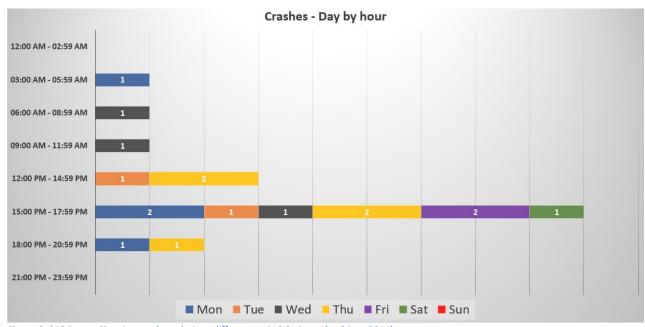
Figure 6 CAS Data – Showing crash analysis at different period during a day (since 2014)

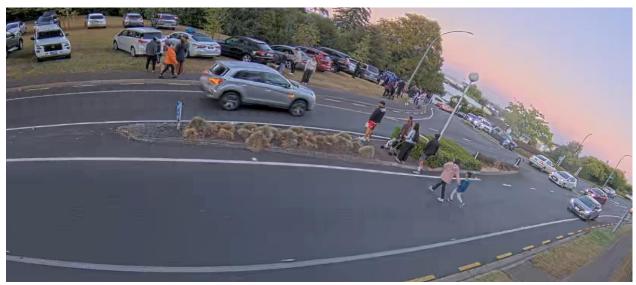
Figure 8 Camera survey captured on 22nd March 2025 (Saturday) (* Balloons over Waikato on Saturday)

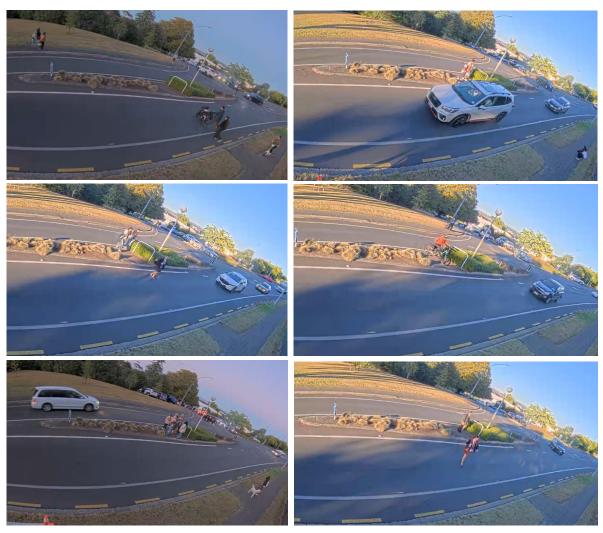
- People were observed trapped on the central island trying to find gaps in the traffic to finish crossing the road due to the high traffic volumes.
- Vehicles accelerating at high speed through the intersection from Lake Domain Drive turning right on to Ruakiwi Road (challenge in finding gap).
- During peak hours the traffic gaps allowing pedestrians to cross the road are minimal and people had to run across the lanes while crossing.
- Existing cutdowns at the crossing are not non-wheelchair friendly due to slope up to the footpath.
- Students and family that used the narrow refuge island, were often in groups >4 which required them to stand on to the front and rear of the existing refuge island.

Figure 10 Site Photos - Observations

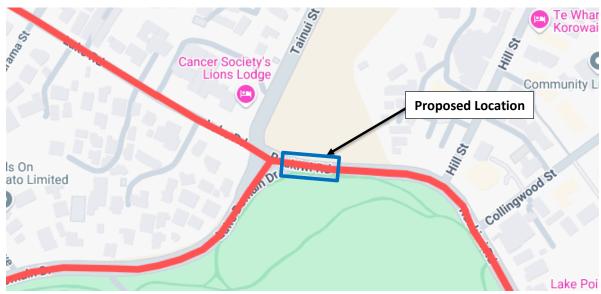
Figure 11 Aerial showing FENZ Route in red and the proposed location in blue rectangle.

Ruakiwi Road is on the Fire and Emergency NZ (FENZ) priority route as shown below. Pending the direction from Elected Members, discussions will take place with FENZ to determine how we can best accommodate their operating requirements.

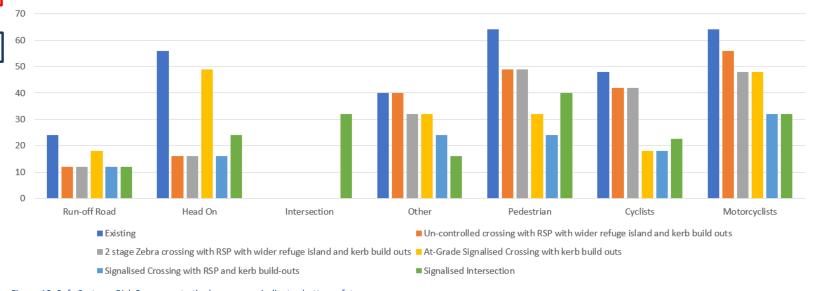
Figure 13 Safe Systems Risk Score – note the lower score indicates better safety.

Ruakiwi Rd Pedestrian crossing Improvements Options Safe System Risk Score by Crash Type

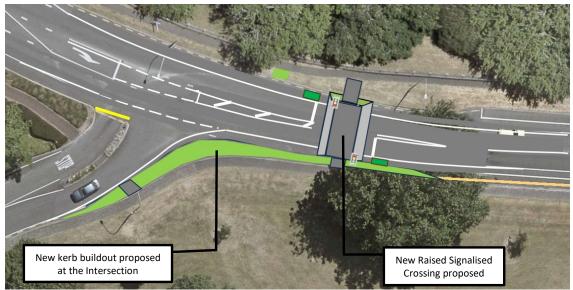
Figure 14 Preferred Option – Signalised Crossing on Raised Safety Platform.

It is recommended that future proofing be provided to enable the crossing to be upgraded to a dual crossing for cyclists. Recommend additional in ground ducting to save costly future pavement works.

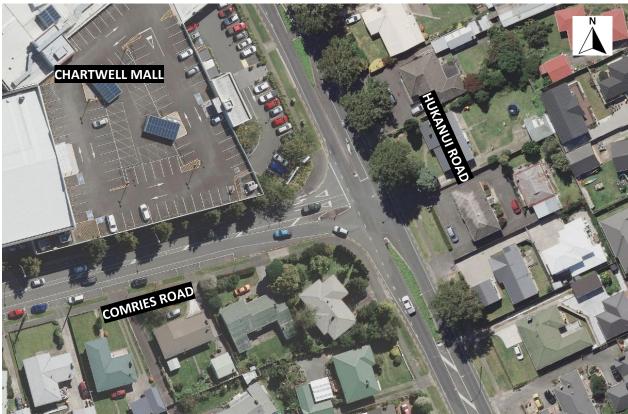
Figure 1: Site Location

The site is located at the intersection of Comries Road and Hukanui Road in Chartwell, on the south-eastern corner of Chartwell Mall. The location is shown below in Figure 1.

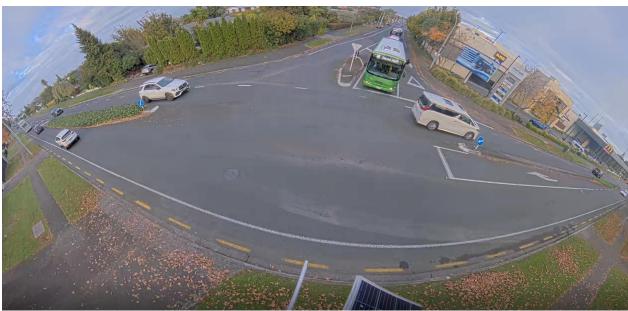
Figure 2: Picture of bus attempting to turn right out of Comries Road with a queue of traffic behind the bus

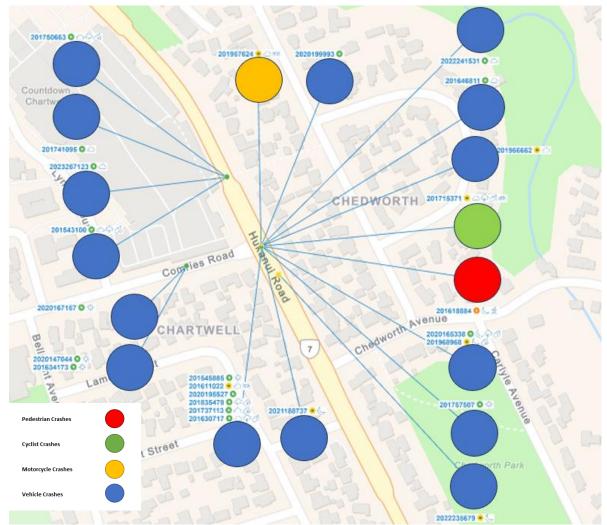
Of the total crashes, 52% are related to crossing/turning crash types where drivers have failed to give way when turning out of Comries Road, which is common for a give-way t-intersection with relatively high traffic volumes. Nine crashes are related to rear end crashes and two are a result of drivers losing control. The total social costs of all reported crashes are estimated to be \$4.178m.

Figure 5: Collision Diagram

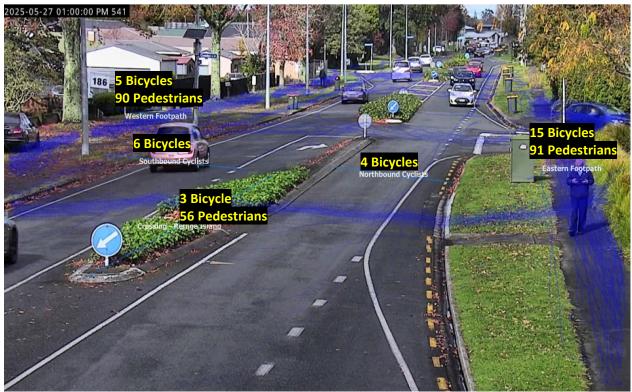
Figure 7: Tuesday 27 May 2025 Pedestrian and Cyclist Movement Summary

An overview pedestrian and cyclist route map and summary of pedestrian and cyclist movements is summaries below in Figure 7 and Figure 8.

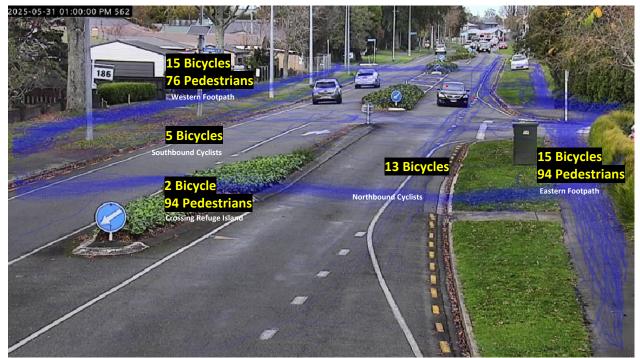
Figure 8: Saturday 31 May 2025 Pedestrian and Cyclist Movement Summary

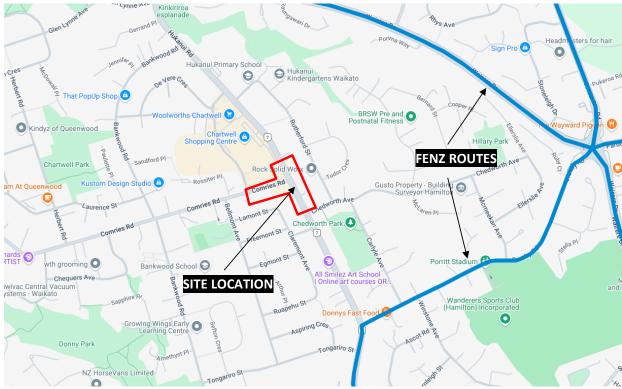
Figure 9: FENZ Routes

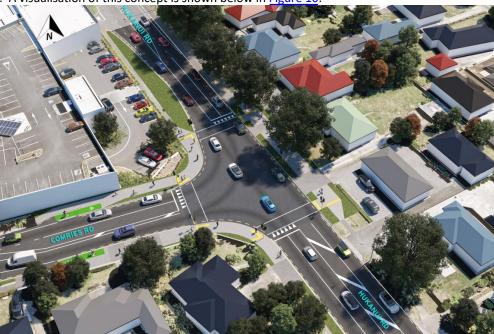
Figure 10: Visualisation of the Signalised Concept of Comries Road and Hukanui Road

The Eastern Pathways School Link SSBC, prepared in 2021, recommended traffic signals at the Comries Road and Hukanui Road intersection. This was identified through a multi-criteria analysis (MCA) process and, at that time, was supported by the community and stakeholders. A signalised intersection would allow both active mode users time to cross the intersection and reduce delays for buses, as well as generally improving safety for all roads users at this intersection. A visualisation of this concept is shown below in Figure 10.

In May 2023, an intersection report was prepared to provide an assessment of the above signalised intersection concept design. The intersection was modelled to assess traffic performance. This study identified that the Comries Road leg of this intersection currently operates at a poor level of service (LoS), particularly for right turn movements. The signalised concept design was assessed to improve LoS for Comries Road, especially for right turning traffic as well as decreasing the likelihood of right-angle crash types occurring. Therefore, a signalised T-intersection is recommended at this location.

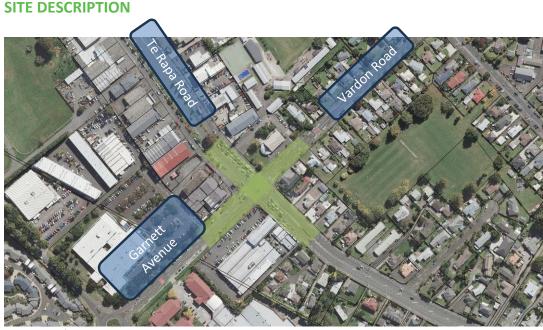
Figure 1: Site location.

The intersection of Te Rapa Road, Garnett Avenue, and Vardon Road is located in Te Rapa. The intersection is located at the southern end of the Te Rapa industrial area. Te Rapa Road is an urban connector that links Te Rapa to the south, including to the city centre. The intersection is used by school children accessing several nearby schools such as Vardon School and St Peter Chanel Catholic School. The intersection is also close to Waterworld, Minogue Park, and Vardon Park.

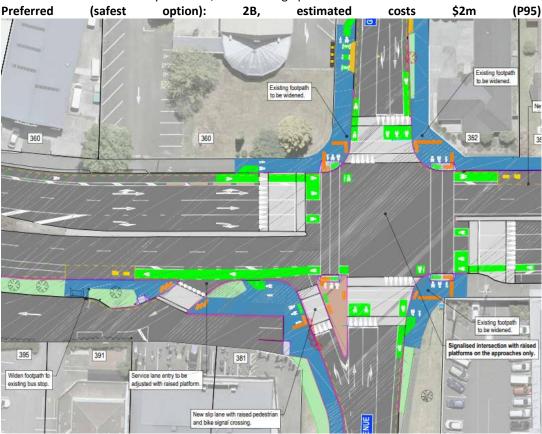
This option raises the intersection to manage driver speeds. Ramps will be designed for a comfortable negotiation speed of 40 km/h (1:20 gradient). This reduces the likelihood of death or serious injury if a crash does occur while still allowing emergency vehicles to travel through with minimal delay.

This option adds the missing pedestrian crossing on the north side of Te Rapa Road, reduces crossing distances, at all crossing points, and controls vehicle speeds which all contribute to making the pedestrians experience (including access for bus passengers) safer and more comfortable.

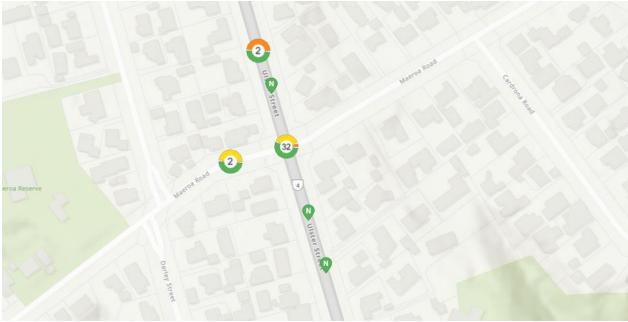
Crashes were most likely (14 out of 39) to be recorded between 1500 and 1800. 'Crossing not turning', i.e. crossroads crashes were the most common movement type (17 out of 39).

Figure 3 CAS Data – Showing Crashes (since 2015)

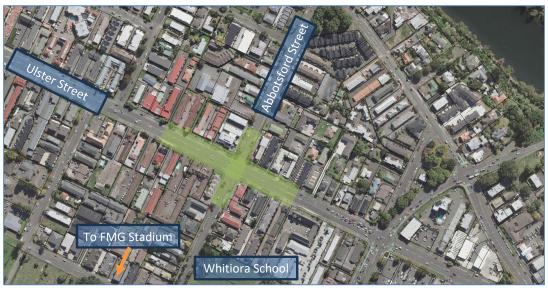
Figure 1 Site location

The intersection of Ulster Street and Abbotsford Street is located in Whitiora. The intersection is near to FMG Stadium and is located within the urban growth area. Ulster Street is an urban connector that links the Central City to the northern suburbs. The intersection is used by school children accessing Whitiora School, and local residents making daily trips including accessing bus stops on Ulster Street.

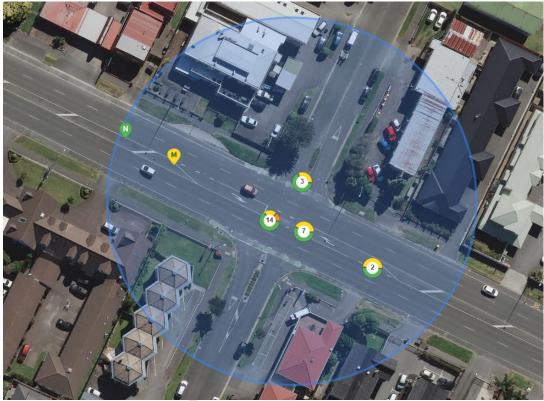
- 2 crashes resulted in serious injuries,
- 11 crashes resulted in minor injuries, and
- 15 crashes did not cause injuries
- The estimated social cost of the recorded crashes at the intersection is \$5,673,400.

Figure 2: Recorded crashes (2015 to 2024) NZTA CAS

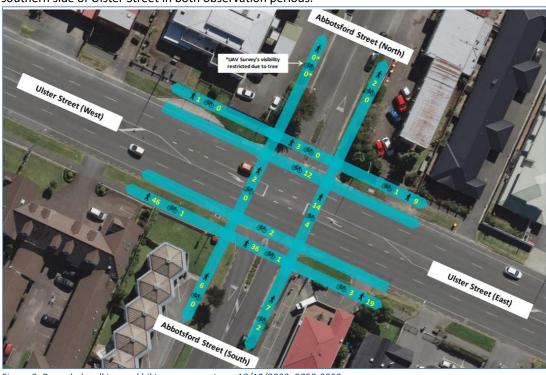
Figure 3: Recorded walking and biking movements on 10/10/2023, 0750-0850

Observed biking volumes were higher eastbound (towards the city centre) in the morning and higher westbound (away from the city centre) in the evening. Observed walking volumes were higher on the southern side of Ulster Street in both observation periods.

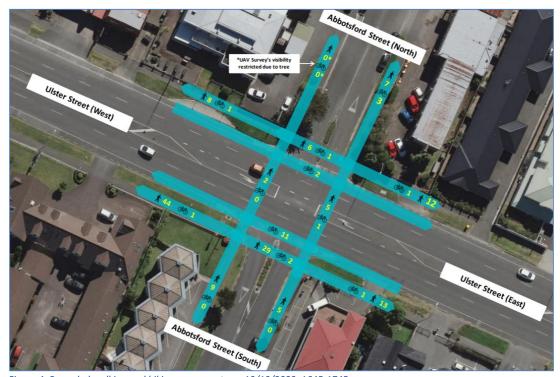
Figure 4: Recorded walking and biking movements on 10/10/2023, 1645-1745

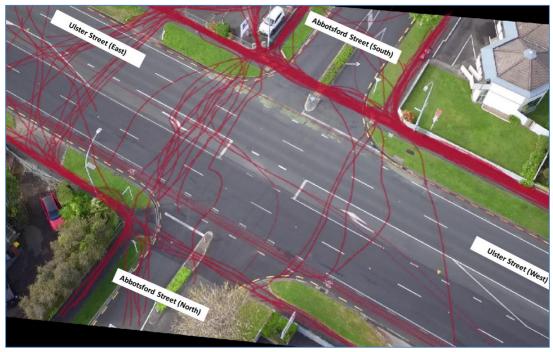
Observed walking routes across Ulster Street were dispersed along the street, however crossings were more likely to be observed east of Abbotsford Street (note that, in the image below, east is on the left). Observed walking routes across Abbotsford Street were concentrated at the existing formal crossings at Ulster Street.

Figure 5 Indicative crossing locations for walking and biking.

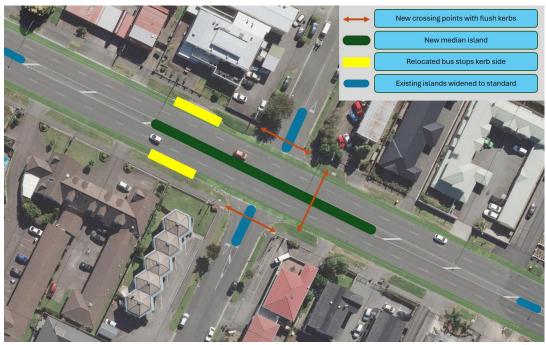
Recommended Option: At-grade uncontrolled crossing with median island Estimated costs \$400k (P95 including 30% contingency).

This option partially mitigates the risk for pedestrians and crossing the road to access Abbotsford Street and the local bus stops. The crossing includes a widened median island to provide safer and more comfortable place for pedestrians to wait while crossing. The crossing is closer to the desire line for pedestrians which will encourage pedestrians to use the facility rather than crossing informally.

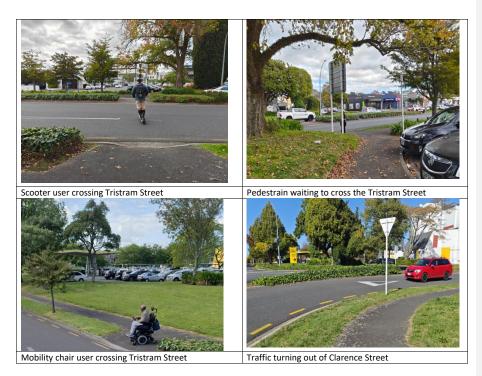
Figure 7 Site Photos - Observations

- Observed vehicles travelling at relatively high speed (particularly northbound) which can lead to serious crashes,
- The existing cutdowns at the crossing are observed to be non-wheelchair friendly due to tree roots under the pavement, on the western side.

- Many people cross Tristram Street, at both the northern and southern crossing, with no formal protection. Choosing high risk decisions often running across the road, when a gap in traffic becomes available.
- People are crossing from the direction they are coming from, for example people coming from Pak'nSave are crossing at the southern crossing point, whereas those who are coming from Clarence Street are crossing at the northern crossing point.
- The left slip lane causes masking when a truck is turning into Clarence Street from Tristram Street

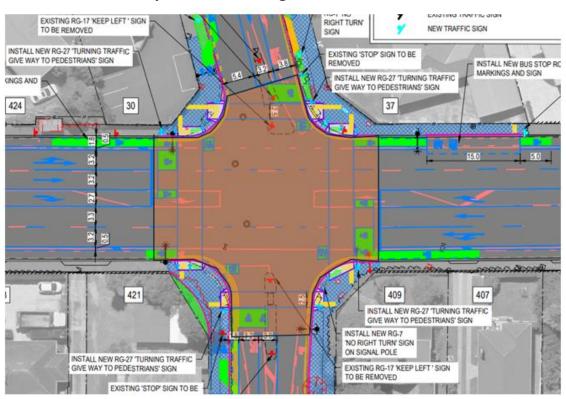
Preferred Safest Option: Raised signalised intersection with relocated bus stops. Estimated cost \$1.5m (P95).

A signalised intersection with raised safety platforms to enable a comfortable negotiation speed of 40 km/h (1:20 gradient). The intersection will include pedestrian crossing on all four legs. Kerb realignments are included to ensure suitable vehicle tracking and provide space for pedestrians waiting to cross the road.

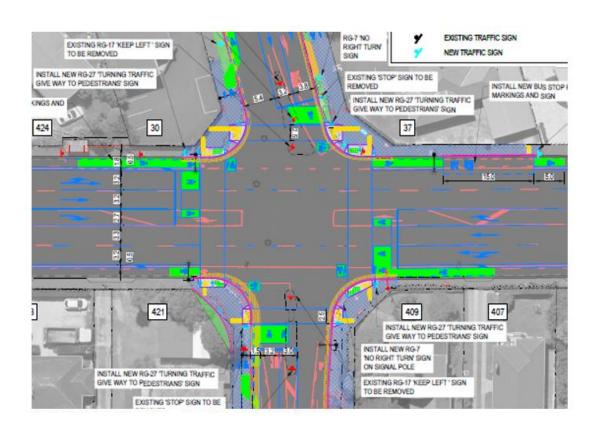
Safer Option: At-grade signalised intersection with relocated bus stops. Estimated cost \$1.3m (P95).

This alternative option, not raised, does not address vehicle speeds, however, is much safer than the existing situation.

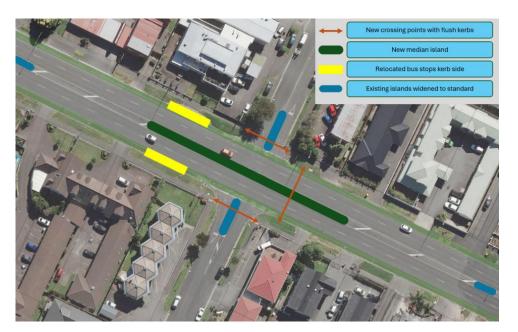
At-grade uncontrolled crossing with median island Estimated costs \$400k (P95 including 30% contingency).

This option partially mitigates the risk for pedestrians. The informal crossing includes a widened median island to provide safer and more comfortable place for pedestrians to wait. The crossing is closer to the desire line for pedestrians.

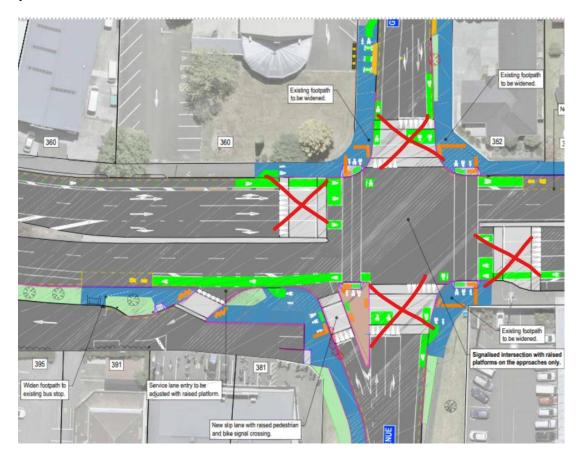
Alternative safer option: estimated costs \$1.5m (P95)

This option is the same as the preferred, except that the raised intersection is removed. Raised safety platforms remain on the left turn slip lane (Garnett Avenue) and at the service lane entrance.

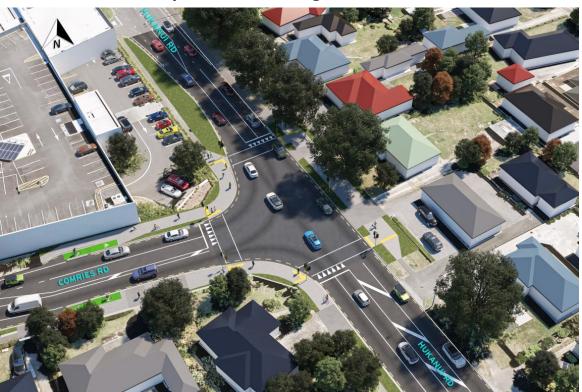
Preferred Safest Option: Raised signalised intersection - Estimated cost \$2.5m (P95).

Signalised intersection would allow both active mode users time to cross the intersection and reduce delay for buses.

Raised intersection will help reduce driver speeds to the desirable safe system threshold speed of 30km/h.

It is also recommended that the proposed signalised intersection is raised as the safest option to assist in lowering driver speeds through the intersection. The raised intersection can help reduce driver speeds to the desirable safe system threshold speed of 30km/h and the lessen the impact and severity should driver vs driver or driver vs active mode user conflict occur.

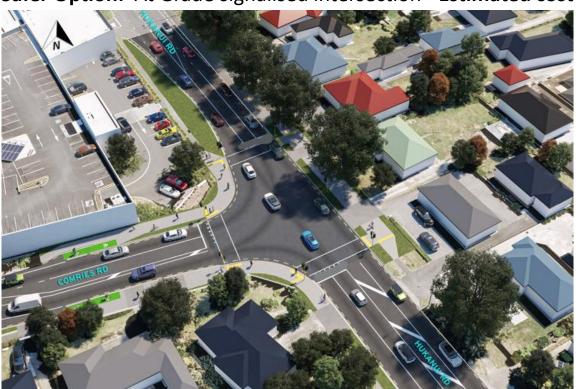
Safer Option: At Grade signalised intersection - Estimated cost \$2.0m (P95).

Signalised intersection would allow both active mode users time to cross the intersection and reduce delay for buses.

At-Grade intersection will unlikely help reduce driver speeds to the desirable safe system threshold speed of 30km/h.

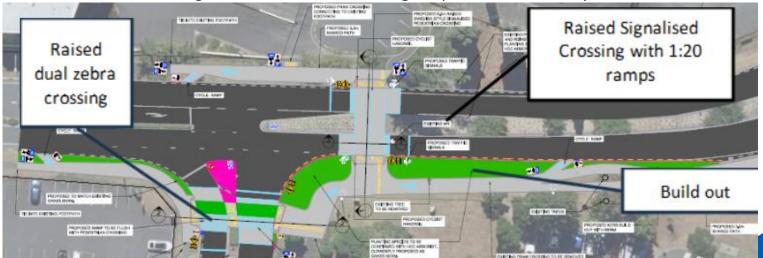
Preferred Safest Option: Raised signalised pedestrian crossing - Estimated costs \$1.58M (P95)

- Signalised crossing would allow active mode users time to safely clear the live lanes.
- Raised safety platform will help reduce driver speeds to 40km/h with a 1:20 ramp grades.
- Proposal include the build out to remove the left slip lane, therefore shortening the crossing distance for both pedestrians and cyclists, as well as shortening the 'run time' for the signals.
- Raised dual crossings will allow a safe crossing for pedestrians and cyclists and for other vulnerable users.

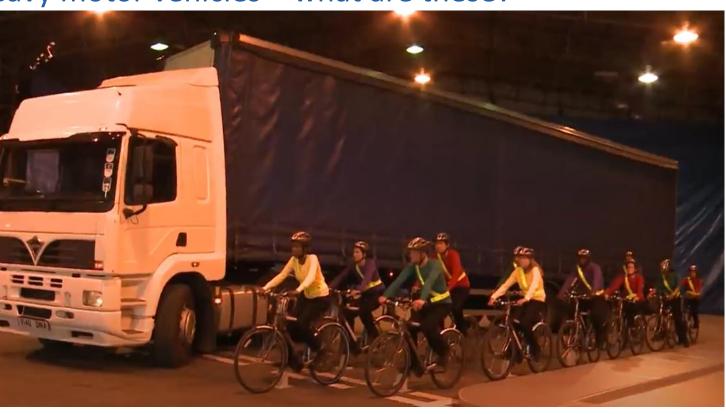
Technology and changes to heavy motor vehicles to reduce the blind spot risk

- Coroners' enquiry for Te Rapa Road/Sunshine Avenue/Bryant Road cycle fatality had a strong focus on exploring this.
- Recommendations aimed at work to be undertaken by Road Controlling Authorities.
- In 'Comments' included the message that caution is required when sharing the road with a large truck must be made clear to cyclists
- Accepted that while some truck modifications may be helpful in keeping vulnerable road users visible on the roads, they did not consider such recommendations practical or viable for current heavy vehicle trucks on our roads
