### **Appendix A Structure Plan and Catchment Extent**

Te Awa O Katapaki Catchment Management Plan

#### Stormwater Model Build Report

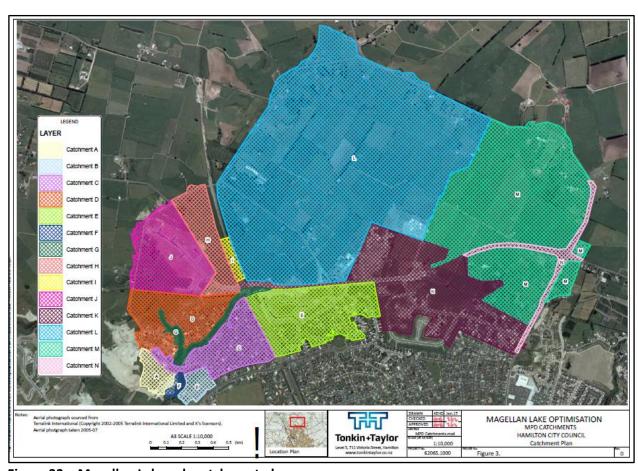
Figure 33 – Magellan Lake sub-catchment plan

The extent of CDL land is shown as catchments A-G in Figure 33. Enhancement works in the form of conversion of the lake to a wetland could provide the required WQV for up to 22 hectares which would comprise catchments A, B and C. The 22-hectare area is that is all that can be practically treated in Lake Magellan as the aforementioned catchments discharge directly to the lake.

Runoff from the remaining catchments D and E is mixed with water from the wider catchment that is be already treated before it reaches Lake Magellan<sup>42</sup> or is already mixed with partially treated catchment water prior to flowing into the Lake. It is not possible to isolate runoff from catchments D and E for treatment within the Lake.

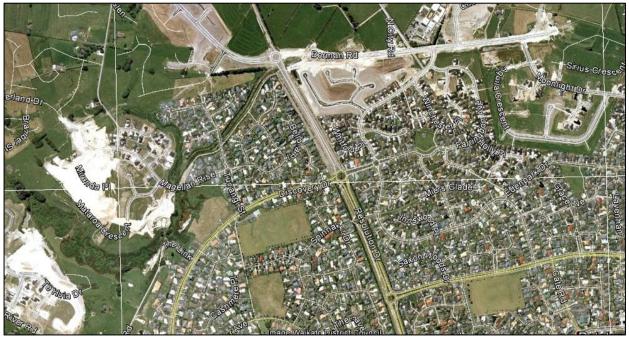
Figure 34 – Aerial image (courtesy Google Earth), January 2008

CDL developed a portion of the area surrounding the Lake prior to the Lake development being consented (approximated as Area C). The aerial photos below illustrate the change in land development between January 2008 and March 2016. In the January 2008 photo the only areas of CDL land undeveloped were the areas immediately east and northwest of the Lake. No stormwater attenuation or treatment devices (other than the Lake and catchpits with gross pollutant traps) were installed in land developed by CDL.

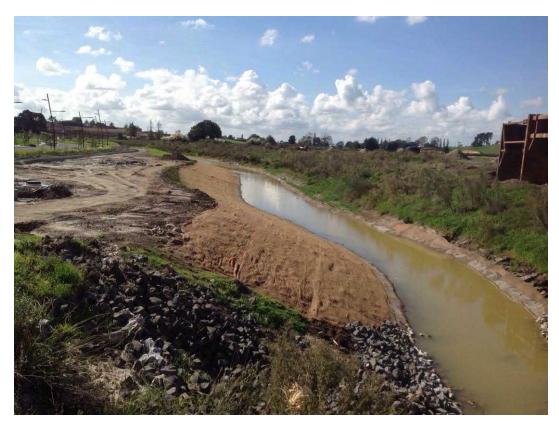
Plate 1: North City Road main swale.

The stormwater swales being constructed in the upper catchment to replace the drains (see Plate 1) currently present habitat equivalent to an open pipe rather than a swale, with poorer quality habitat than a rural drain. The swale upstream of North City Road is almost straight with no variation in depth or width and no constructed meanders or habitat features. The swale banks are lined with matting or geotextile (see Plate 2), but planting had not been undertaken at the time of the survey. Sediment deposition has occurred throughout the swale systems either as a result of collapsed banks or through stormwater inputs. Where riparian vegetation has reestablished (see Plate 3), it consists of adventive pasture and weed species such as rank grass, red clover, fathen and dock. These swales are likely to offer lower habitat quality than the farm drains they replaced.

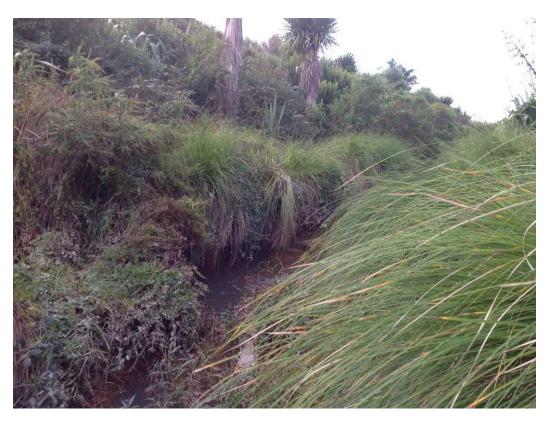
Plate 4: Tuirangi Floodway.

The Tuirangi Floodway is an artificial channel created to replace the original TAOK channel to facilitate land development. Although mainly straight and uniform, the riparian margin and floodplain has been extensively planted and aquatic macrophytes are abundant in the channel in some places (see Plate 4). This has resulted in greater aquatic habitat diversity than would usually be expected in an artificial system, because water flow is creating meanders, pools, and eddies around the overhanging and in-stream vegetation.

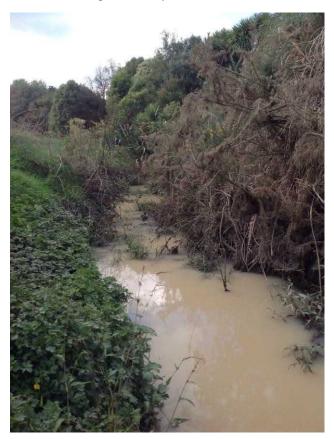
Plate 5: Trinidad Place tributary.

The Trinidad Place tributary is a small modified waterway with headwater wetlands draining down a small gully system to a confluence with the Tuirangi Floodway (see Plate 5). It has little natural riparian vegetation but is somewhat protected by the very steep gully banks with weed species overhanging the channel. It has relatively natural meanders, and variation in water depth and flow. It may dry up or become intermittent in summer when flows and shallow groundwater levels drop, but it is likely that some pools remain as habitat refuges.

In addition to the effect of iron drainage, fine colloidal clay particles were observed contributing to turbidity throughout the catchment, particularly at Trinidad Place (see Plate 5). Suspended sediment and turbidity are elevated at sites 1-3 and 5, partly in response to the high rainfall event of 18 April 2015 and the resulting erosion effects. However, Trinidad Place has particularly high suspended sediment loads and turbidity that appear to be a result of construction site runoff. Sedimentation was observed in several locations throughout the catchment, with lobes of sediment present in newly constructed swales and the Trinidad Place tributary in addition to thick sediment coating vegetation in many places after the 18 April 2015 rainfall event.

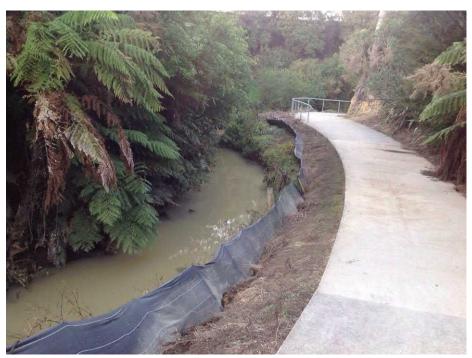
Plate 6: Bentley Rise TAOK Stream main stem.

The TAOK Stream between Magellan Lake and Petersburg Drive is a modified habitat with water depth and channel width varying considerably along the main stem. Active erosion and scour was common throughout the middle reach at the time of survey (see Plate 6), although subsequent observations in 2016 indicate bank stability has stabilised with development of bank vegetation.

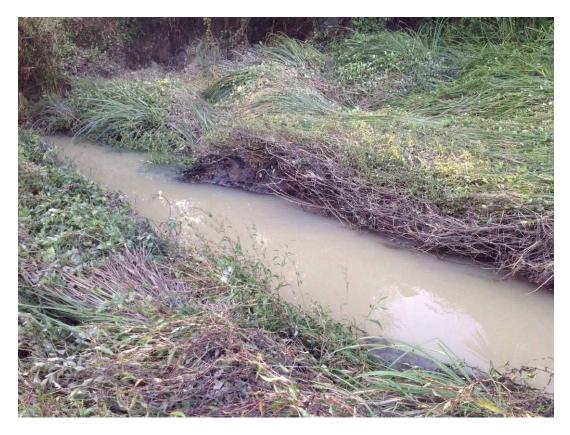
Plate 8: TAOK Stream upstream of River Road showing sedgeland vegetation.

As a result of the 18 April 2015 rainfall event, water depth was observed to have been approximately 1.5m above the channel based on debris deposition and vegetation flattening (see Plate 8), and parts of the *Carex* sedgeland had been scoured out and overturned. However, bank erosion and channel scour is likely to have been significantly worse had dense riparian and wetland vegetation not been present.

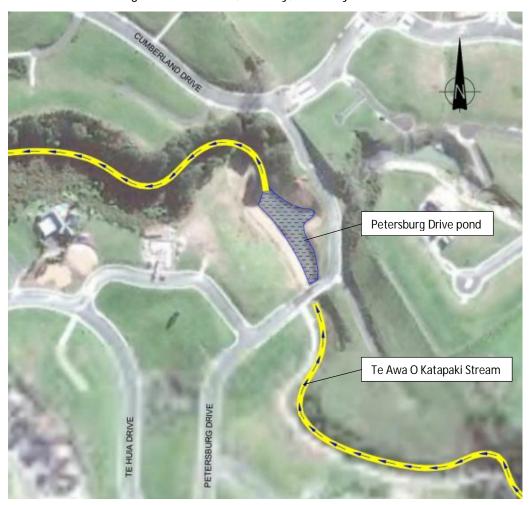
Figure 2.1: Location of Petersburg Drive online pond

Monitoring of the effect of Petersburg pond (see Figure 2.1) on TAOK Stream water temperature and dissolved oxygen was undertaken by T+T for HCC as part of its CSDC monitoring programme<sup>7</sup>. Continuous water temperature data were collected at locations upstream and downstream of the pond over the 2013/14 summer period with data sondes deployed to monitor dissolved oxygen for one week each month during December 2013, January, February and March 2014.

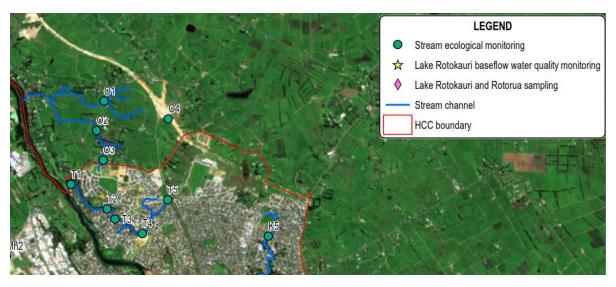
Stream habitat and sediment quality data have been collected from five sites on the TAOK Stream since 2013 as part of HCC's CSDC monitoring programme. Site locations are shown as T1 to T5 on Figure 2.2. All five sites were monitored in 2013, with selected sites monitored in 2019 and 2020 following a change in monitoring approach and a shift to prioritised monitoring. Monitoring comprises a qualitative habitat assessment (QHA) undertaken over a 100 m reach in accordance with WRC's Regional Guidelines for Ecological Assessment of Freshwater Environments<sup>8</sup>, collection of a single macroinvertebrate sample and collection of a composite sediment quality sample.

Figure 2.2: Location plan extracted from HCC's SREMP and showing existing TAOK monitoring site locations (Sites T1 to T5).

Monitoring site locations for the TAOK catchment are shown in Figure 2.2. TAOK monitoring site locations were established prior to the bulk of the development occurring upstream of Resolution Drive. Consideration should be given to adding a 6<sup>th</sup> stream ecological monitoring site is added to the ongoing monitoring programme in the upper catchment (Site T6).

The SREMP (CSDC driven monitoring programme) includes visual inspection-based water quality monitoring in the TAOK. The water components of the SREMP that are relevant to the TAOK catchment are described in detail in the SREMP and summarised below. Site locations are shown on Figure 2.2. In all cases the monitoring is adaptive (site locations and frequency can be amended as needed) and there are triggered actions and responses. The SREMP should be referred to for detail.

The SREMP (and previous CSDSC monitoring plan) has an established network of monitoring sites throughout Hamilton City, including 5 sites in the TAOK catchment. Ecological monitoring includes habitat quality using WRC's Regional Ecological Monitoring of Streams (REMS) protocol, macroinvertebrate and sediment quality sampling. Sites are visited and sampled annually, two yearly or four yearly depending on catchment development progress and data results and trends. Site locations are shown on Figure 2.2. with the key components of the monitoring summarised below.

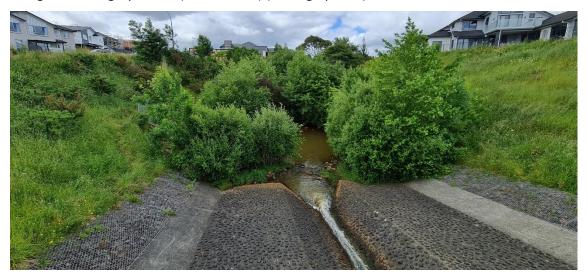
Photograph 3.1: Vegetation observed around the stilling basin downstream of Magellan Lake showing grey willow growing around the stilling basin.

Riparian planting was undertaken by CDL along the reach of the TAOK Stream from the end of the stilling basin to the existing well shaded part of the stream (approximately 50 m) in April 2011. The stream reach immediately downstream of Magellan Lake was observed to be overgrown by exotic weed species. The immediate area downstream of the outlet of Magellan Lake (stilling basin) was overgrown with grey willow (*Salix cinerea*) (Photograph 3.1).

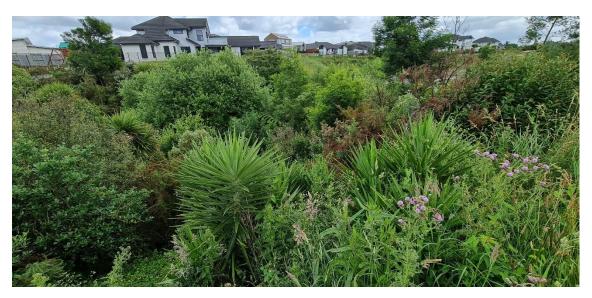
Photograph 3.2: Vegetation observed south of the stilling basin downstream of Magellan Lake showing numerous exotic weed species.

In the area downstream of the stilling basin, there were sparse taller native species observed such as cabbage tree (*Cordyline australis*), *Comprosma robusta* and ponga/tree ferns. However, the area was mostly inundated with weeds and exotics of varying strata (herbs to tree species) (Photograph 3.2). There was also no evidence of any maintenance of the area. Because of the density of the large weeds and steep terrain, we did not access the understorey to assess the success of any understorey plantings.

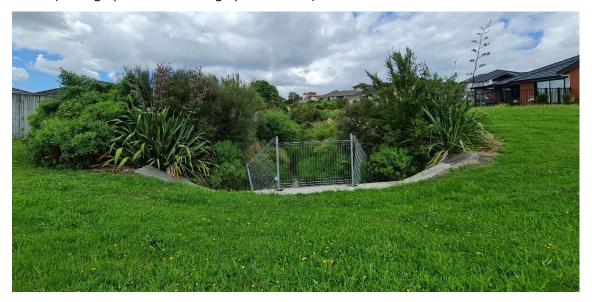
Planting work in this area was completed in August 2013. The riparian plantings of the watercourse immediately south of Cumberland Drive have been more successful than those downstream of Magellan Lake. Most of the native species have been able to prevent the invasion of larger exotic weeds (Photograph 3.3 and Photograph 3.4 below).

Photograph 3.3: Riparian planting along the watercourse immediately south of Cumberland Drive have been relatively successful (view from Cumberland Drive).

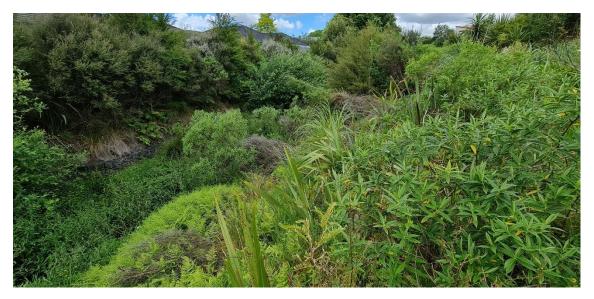
Photograph 3.4: Good growth of planted natives and few weed species.

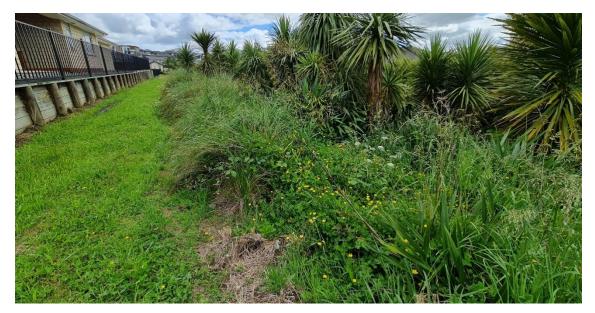
However, at the southern end of the plantings, exotic grasses and species such as creeping buttercup are smothering plantings (Photograph 3.5). There is no evidence of any recent maintenance besides mowing of the grass immediately adjacent to the plantings.

Photograph 3.5: Southern end of riparian planting south of Cumberland Drive showing pasture grass species smothering plantings.

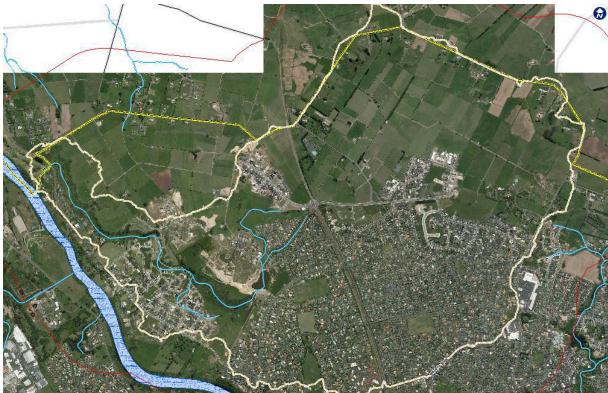
Figure 1 Te Awa O Katapaki Catchment.

Note: Topographical Catchment boundary shown in light orange, Te Awa O Katapaki Stream shown in light blue

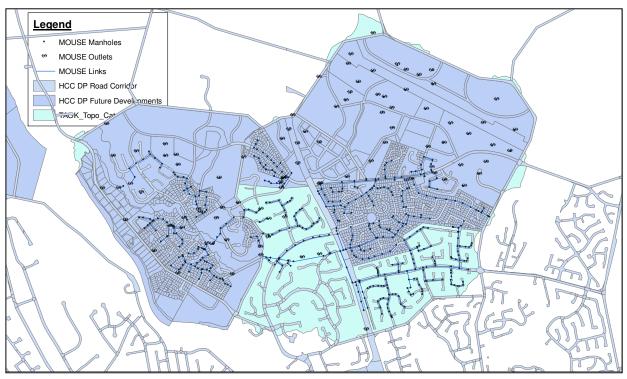
Figure 3 Extent of hydraulic model used for FHM

The figure below shows the extent of the hydraulic model.

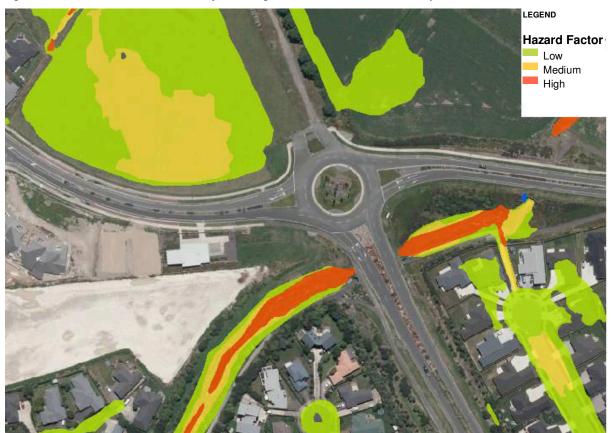
Figure 5 Hazard classifications for the 100 year existing scenario at the Borman Road underpasses

While the flows increase significantly for the future scenario, flows are predicted to be contained within the floodway extents. Future development in the upper catchment is expected to result in flows being re-directed along roadways. Some surface ponding is still predicted to occur in the upper catchment; however this is reduced compared to the existing scenario.

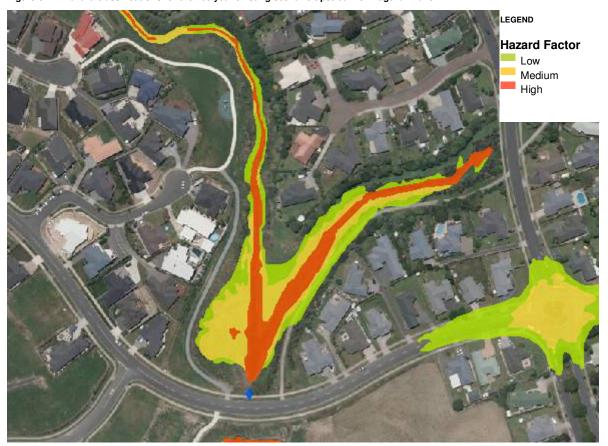
Figure 6 Hazard classifications for the 100 year existing scenario upstream of Magellan Lake

Flow through this portion of the catchment is predicted to double for the future scenario. While flow depths increase about 200 mm, this is still predicted to be contained within the reserve area and just outside of private property boundaries.

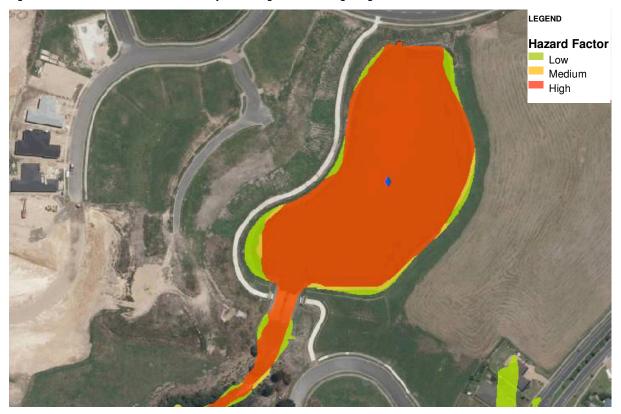
Figure 7 Hazard classifications for the 100 year existing scenario through Magellan Lake

While flow rates through the lake are expected to double for the future scenario, the lake level is expected to increase by only about 300 mm. The additional flow volume is likely to be managed effectively through the lake due to the lake volume and the effect of the outlet control structure.

The velocity increase within the lake is expected to be negligible.

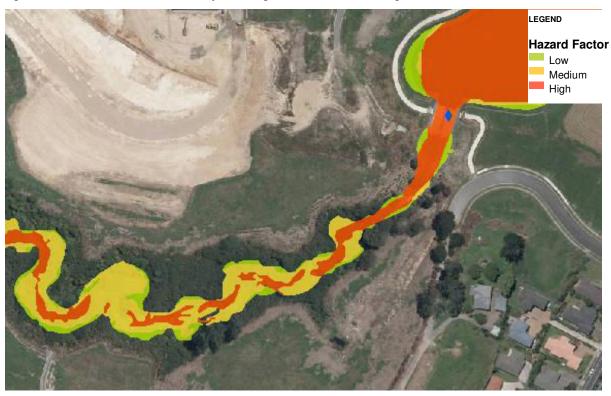
Figure 8 Hazard classifications for the 100 year existing scenario downstream of Magellan Lake

Flows across the outlet weir of Magellan Lake are expected rise about 700mm between the existing and future scenarios. Flood water is expected to be contained within the structure, however the flow velocities are likely to increase by about 20% as the discharge increases for larger storm events and development scenarios with more runoff.

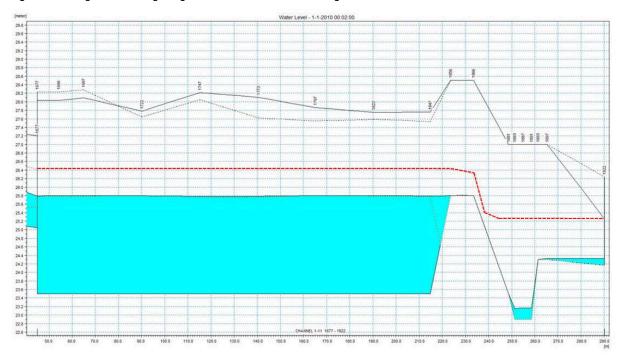
Figure 10 Long-section through Magellan Lake and downstream stilling basin

Analysis has been undertaken to determine the lake level and flow velocity at the outlet of Magellan Lake. The analysis involved modelling of the lake and its outlet energy dissipation structure (stilling basin) using as-built plans for the 2 year and 10 year storm events.

Figure 10 below shows a portion of the model setup through the lake and spilling basin, with the left and right banks and chainage shown in the top two lines. The area shown in blue represents the water level at the very start of the 2 year event, while the red line indicates the maximum water level.

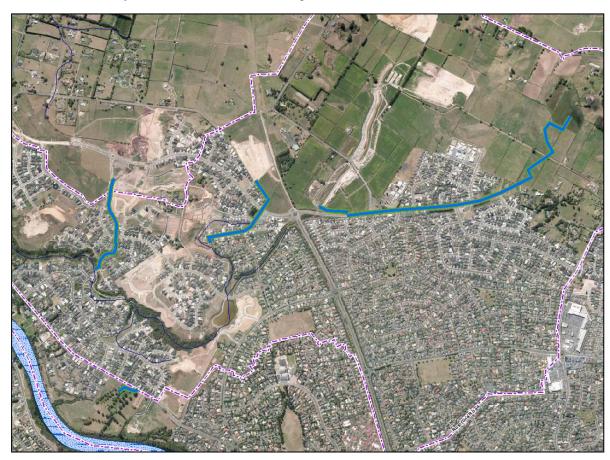
Figure 2 - Overland flowpath figure from ICMP draft report

- Downstream of the Bourne Brook Swale, which has not been identified as a key overland flowpath in the draft ICMP report; and
- The Borman Road overland flowpath. Development since the drafting of the ICMP has caused some uncertainty around the current OLFP alignment.

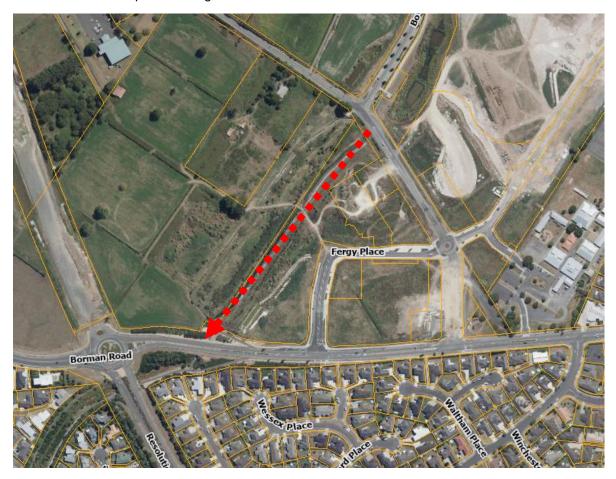
Figure 3 - Proposed alignment for Bourne Brook overland flowpath

It is recommended that HCC ensure that this overland flowpath is incorporated into the updated consent and the flowpath is recognised in the final ICMP.

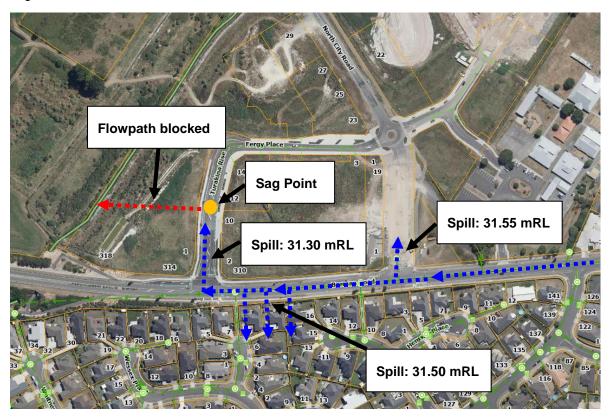
Figure 4 - Current Borman Road overland flowpath location

Partially due to stockpiling of fill material west of Turakina Rise, no flowpath currently exists between the sag on Turakina Rise and the TAOK channel. Once the volumes within Turakina Rise sag is exceeded, any additional flow would flow through the footpath adjacent to the private properties, generally in the vicinity of 10 – 16 Welwyn Place and then pond at the North City Road sag location.

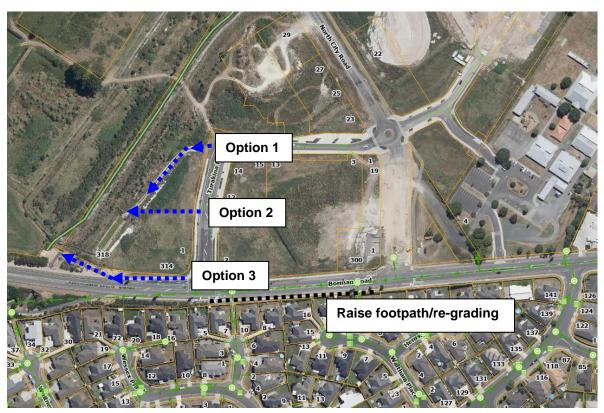
Figure 5 – Potential concept options for Borman Road overland flowpath locations

At this stage it is recommended that the Option 2 alignment be incorporated in the final TAOK ICMP. This option will retain the OLFP at a location that minimises ponding on Turakina Rise. It is recommended that HCC make some allowance for minor civil works along the Borman Road footpath and/or intersection with Turakina Rise. Only minor elevation differences exist between the sag points and regrading works may be required for the function of the flow path.

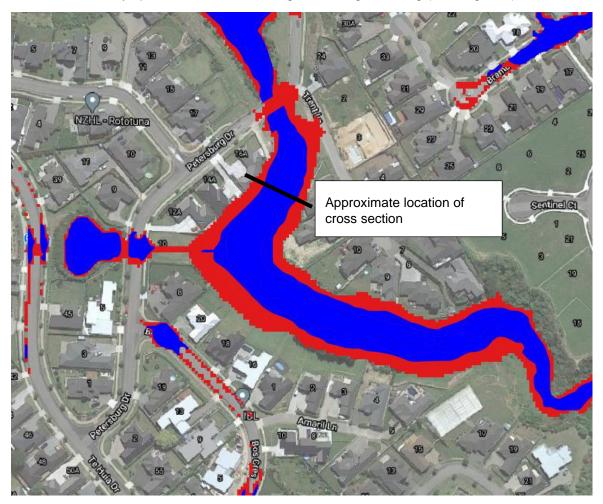
Figure 6 Flood hazard extents upstream of Petersburg Drive. ED+CC results shown in blue (2015 model), MPD+CC results shown in red (2017 model).

Based on the outcomes of their modelling, AECOM identified that the critical area of potential flood hazard to private properties along the main TAOK channel (due to greenfield MPD development) is located immediately upstream of the Petersburg Drive bridge crossing (refer Figure 6).

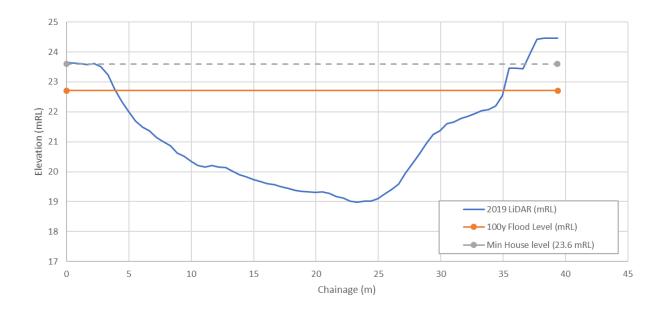
Figure 7 TAOK Creek section, upstream of Petersburg Drive bridge crossing.

Peak flood depths from the truncated model and channel bathymetry data were used to interpret peak water surface elevation at a section upstream of the Petersburg Bridge (Figure 7) to confirm the AECOM conclusions. Based on Figure 7 the 100y ARI MPD peak water level is approximately 1 m below building pad levels in this location, i.e. while the MPD scenario predicts an increase in flood depths, private properties are not impacted.

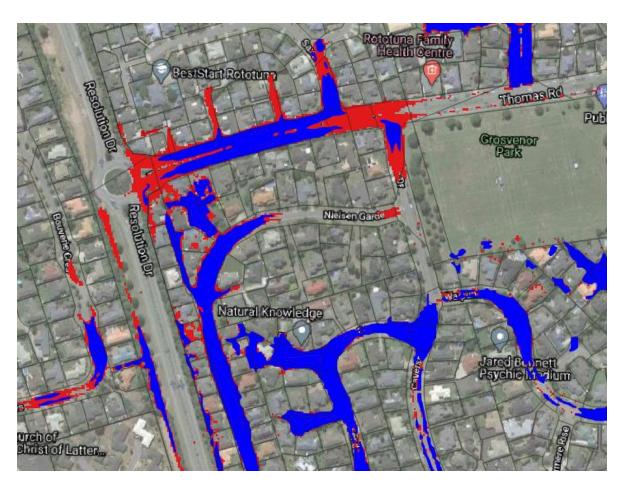
Figure 8 Flood hazard extents at the intersection of Resolution Drive and Thomas Road. ED+CC results shown in blue (2015 model), MPD+CC results shown in red (2017 model).

Increases in brownfield flood extent are observed in several locations throughout the catchment. This appears to be driven by an increase to brownfield impervious assumptions in the MPD scenario when compared with the ED scenario (to simulate in-fill development). This increase in extent therefore represents the effects of in-fill development without mitigation. The most significant area of increase in extent is shown below in Figure 8. In this location Resolution Drive presents as a blockage to overland flow and thus exacerbates the additional runoff volumes cause an increase in ponding in this location. The increase in ponding results in an increase of flood hazard extent on approximately 6-7 private properties. Most of these properties were impacted to some extent in the ED scenario.
