Soil information for four Hamilton southern wastewater treatment plant land treatment sites

Prepared for: Beca International Consultants Ltd

Contract Report: LC4260

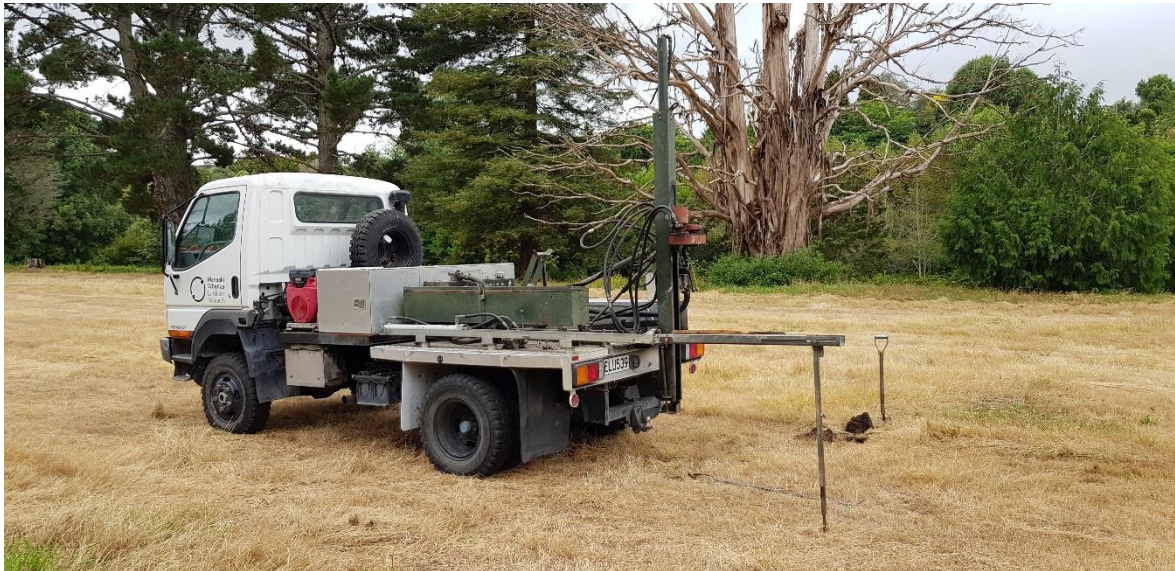
Figure 1. A light coring rig was used to obtain an undisturbed soil core for description where crop damage was not of concern.

In the field, soil observations to about 1 metre below soil surface were undertaken using a light coring rig (Figure 1) or by hand augering where use of the coring rig would cause crop damage. Appendix 1 shows observation sites at the completion of the observation in the event of claims for crop damage. Soil descriptions placed emphasis on soil properties most relevant to irrigation of treated wastewater (i.e. colour, texture, consistence, drainage). Sites were located using a hand-held Global Positioning System device (Garmin GPSMAP® 64s) and are shown in Appendix 2.

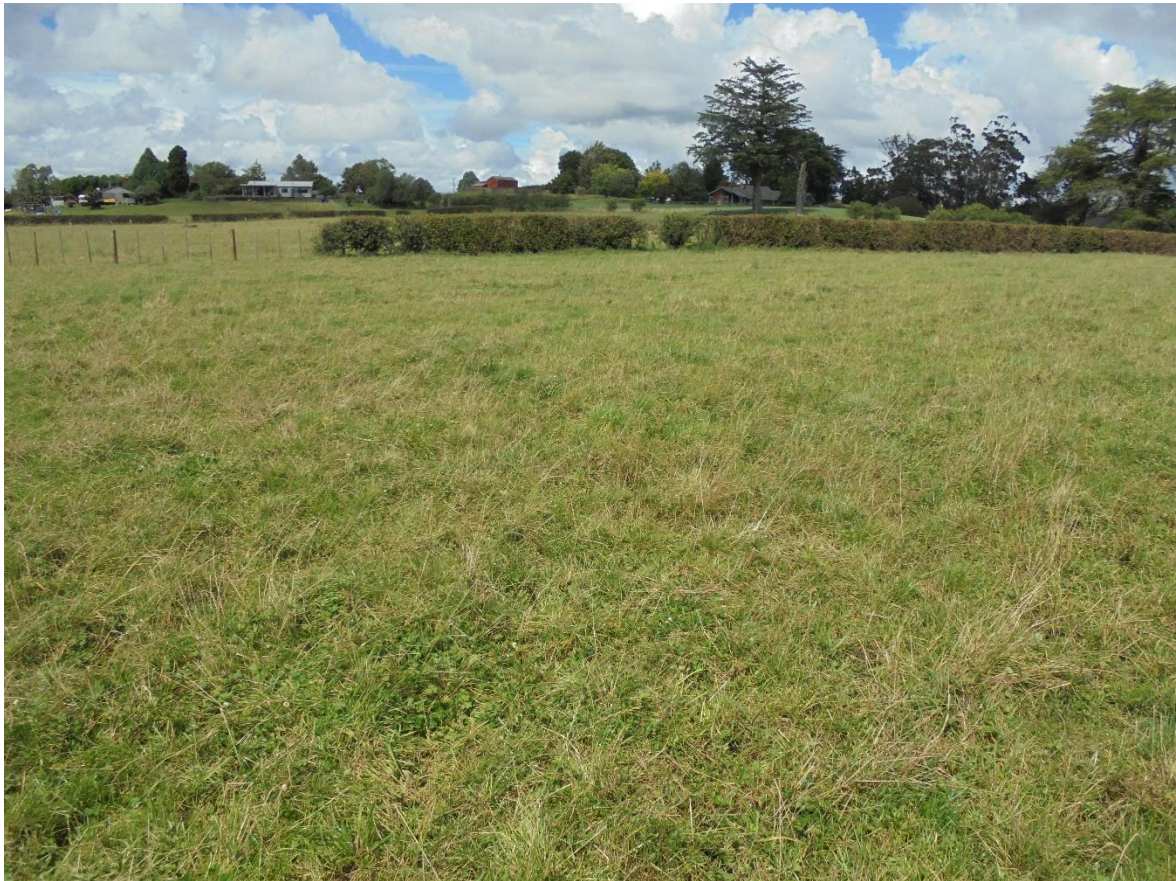
Figure 2. Sharpe Farm is predominantly flat to undulating but with minor undulating toeslopes in the southwestern part of the site.

At Sharpe Farm (Figure 2), S-Map online shows two map units. The major map unit areas relate to alluvial soils on the Hinuera Formation (deposited by the ancestral Waikato River) but these are away from the levees and in a backswamp landscape position where we would expect less well-drained soils (Pukehina and Wharepunga families). The very minor map unit area pertains to volcanic tephra covered low hills (Mairoa and Te Rahu families) which are surrounded by alluvium of the Hinuera Formation. Before S-Map online the Mairoa family would have been included in Tirau soils while the Te Rahu family would have been included in Hamilton soils.

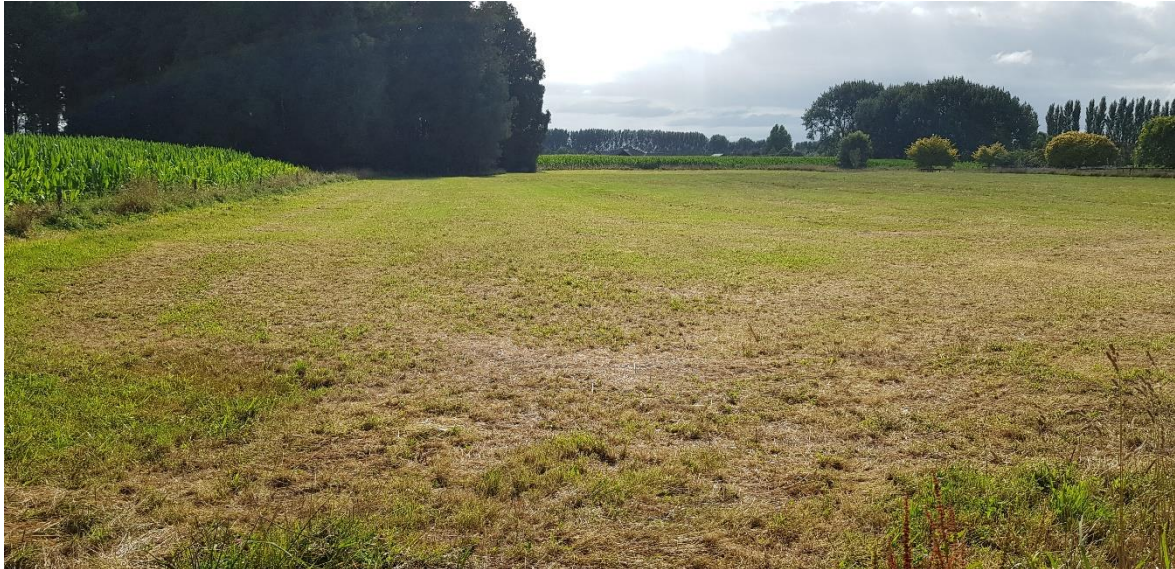
Figure 3. Low-lying land at Narrows Road is shown by S-Map online to be predominantly poorly drained Pukehina family soils developed on the alluvial Hinuera Formation.

At Narrows Road S-Map online shows two map units (Figures 3–4). Major map unit areas relate to alluvial soils on the Hinuera Formation but away from the levees and in a backswamp landscape position, so we expect less well-drained soils (Pukehina and Wharepunga families). Before S-Map, the Pukehina family would have been included in Te

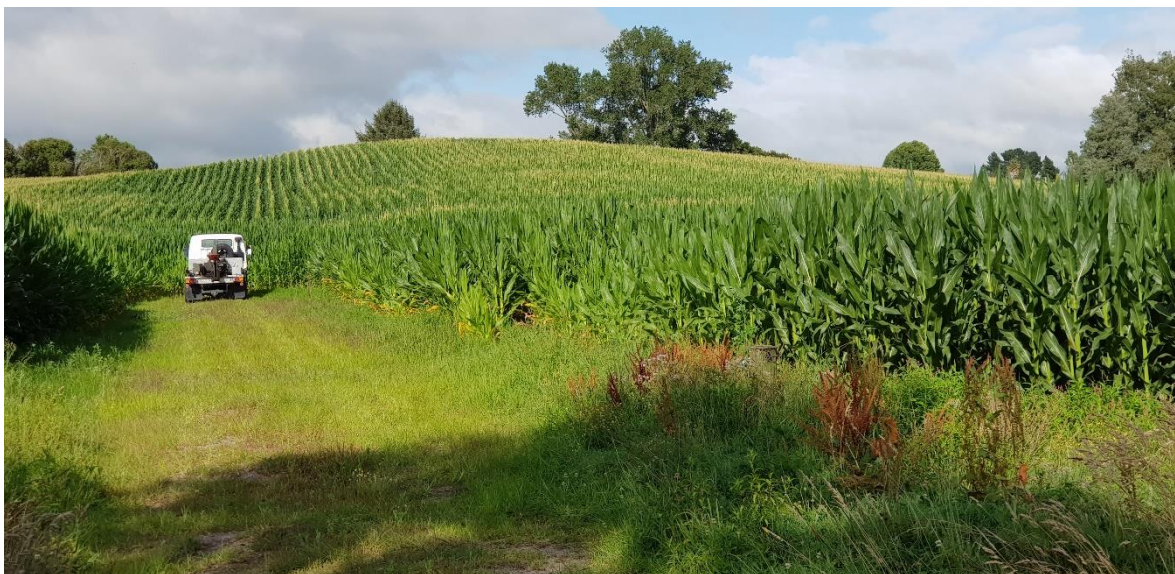
Figure 4. Higher elevation rolling land is shown by S-Map online to be Mairoa and Te Rahu soil families developed in volcanic tephra.

Kowhai soils while the Wharepunga family would have been included in the Bruntwood soils of Singleton (1991). The minor map unit relates to low hills that are volcanic tephra covered (Mairoa and Te Rahu families) which are surrounded by alluvium of the Hinuera Formation. Before S-Map online, the Mairoa family would have been included in Ohaupo soils, Te Rahu family would have been included in Hamilton soils.

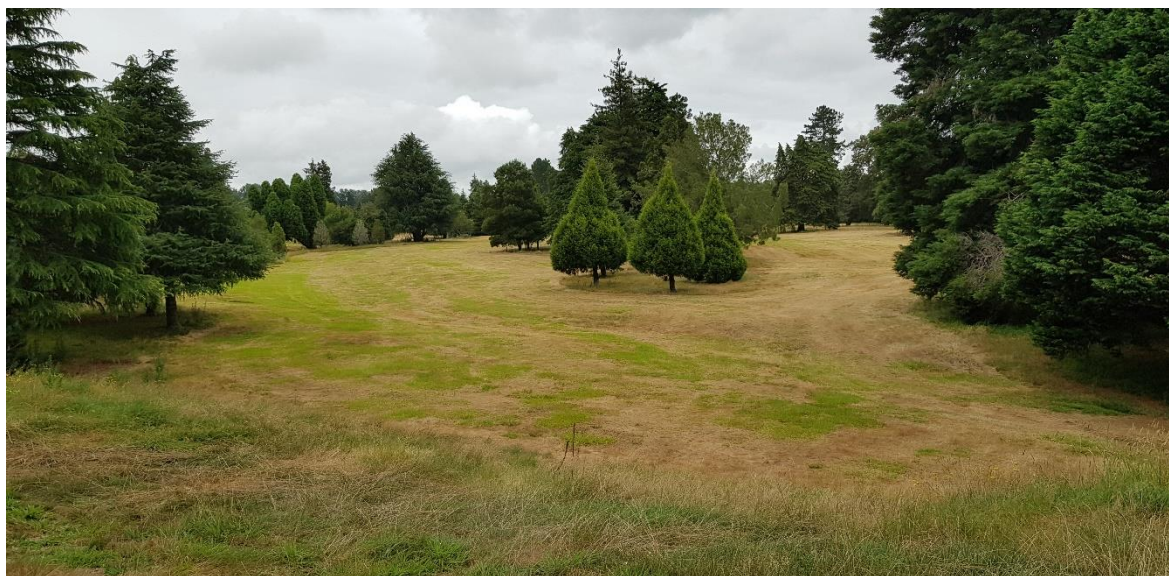
Figure 5. The Golf Course site has well drained Turangi family soils developed in pumice alluvium.

S-Map online shows one map unit with two soil classes both developed on terraces formed from the Taupo Pumice alluvium from 186 AD eruption deposited by the Waikato River. The soil classes are both deep (Turangi family), but one is sandy and the other loamy over sand (Figure 5). Before S-Map, the soils were included in Waikato soils.

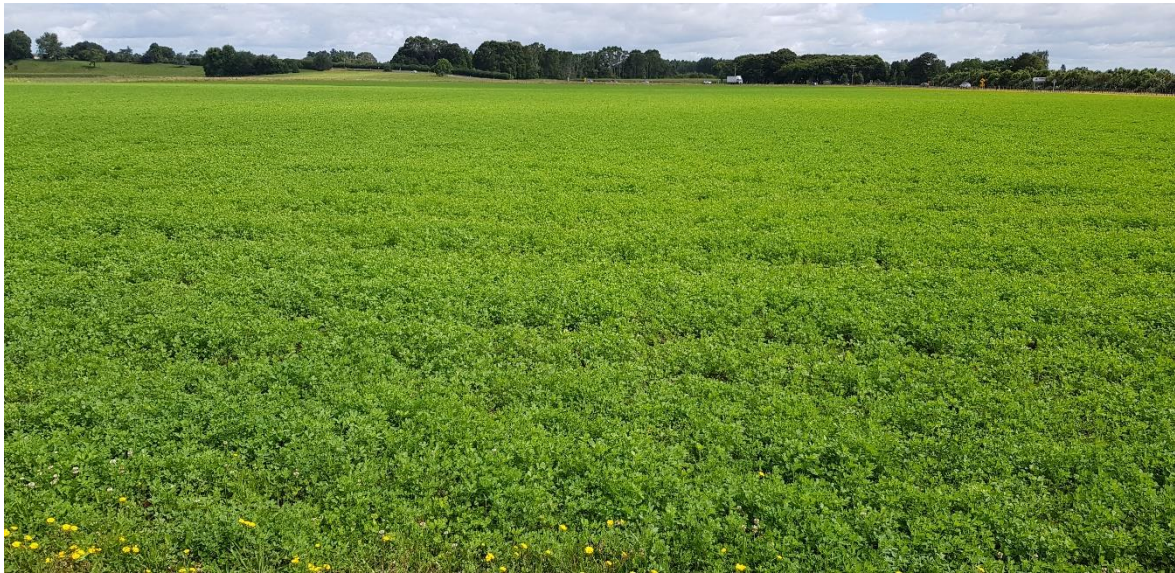
Figure 6. S-Map online shows Penniket Road Site 3N to have soils within Otorohanga and Airfield soil families.

There are two sites at Penniket Road (3N and 3S; Figures 6 and 7). Grange et al. (1939) show the Penniket Road sites to be Horotiu sand and coarse sandy loam with Horotiu sandy loam towards the north. At both Penniket Road sites (3N and 3S) S-Map online shows two map units both developed on the alluvial fan surface. The alluvial fan was deposited by the ancestral Waikato River and is known as the Hinuera Formation. Being an alluvial surface, the levees have better drained soils (Otorohanga family) while in lower landscape positions soils become less well-drained (Airfield family). Before S-Map, Otorohanga family soils were included in Horotiu soils while Airfield family soils were included in Whatawhata soils (Bruce 1978). The Otorohanga family developed on Hinuera Formation has volcanic tephra in the upper soil profile (>35 cm thickness) that was deposited in the last 20,000 years and which gives it high phosphorus retention.

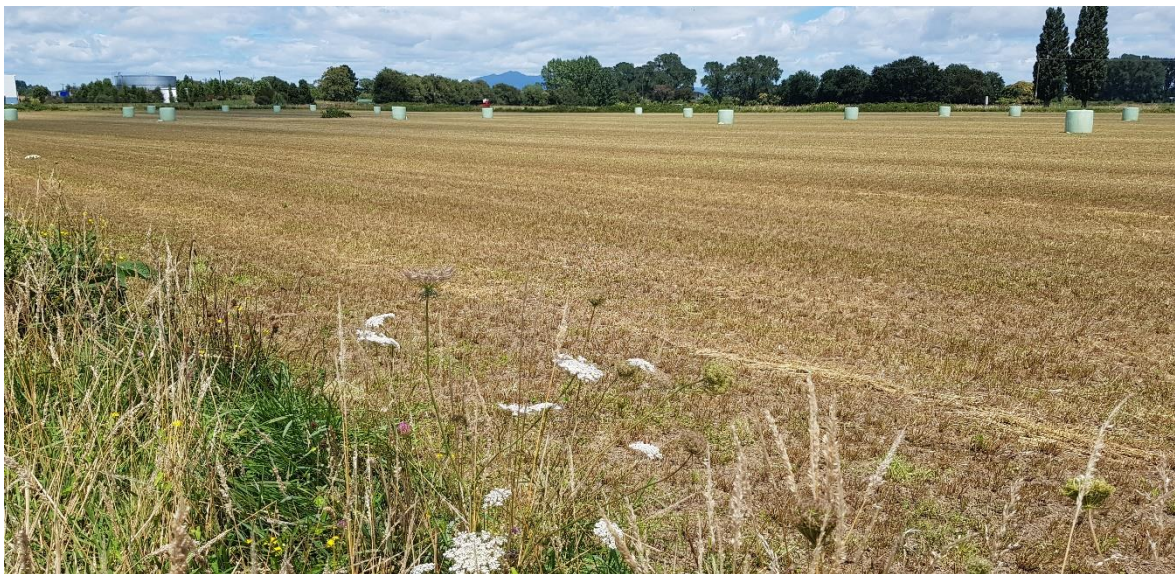
Figure 7. S-Map online shows Penniket Road Site 3S to have Otorohanga, Airfield and Pukehina soil families.

Grange et al. (1939) show the southern Site 3S at Penniket Road to be Horotiu sandy loam while S-Map online also shows Otorohanga and Airfield families present, with the potential for Pukehina family towards the south.

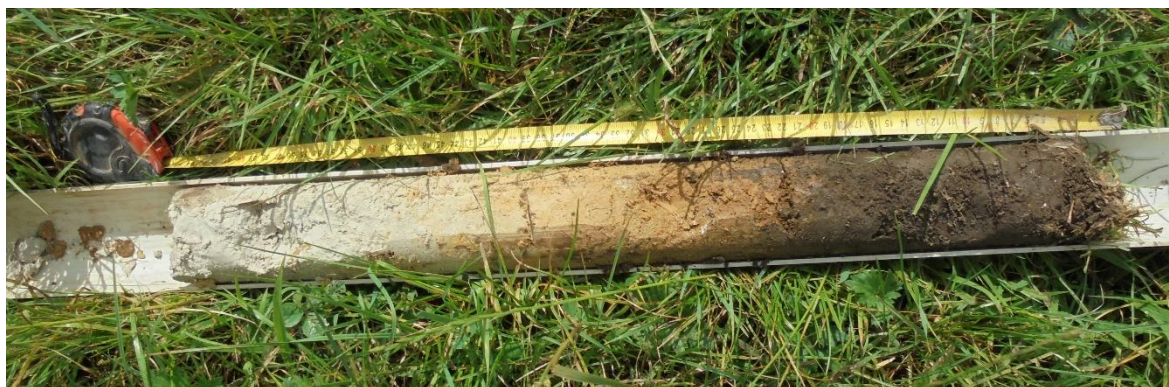
Figure 8. Imperfectly drained soil typical of the alluvial Hinuera surface at Sharpe Farm. Grey colours indicate waterlogged conditions for much of the year.

Most of the land at Sharpe Farm is planted in pasture and two distinct landform units are evident. The majority of the land is a dissected terrace (Hinuera Formation) of the Waikato River with a combination of imperfectly drained and poorly drained soils (Figures 8 and 9). Grey colours in the subsoil of these soils indicates waterlogging for considerable periods of the year. Well-drained soils mapped by Grange et al. (1939) were not evident although now the definition of 'well drained' has been revised and formalised. A water table was often encountered between 57 and 70 cm below the soil surface in February 2023. Wetter areas of the farm had drainage ditches.

Typically, the imperfectly drained soils have a dark loamy topsoil overlying a loamy yellowish brown upper subsoil. Lower subsoils are firm and grey. The grey colour indicates waterlogging for considerable periods of the year. Below about 70 cm the soils are often developed in pumice sand, but this can be waterlogged as well. Where upper subsoils are yellowish-brown, they are judged to have moderate anion retention. This means the soil has some ability to retain phosphorus.

Although Joe (1986) did not measure the hydraulic conductivity of similar soils, the upper subsoils are judged to have K_{sat} of $2 \times 10^{-5} \text{ m s}^{-1}$ to $1 \times 10^{-6} \text{ m s}^{-1}$; whereas the firm grey lower subsoil is judged to have K_{sat} of c. $2.5 \times 10^{-6} \text{ m s}^{-1}$, with K_{40} of c. $3.9 \times 10^{-7} \text{ m s}^{-1}$.

The imperfectly drained nature of the soil, with indication of subsoil waterlogging, combined with restricted subsoil permeability indicates limitations to year-round application of treated wastewater. Deficit irrigation using storage within the topsoil and yellowish-brown upper subsoil is feasible. However, care must be taken not to graze stock on 'wet' topsoils.

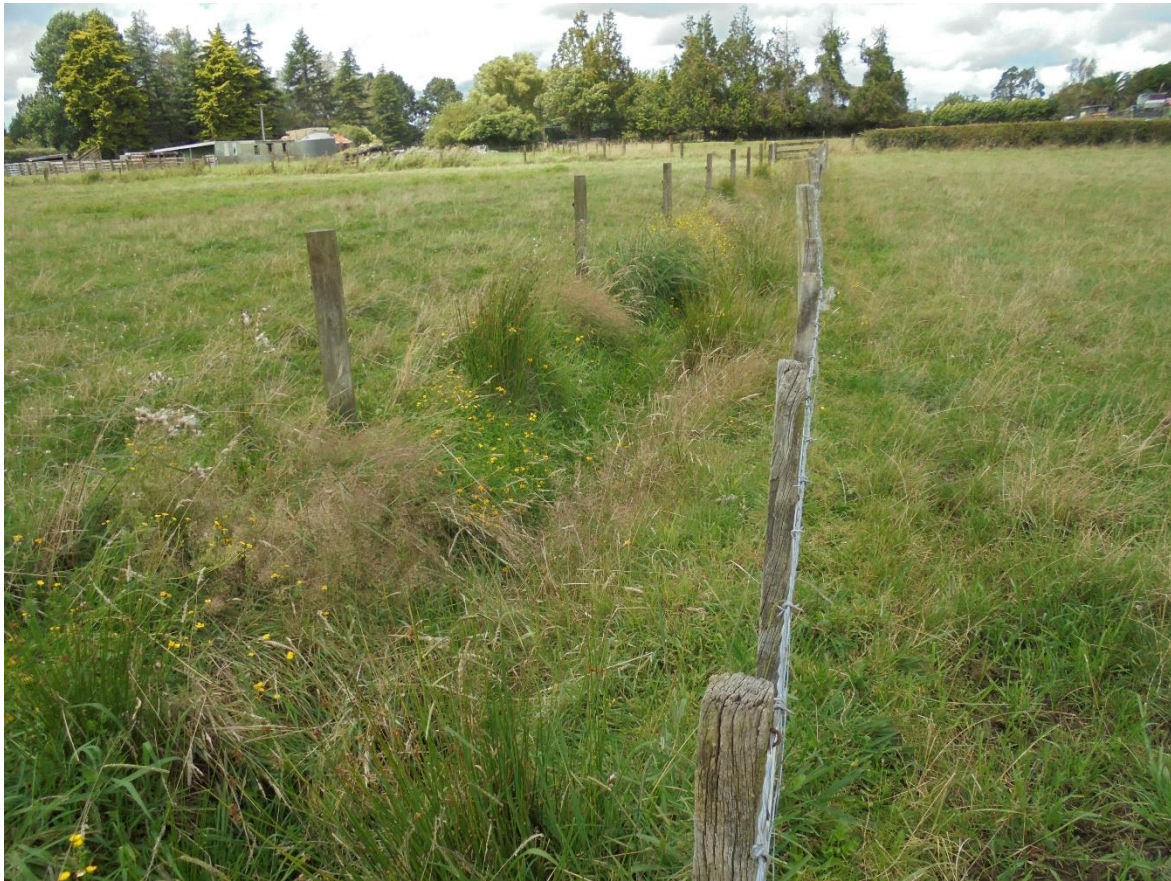
Figure 9. Drainage ditches in the terrace land are also a sign of imperfectly and poorly drained soils at Sharpe Farm.

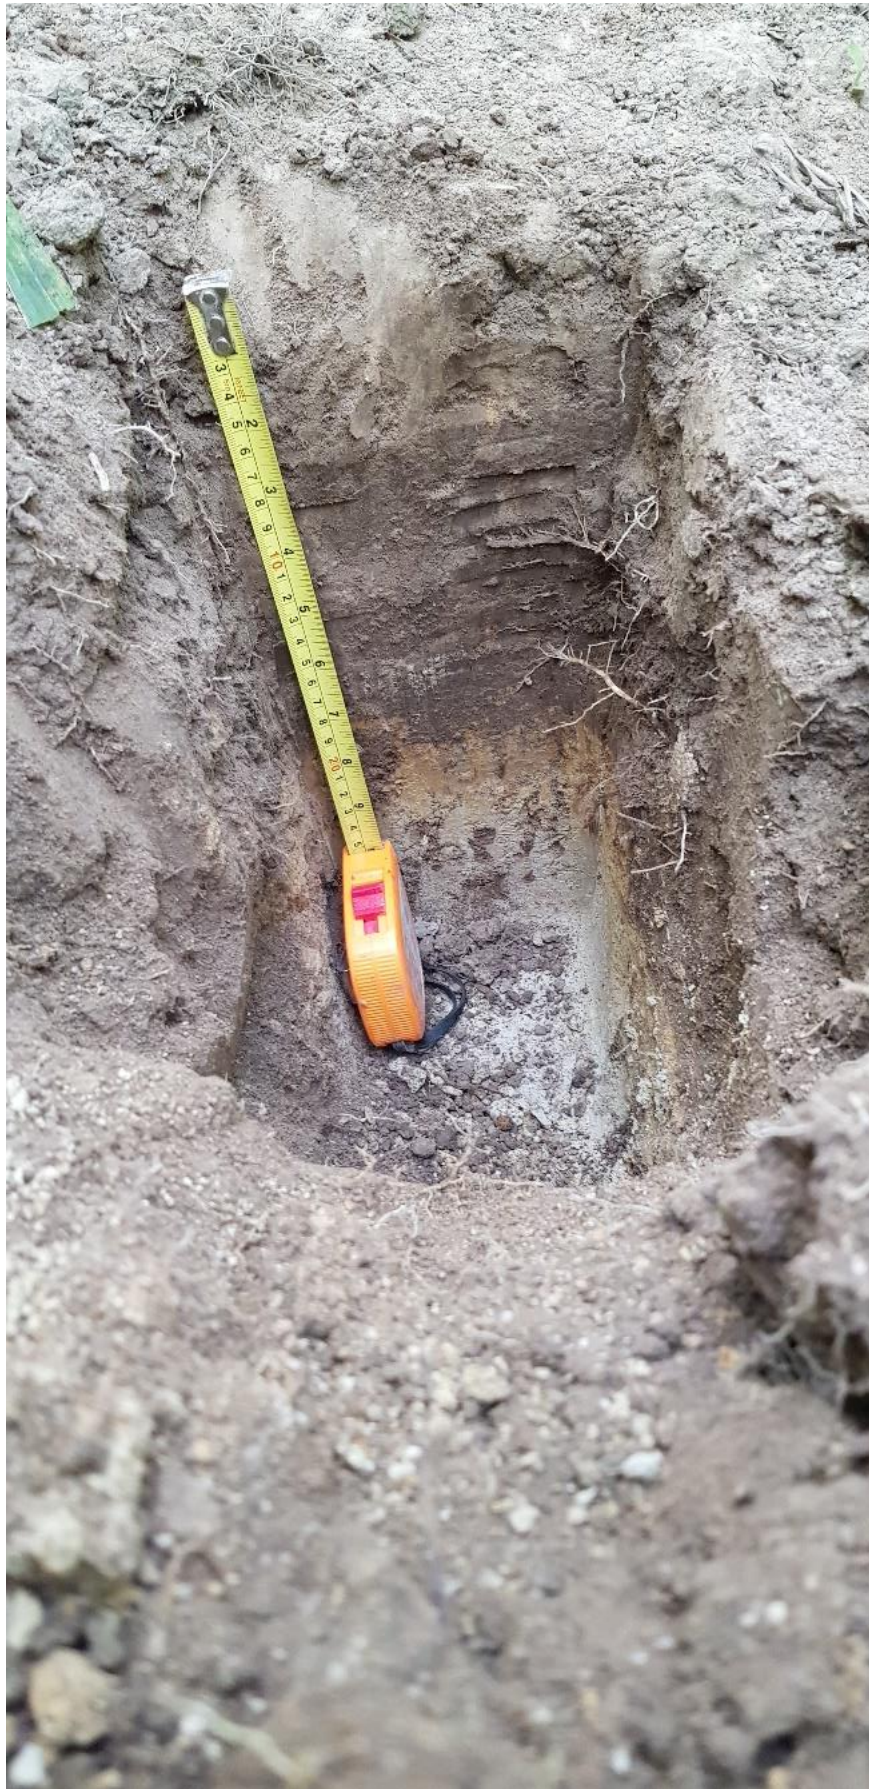
Figure 10. Greyish colours in the Pukehina family soil above 30 cm indicate a poorly drained soil.

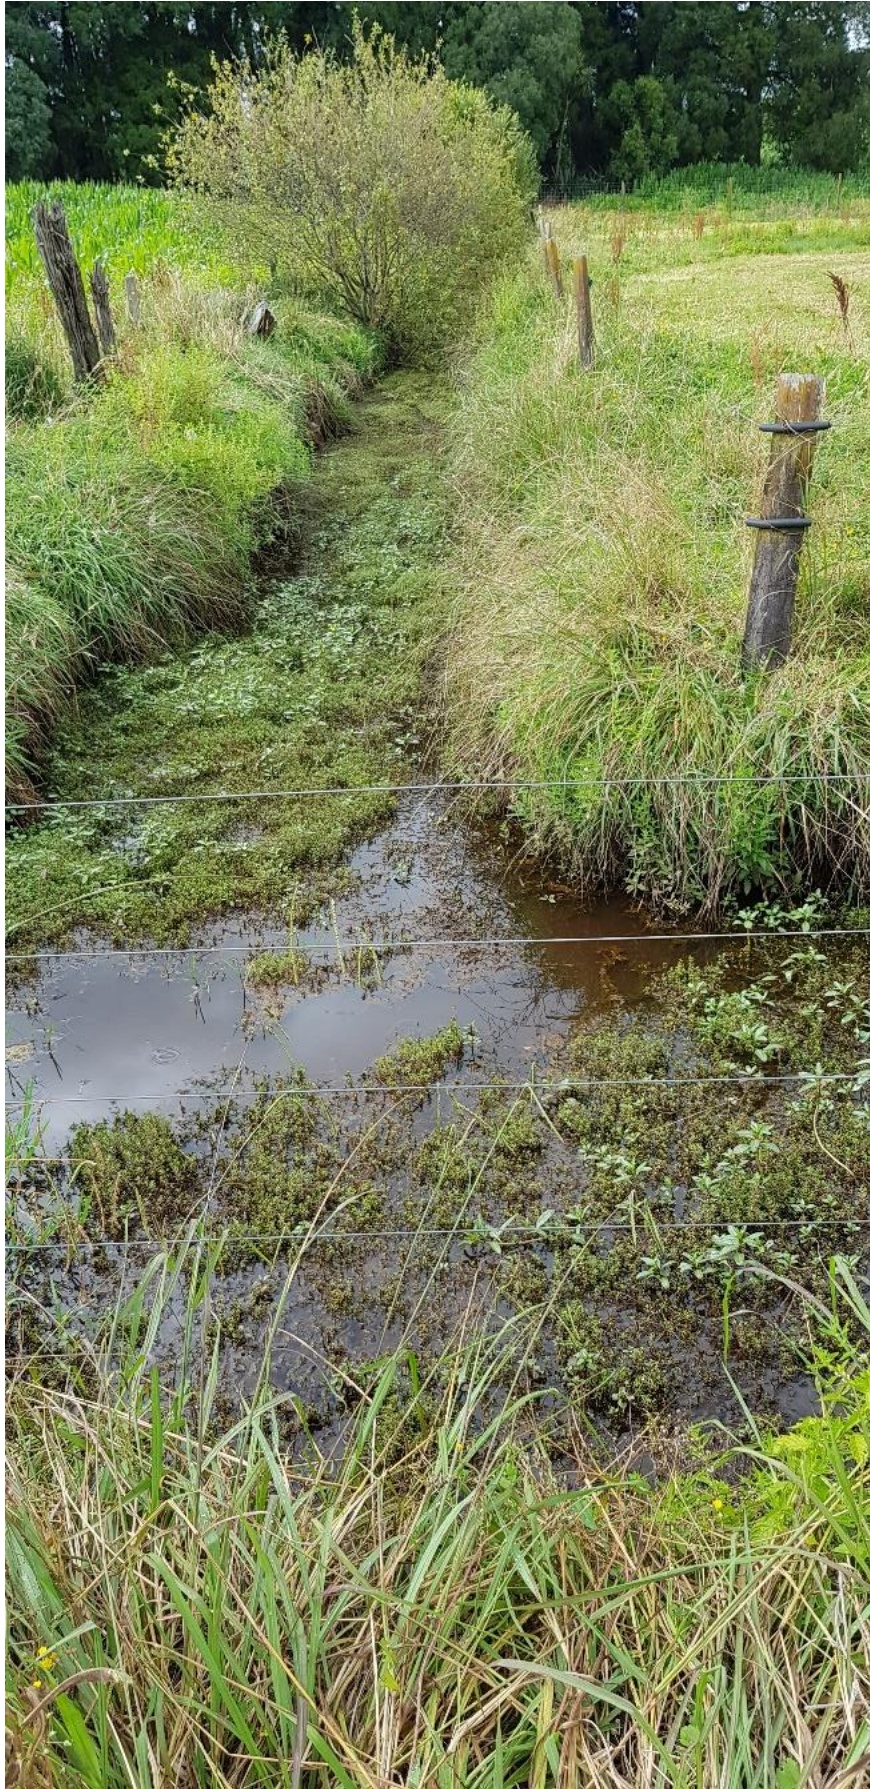
Figure 11. Deep drains are another indication of poorly drained soils on the low-lying land.

The poorly and very poorly drained soils have indications of waterlogging to the base of the topsoil, or even above this level in the case of very poorly drained soils (Figures 11 and 12). The waterlogging is a restriction to year-round application of treated wastewater. Deficit irrigation of poorly drained soils may be feasible where water storage of the topsoil only, is considered. However, care must be taken not to stock 'wet' topsoils.

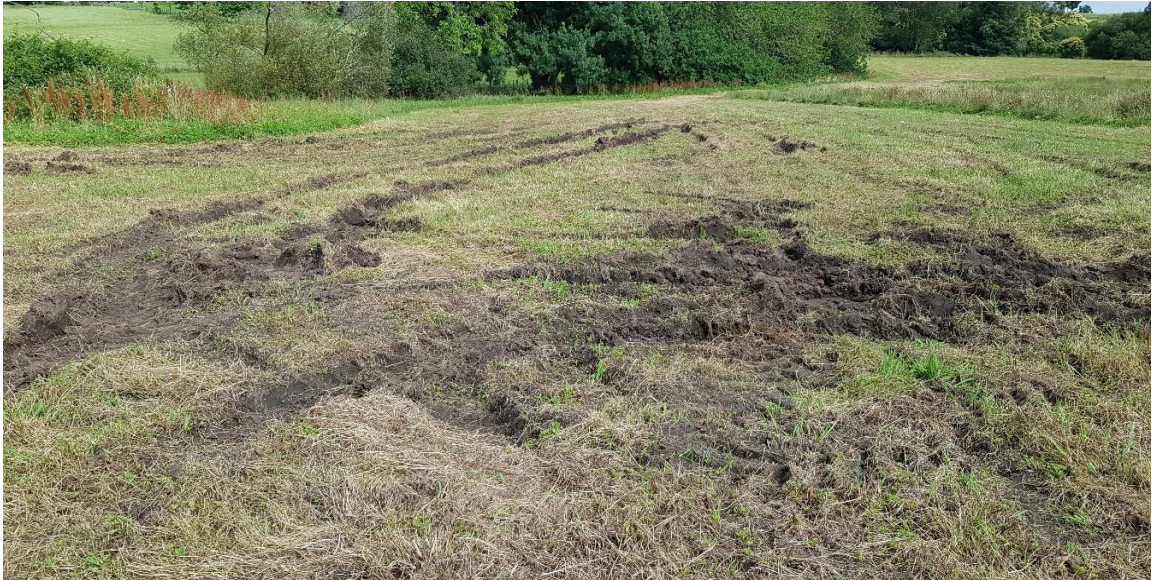
Figure 12. Soft surface conditions in embayments are associated with very poorly drained soils.

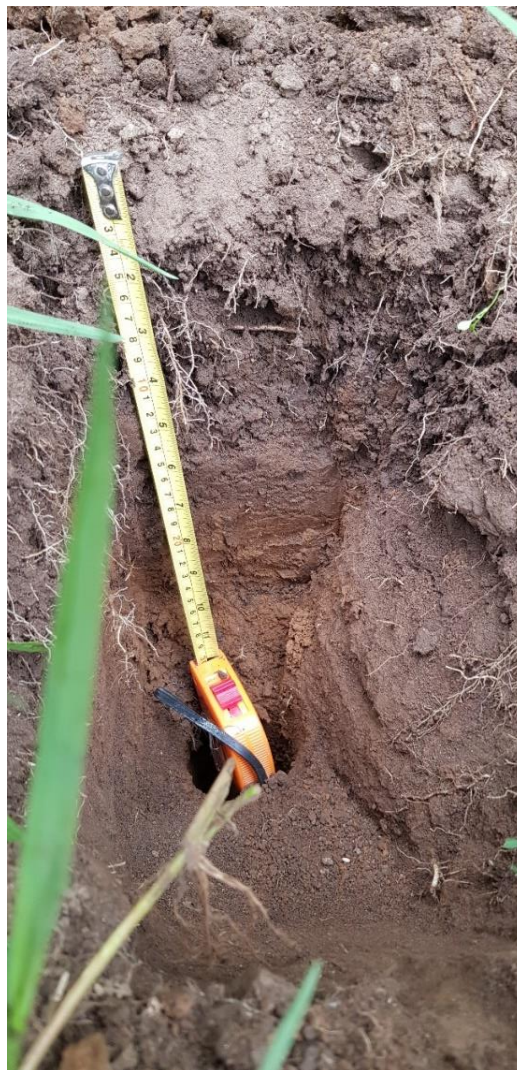
Figure 13. On elevated rolling land at the Narrows Road site, soils are developed in clayey Hamilton Ash which is very firm.

The soils on elevated rolling land are well drained, developed in clayey Hamilton Ash beds. Similarly, topsoils are cultivated to about 20 cm and overlie very firm clayey subsoils (Figure 13). In these soils, clay from upper soil layers is often translocated down the soil profile and deposited below about 50 cm. The translocated clay tends to block soil pores and reduce hydraulic conductivity. The K_{sat} and K_{40} of similar soils are $5.7 \pm 1.0 \times 10^{-5} \text{ m s}^{-1}$ and $1.8 \pm 0.2 \times 10^{-6} \text{ m s}^{-1}$, respectively, in the upper subsoil; and $2.9 \pm 3.7 \times 10^{-6} \text{ m s}^{-1}$ and $1.6 \pm 1.0 \times 10^{-6} \text{ m s}^{-1}$, respectively, in the lower subsoil (Joe 1986). At the toe of slopes on the rolling land, soils tend to become less well-drained with manganese concretions in the upper subsoil which indicated waterlogging for some period of the year.

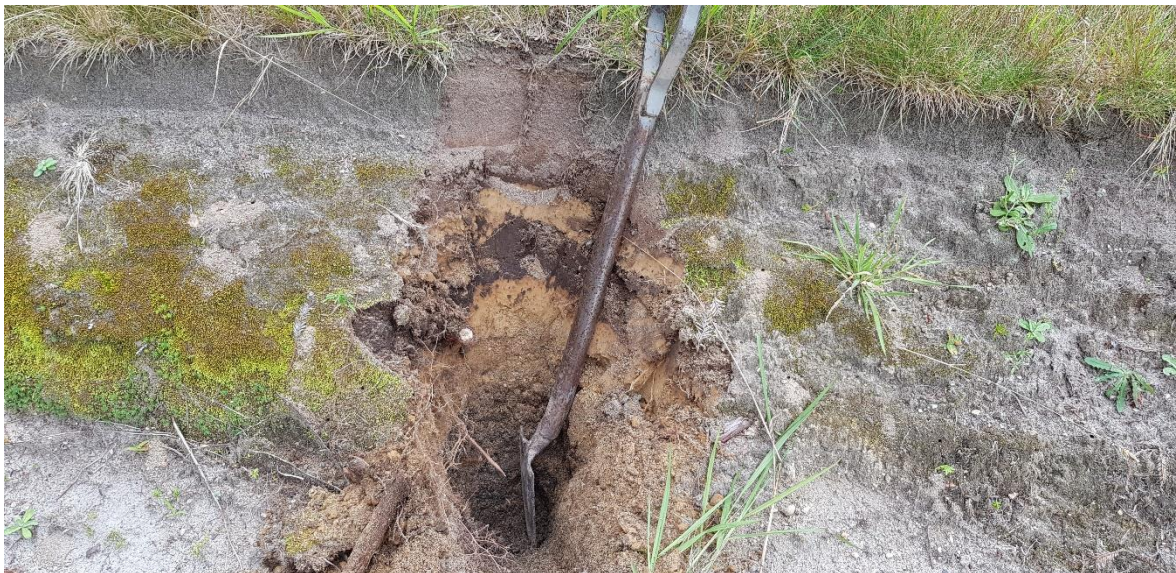
Figure 14. Turangi family soils at the Golf Course site often show signs of disturbance.

At the Golf Course, soils are developed in well-drained rhyolitic alluvium deposited by the Waikato River. Natural river channels and the development of the golf course mean the soils show much variation and disturbance (Figure 14) but typically a dark sandy loam topsoil to about 20 cm overlies yellowish-brown sand to about 50 cm where soil weathering slows, and the sand reflects the colour of the original alluvium (Figure 15). Although Joe (1986) did not report hydraulic conductivity measurements for these soils K_{sat} and K_{-40} are judged to be c. $4.0 \times 10^{-4} \text{ m s}^{-1}$ and $7.4 \times 10^{-5} \text{ m s}^{-1}$, respectively. Rhyolitic stones and pumice are common throughout the soil. Although much of the land is disturbed, the disturbed material is generally the same rhyolitic alluvium. An exception is the lower terrace adjacent to the eastern terrace riser which can have up to 70 cm imported fill over an organic-rich buried topsoil (Figure 16).

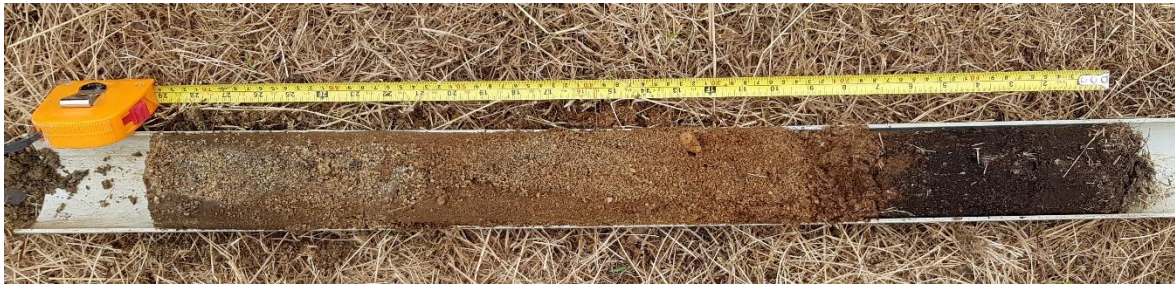
Figure 15. Typical well drained Turangi family soil at the Golf Course site.

Below the topsoil, sandy Turangi family soils are judged to have rapid saturated hydraulic conductivity ($K_{\text{sat}} > 4 \times 10^{-5} \text{ m s}^{-1}$).

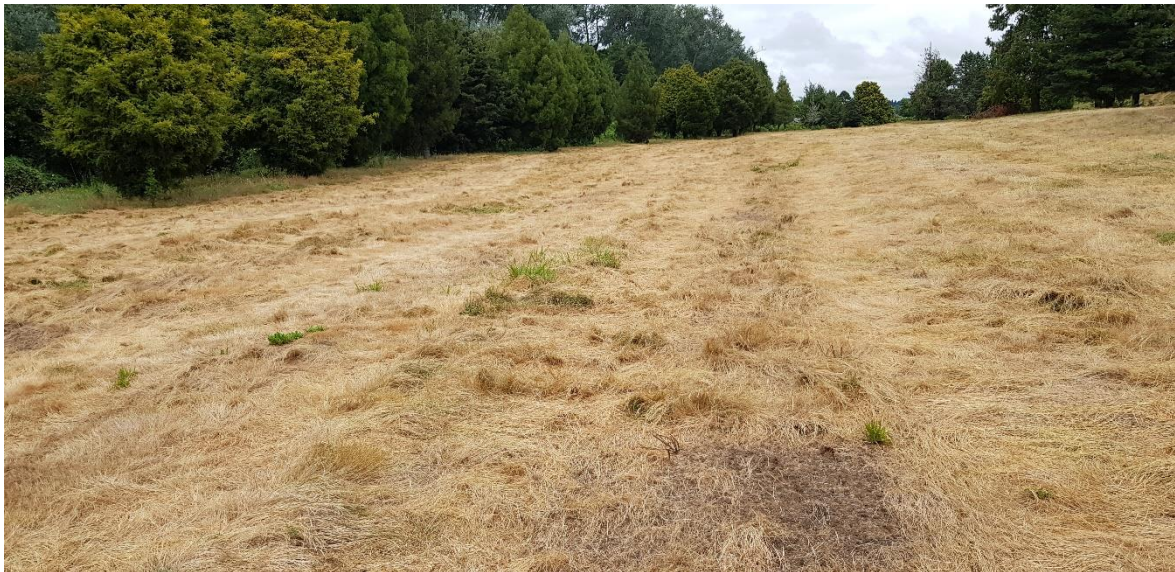
Figure 16. The lower terrace adjacent to the eastern terrace riser can have up to 70 cm of imported fill.

At the Golf Course site, surface applied treated wastewater will potentially move through the soil rapidly, so this site is suitable for year-round application of treated wastewater. However, the nature of the soil material indicates little renovation is likely. The amount and nature of imported fill on the low terrace adjacent to the eastern terrace riser may need further investigation.

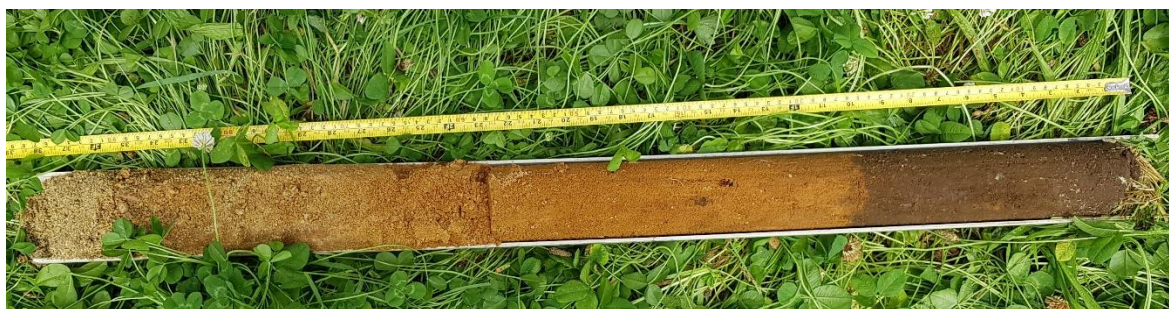
Figure 17. Well drained Otorohanga family soil at Penniket Road site 3N where yellowish-brown loamy upper subsoils are expected to retain phosphorus and filter microbes.

Soils at Site 3N at Penniket Road are predominantly well-drained Otorohanga family soils developed in < 20,000 year-old volcanic tephra overlying the rhyolitic alluvium of the Hinuera Formation (Figure 17). The alluvium is older (c. 20,000 years old) than the alluvium of the Turangi family soils at the Golf Course site (c. 2,000 years old). Typically, Otorohanga family soils show a dark brown loamy topsoil over a yellowish-brown loamy

upper subsoil on a very pale brown sandy lower subsoil. Judging from soil colour and simple reactive aluminium tests done in the field indicate they have high or very high anion retention (Blakemore et al. 1987) indicating they would be able to retain large amounts of applied phosphorus with only minor phosphorus leaching. Similar soils have K_{sat} and K_{40} of $4.0 \pm 1.2 \times 10^{-5} \text{ m s}^{-1}$ and $5.9 \pm 0.7 \times 10^{-6} \text{ m s}^{-1}$, respectively, in the upper subsoil; this increases to $4.0 \pm 2.9 \times 10^{-4} \text{ m s}^{-1}$ and $7.4 \pm 3.1 \times 10^{-5} \text{ m s}^{-1}$, respectively, in the lower subsoil.

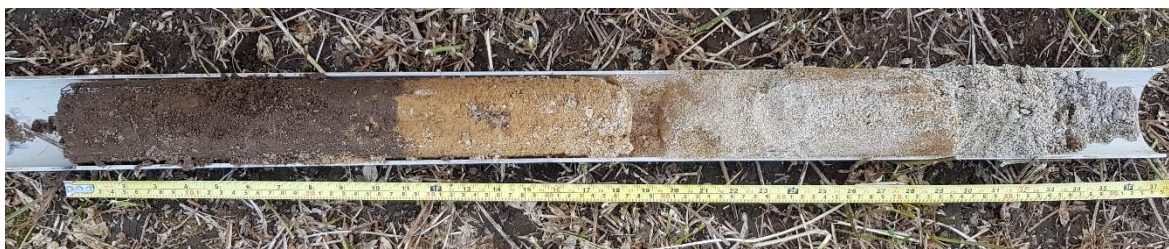
Figure 18. Well drained soil at Penniket Road 3S.

Soils at Site 3S Penniket Road are a well-drained inclusion within the map unit showing Otorohanga family soils. They are developed in re-sorted volcanic tephra that has been combined with sandy rhyolitic alluvium of the Hinuera Formation (Figure 18). The alluvium is older than the alluvium of the Turangi family soils at the Golf Course site. Typically, the soils have a dark yellowish-brown loamy topsoil up to 30 cm thick on a brownish-yellow upper subsoil. The lower very pale brown sandy subsoil shows little soil development, reflecting the colour and structure of the unweathered sandy alluvium. Judging from soil colour and simple reactive aluminium tests undertaken in the field they have medium (Blakemore et al. 1987) anion retention in the upper subsoil indicating they would be able to retain moderate amounts of applied phosphorus with only minor phosphorus leaching. Similar soils have K_{sat} and K_{40} of $4.0 \pm 2.9 \times 10^{-4} \text{ m s}^{-1}$ and $7.4 \pm 3.1 \times 10^{-5} \text{ m s}^{-1}$, respectively, in the lower subsoil. Our experience is that the loamy upper subsoil material is a good filter to bacteria and possibly viruses.
