**From:** Official Information  
**Sent:** Thursday, 20 October 2022 8:32 am  
**To:** [REDACTED]  
**Cc:** Official Information  
**Subject:** Final Response (Part 2) - LGOIMA 283693 - [REDACTED] - Information regarding the proposed sale and development of Sonning Car Park

# Sonning Car Park

## 191 River Road, Hamilton

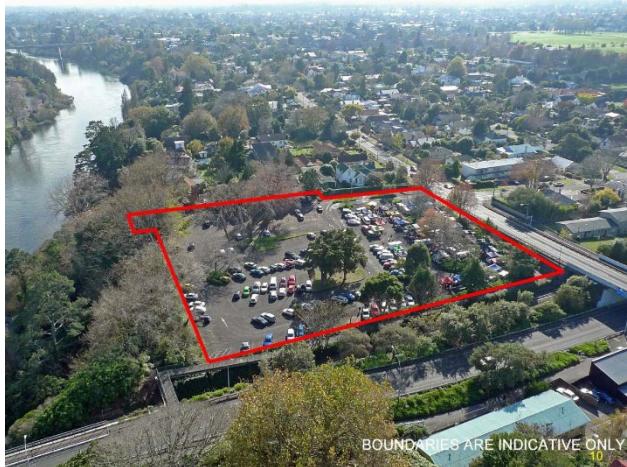
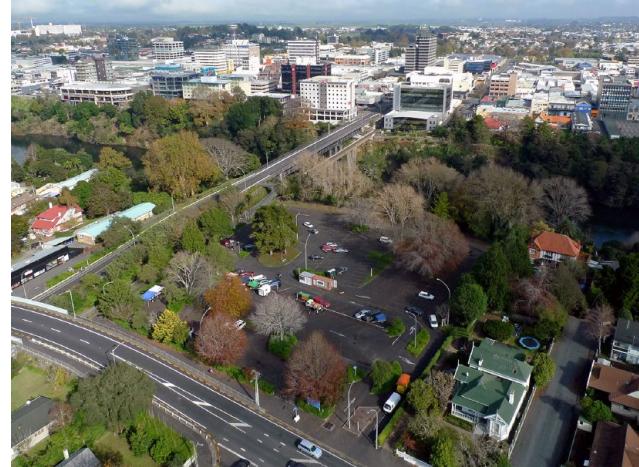
The site currently comprises a paid parking facility. Site improvements consist of a flat asphaltic surface carpark yard as well as other minimal curb and channel improvements. Lighting, as part of the carpark, make up the only other improvements on site.

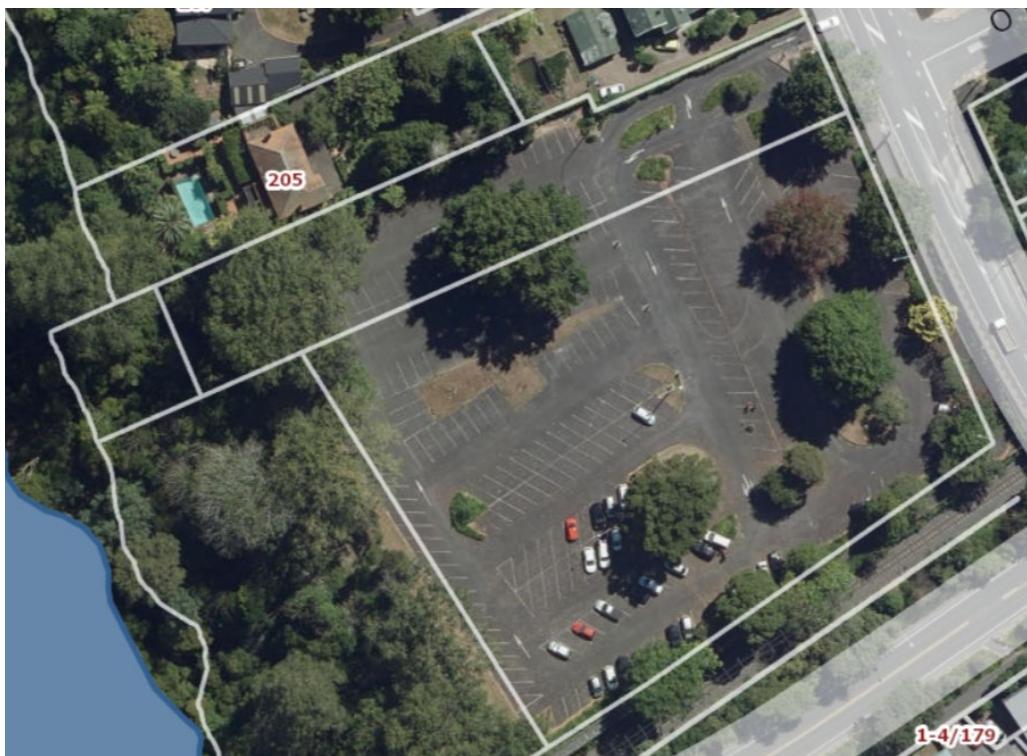
There are several mature trees on the site as seen in the image below. Hamilton City Council's list of Protected Trees "Schedule 9D: Significant Trees" has been checked and this site is not named as an area having protected trees present.

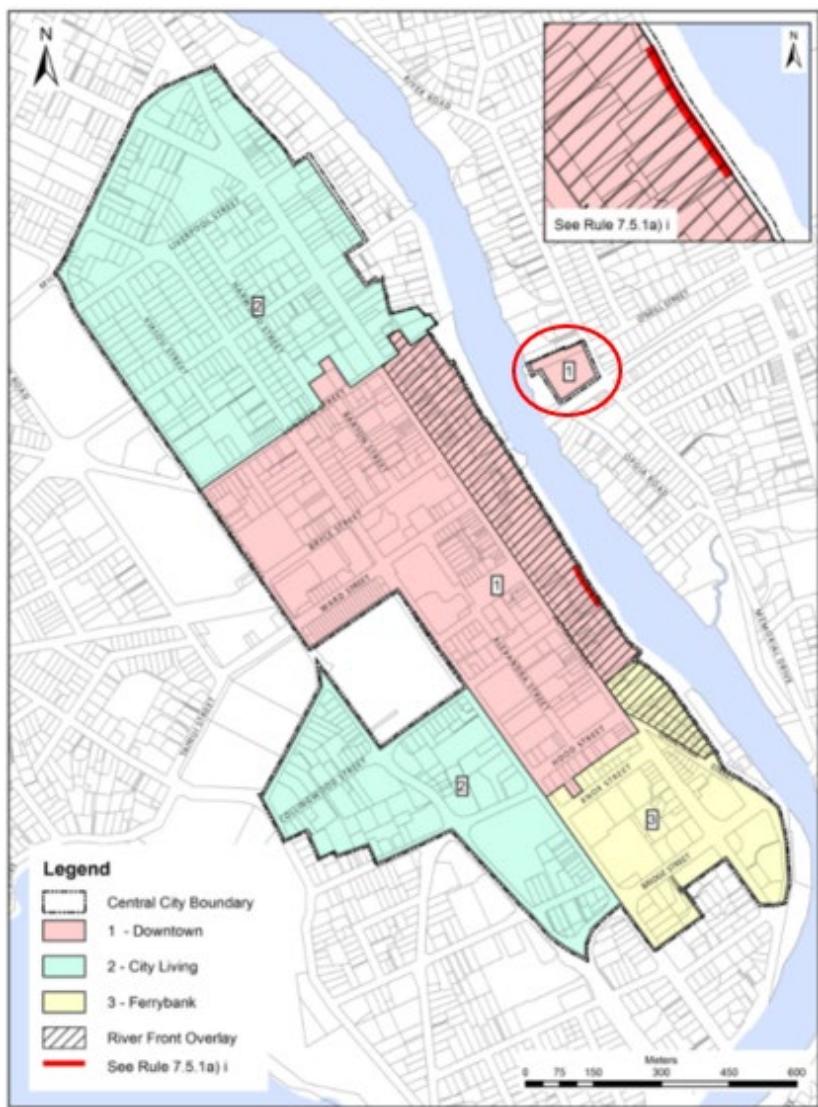
The site is zoned Central City Zone - Precinct 1 - Downtown Precinct in the Hamilton City Council Operative District Plan. Whilst situated outside of the CBD, this property is considered a strategic site given its connectivity to the CBD and the Claudelands Events and Entertainment Centre.

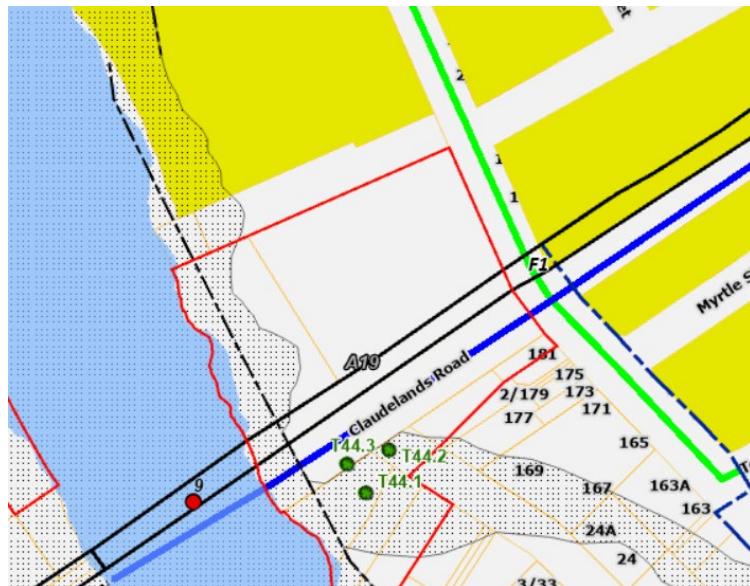
Part of the site (7,264m<sup>2</sup> of Allot 465 Parish of Kirikiriroa) is classified as a Significant Archaeological Site – Group 1. See below image with Red Border outlining the Significant Archaeological Site Group 1 boundary. Note the Red area shown also includes neighbouring properties.

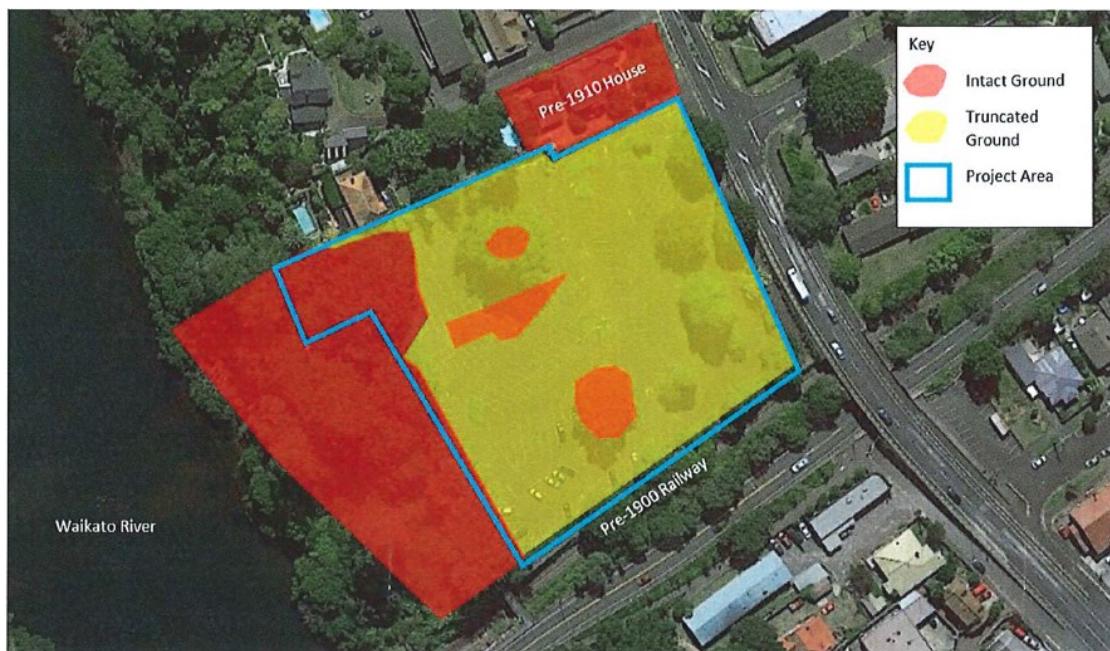
Figure 3. Results of site visit 23/11/2020, showing areas of high archaeology risk (red), where intact archaeological remains are highly likely and moderate archaeological risk (yellow), where the archaeology is likely to have been disturbed.

These observations indicate that there is risk of intact archaeological material along the western edge of the project area and in the grassed garden areas (Figure 3). It is likely that the development of the carpark has truncated the site across the remainder of the Project area. However, there remains risk that deeper archaeological features remain intact below the carpark.

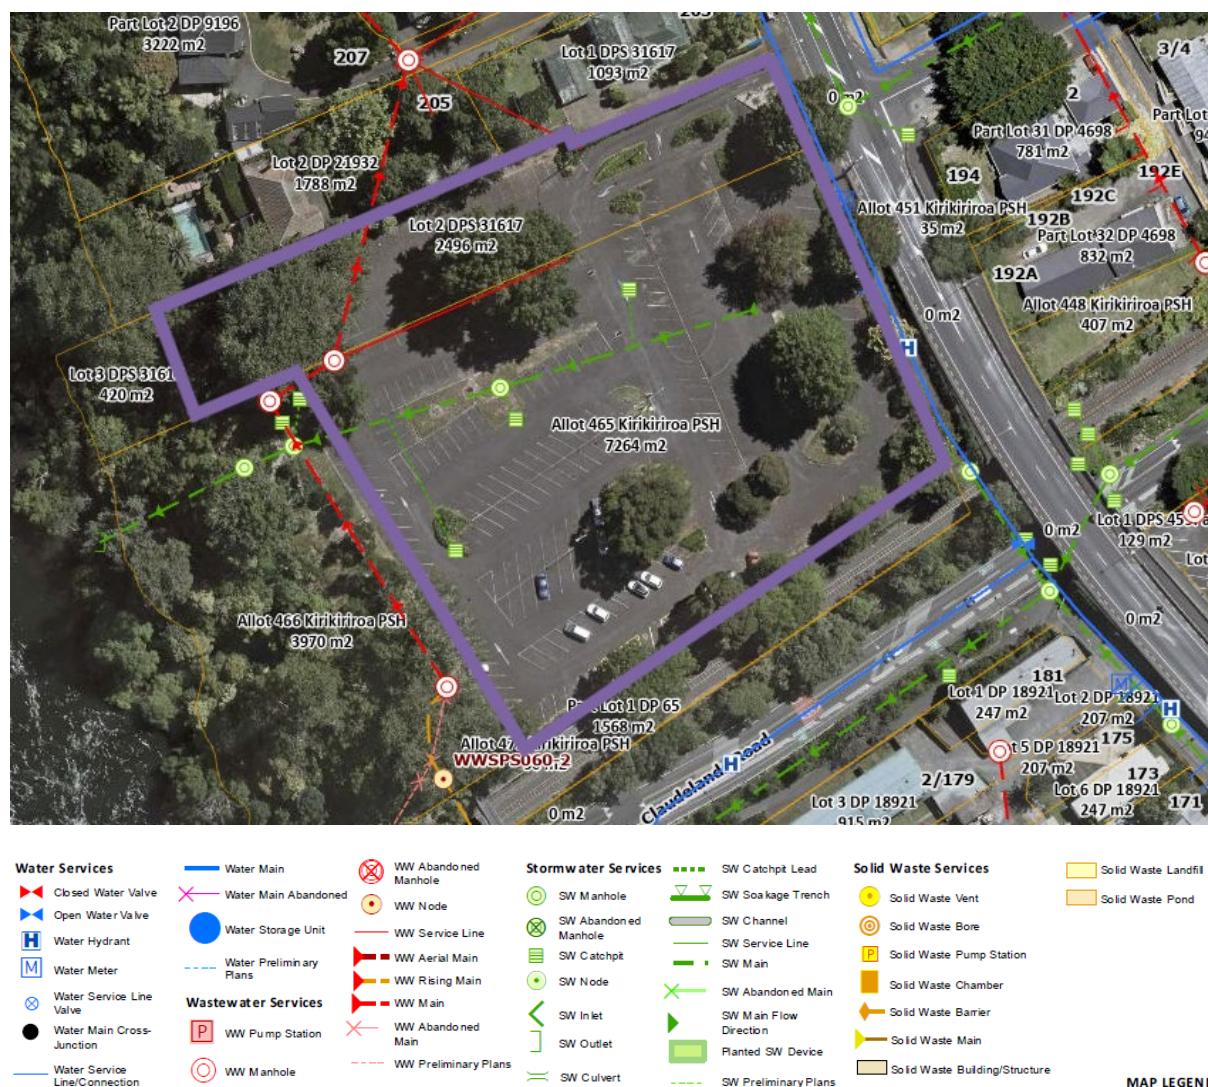
A stormwater main is located on the property as shown above with the green dotted line with arrows showing direction of flow towards the river. Three stormwater catchpits, and catchpit leads are also present within the property leading to an outlet structure into the Waikato River. A manhole is also present represented by the green circle symbol. This stormwater infrastructure appears to service the property only and does not appear to service a wider catchment. Capacity of this infrastructure is unknown however any comprehensive development of the property will need to consider treatment of stormwater albeit the existing site is almost fully impervious.

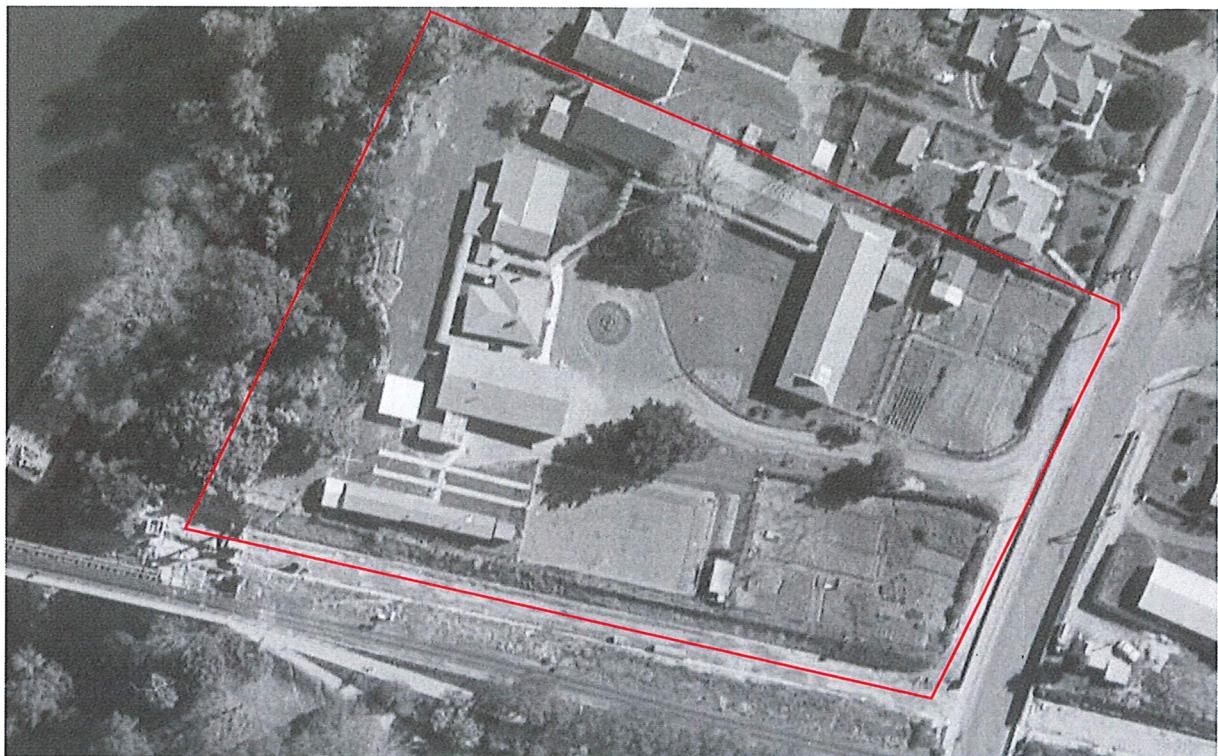
The earliest identified aerial photograph from 1943 shows the project area to be primarily open space with a number of buildings at the river end. This continues to be the case into the 1960s. An aerial photograph from 1961 shows the construction of the new railway bridge and tie in along the southern border of the Project area. It also shows the student’s hostel, as well as a couple of additional buildings and what appears to be gardens (Figure 1). Aerial plans indicate little change until the site was razed and a carpark developed between 1971 and 1974.

Figure 1: Aerial photograph, dated 1961, of the Project area (red box). Source: Retrolens

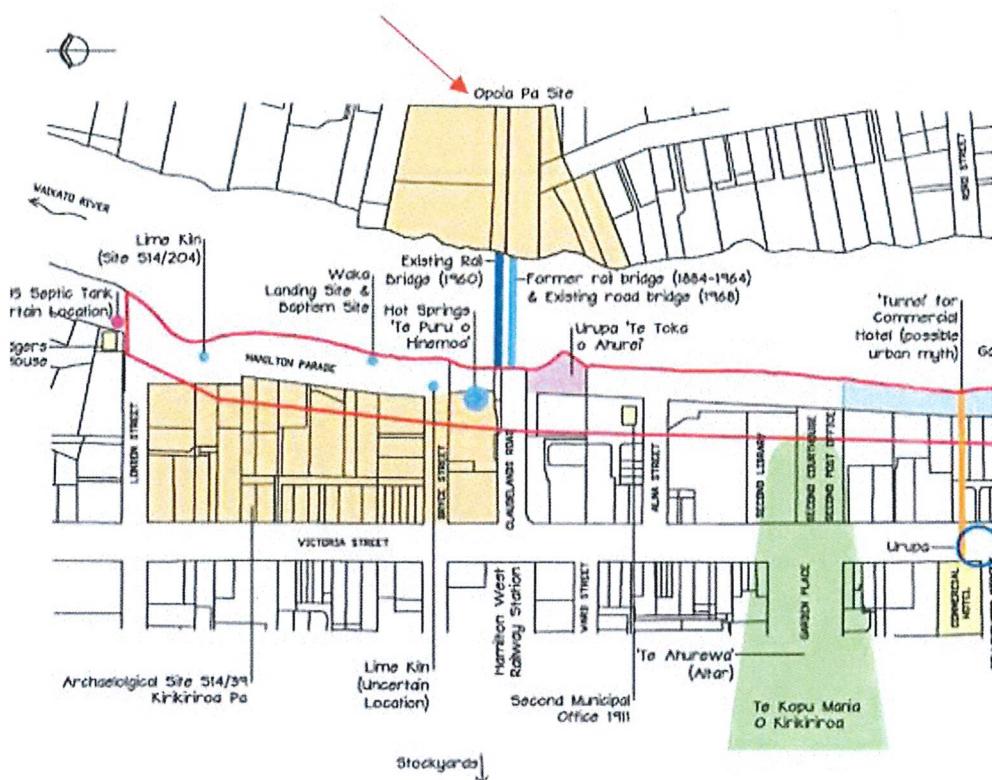
A 2000 archaeological and cultural assessment of the Central City Riverside area by Opus International Consultants and Cultural Interface Solutions mapped the extent of Opoia Pā on both sides of Claudelands Road (Figure 2).

Figure 2. Portion of Summary Plans from Opus & Cultural Interface Solutions (2000) showings sites of archaeological and cultural sites.

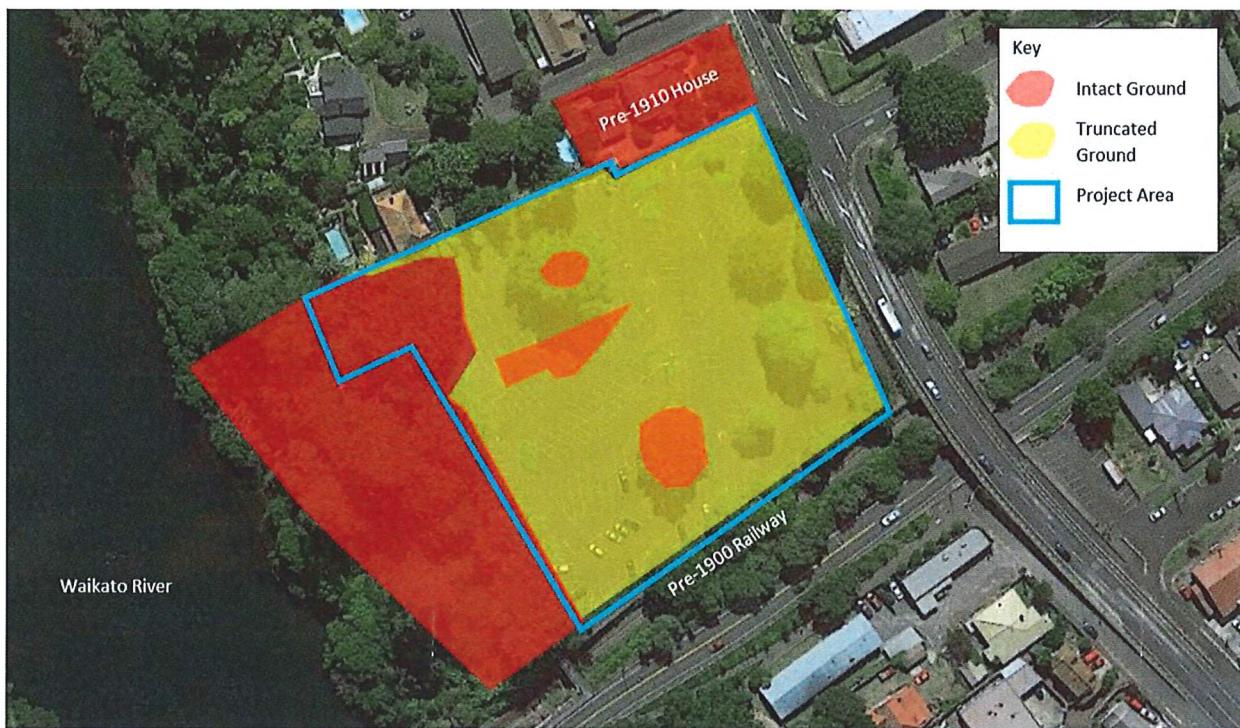
Figure 3. Results of site visit 23/11/2020, showing areas of high archaeology risk (red), where intact archaeological remains are highly likely and moderate archaeology risk (yellow), where the archaeology is likely to have been disturbed.

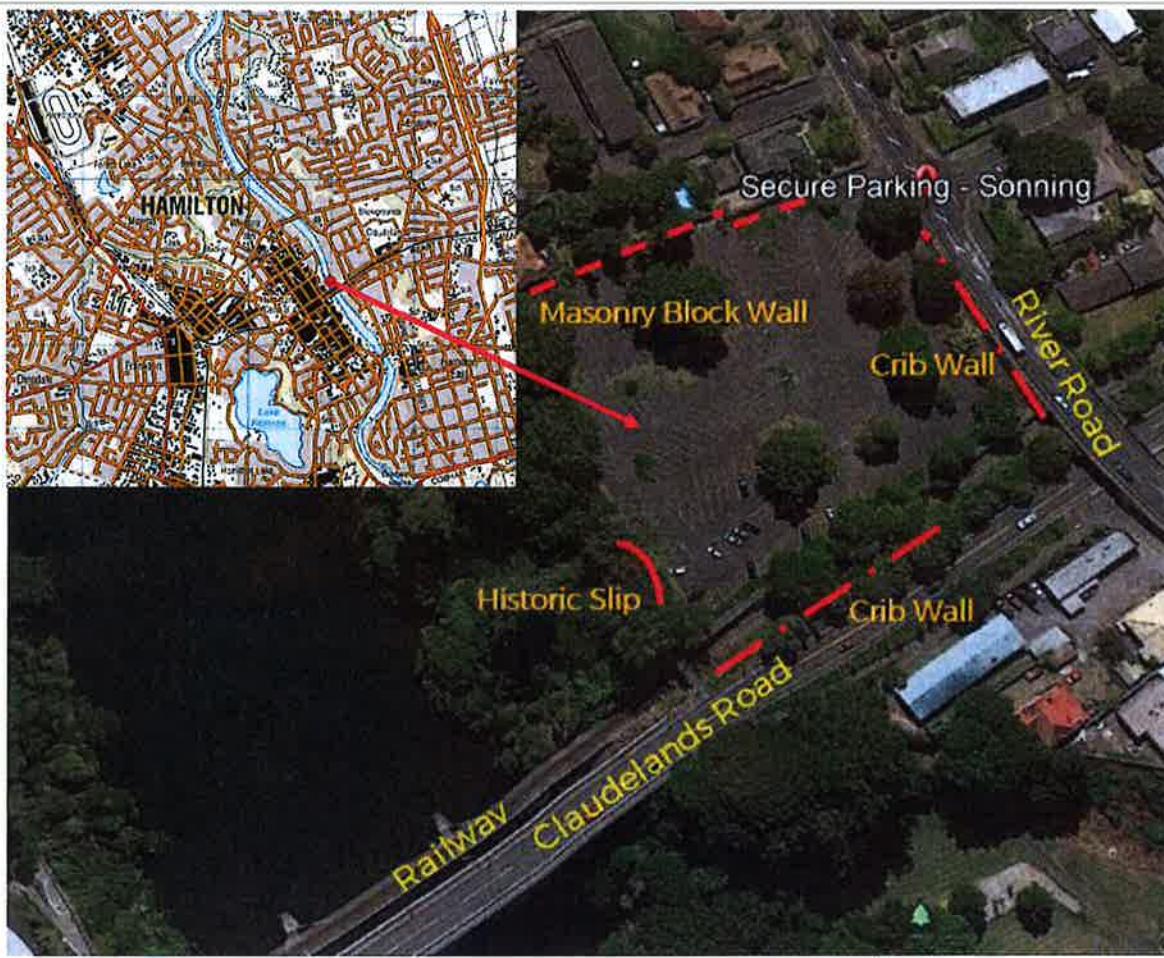
Figure 1: Site Location

At the time of the site walk over, a previous shallow seated slip was identified within the slope to the south west corner of the carpark, located approximately 27m north of the railway boundary. The slope was observed to be heavily vegetated at the time of inspection. Reviewing the Retro lens database (Waikato Regional Council, 2020), the slip was identified as having occurred around 1953. A crib wall is present along the sites southern boundary supporting the railway and Claudelands Road with a second crib wall to the south-east corner of the site of supporting the approach to River Road overbridge. A masonry block wall is present at the northern boundary providing support to the properties within the residential area. The car park area was observed to be relatively flat with several trees present.

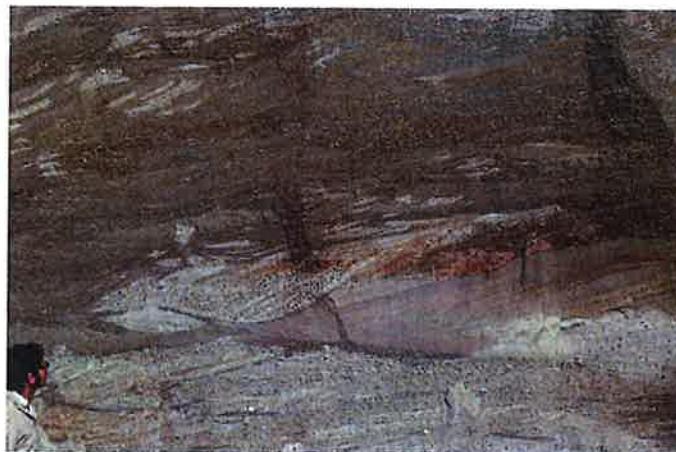
Figure 2: Hinuera Formation showing lensed nature of the soils (McCraw, 2011)
