# Amberfield subdivision, Peacocke

Freshwater ecological impact assessment  
Prepared for Weston Lea Limited

16 May 2018

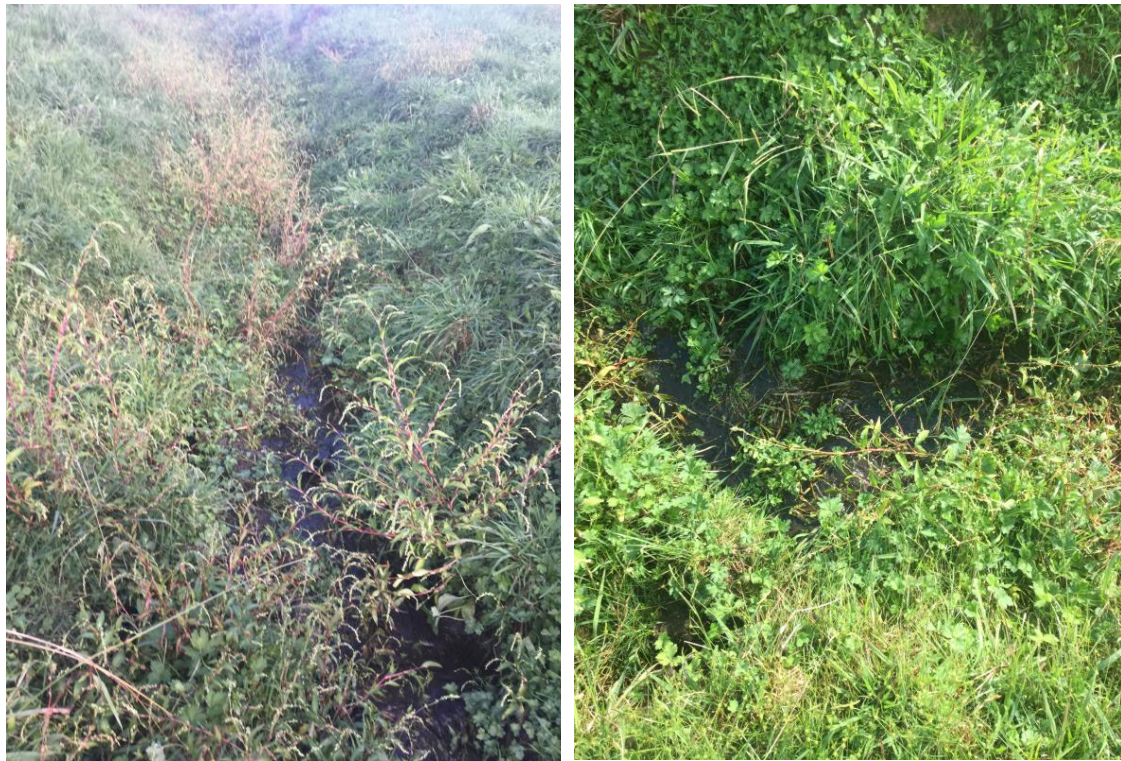
downstream end (riparian vegetation along the Waikato River). Aquatic vegetation present included willow weed (*Persicaria maculosa*). Stock are not excluded from the waterway with pugging and grazing evident in both the waterway channel and seepage area. Images 1 and 2 show watercourse one.

*Images 1 & 2: Water flowing along a small stream channel towards the north of the site. Grazed pasture grasses present along the riparian margin with willow weed.*

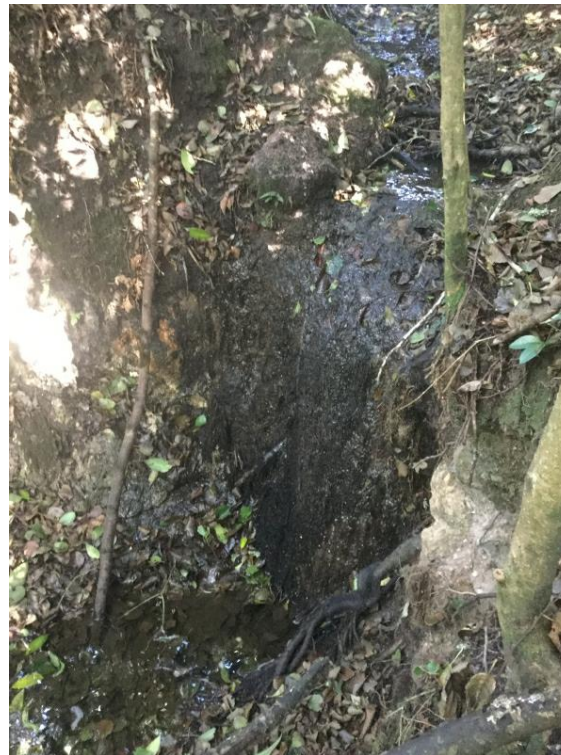
Image 4: One of the small waterfalls at the downstream end of watercourse two.

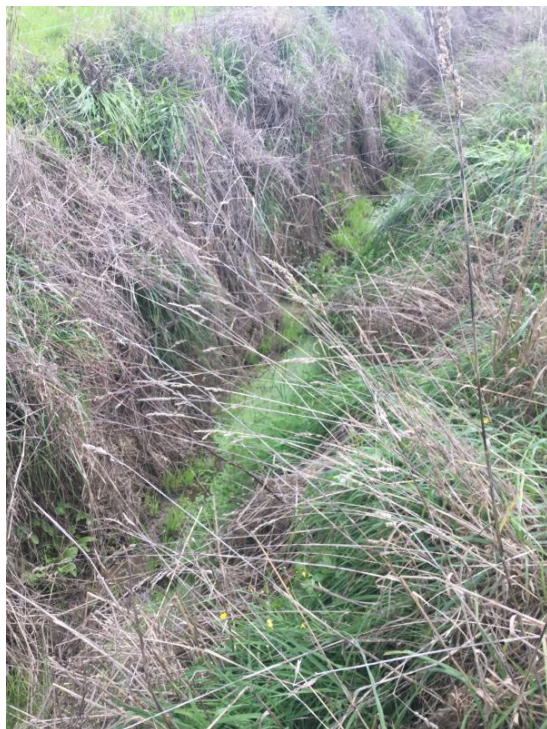
The south-western branch consists of two incised ephemeral and intermittent farm drains that follow a more natural flow path from just upstream of their confluence. Downstream of the confluence, the waterway follows a small gully that flows beneath a farm race before discharging into the main stem. There is an approximately 2m drop immediately downstream of the farm race. Stream channel width was mostly between 0.2 and 0.5m and depth was generally less than 0.2m with sections of subsurface flows. The south-western branch consists of poor fish and macroinvertebrate habitat with limited habitat available (some rooted aquatic vegetation) and mostly uniform hydrologic conditions. The substrate consists of fine soft sediment with stock access to sections of the stream. Riparian vegetation is mostly absent consisting of low stature rank vegetation although shading is provided in some parts due to the incised nature of the channel. Images 5 and 6 show the south-western branch.

*Image 5: Shallow water present in the base of an incised farm drain in the south-western branch of watercourse three.*

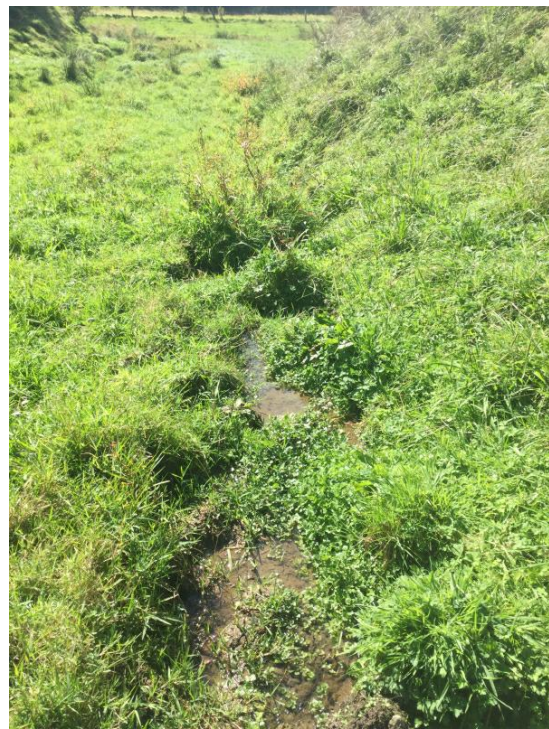
*Image 6: Intermittent stream reach downstream of the farm race (immediately before it discharges into the main stem) on the south-western branch of watercourse three.*

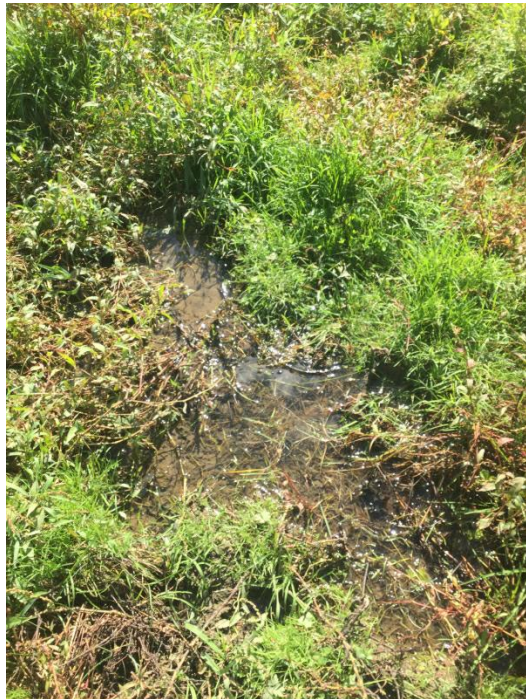
The main stem of watercourse three begins at the head of the gully with a small ephemeral reach that becomes intermittent downstream. The intermittent reach consists of a combination of sections including defined channels, wet areas with no defined channel and subsurface flows. There is also a pond area which was dry at the time of the site visit. Riparian vegetation consists of pasture and willow weed, although some trees and shrubs are present towards the downstream extent of the intermittent reach. The waterway bed, where a channel was present, consisted of fine soft sediment. Water depth was generally less than 0.2m where water was present in the stream channel. The intermittent reach provides marginal habitat for instream fauna although there is poor connectivity. Various sized culverts are present along the

*Image 7: Stream channel along the main stem of the intermittent section of watercourse three.*

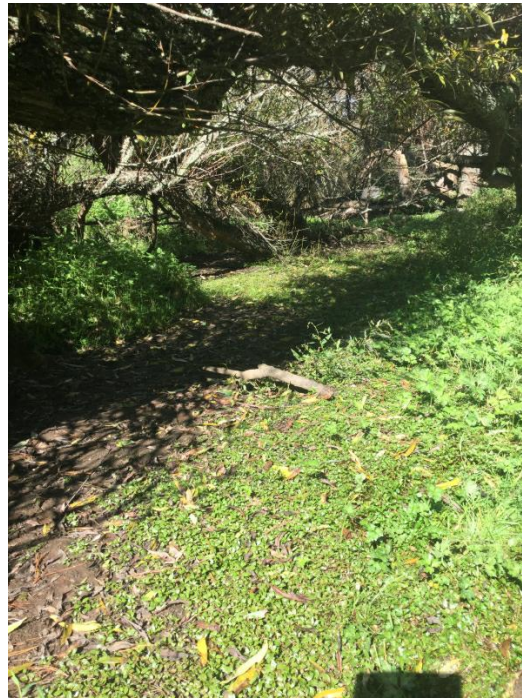
*Image 8: Dry stream bed at the downstream end of the intermittent section of watercourse three.*

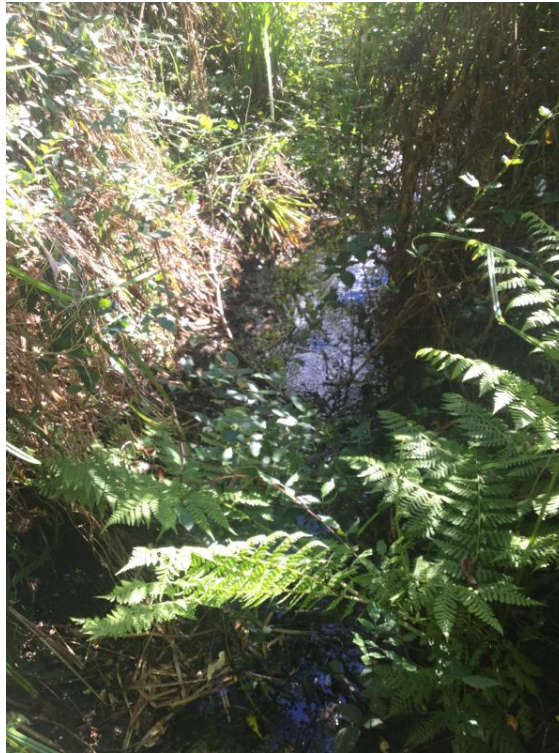
Riparian vegetation was patchy within the approximately upstream 160m of the permanent reach consisting of some larger trees and shrubs as well as more open areas of low stature rank vegetation. The remaining downstream reach consisted of more dense vegetation providing contiguous cover over the stream. Aquatic vegetation was present at points and included willow weed, duckweed and watercress. Stock could access parts of the stream reach, although some fencing and the steep sides of the gully would exclude stock from some sections. Images 9 and 10 show the permanent stream habitat of watercourse three.

*Image 9: Water flowing along permanent stream habitat of watercourse three.*

- Intermittent and permanent stream reaches within watercourse three, that are not directly affected by the development, are enhanced to improve freshwater ecological values (see Figure 3, Appendix 1). Enhancement of watercourse three is proposed to mitigate for the loss of 208m of intermittent and 27m of permanent waterway across the site (all are categorised as low ecological value). The proposed enhancements to watercourse three will include approximately 543m of intermittent and 154m of permanent waterway<sup>7</sup>. We recommend the preparation and implementation of an enhancement plan that includes the following aspects:

- Creating a channel in the intermittent stream reach, where there is no defined channel, to improve connectivity within the waterway. This provides the opportunity to create a variety of hydrologic conditions (i.e. pools, riffles, run) and instream habitats.

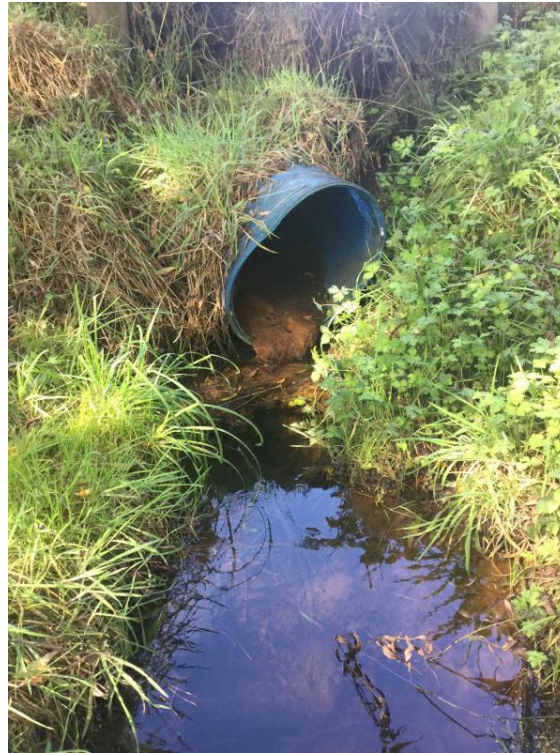
Water flows via sub-surface from the intermittent stream reach beneath a farm crossing with a blocked culvert and into the permanent stream section of watercourse three. From this point, the waterway follows a natural flow path at the base of a steep sided gully before discharging into the Waikato River. The channel varies in width from less than 0.3m to over 1m, although the channel is mostly 0.5m wide. Water depth is generally shallow varying between 0.2 and 0.5m, with 0.7m observed to be the deepest point during the site assessment. The permanent reach contains some pool and riffle habitat as well as undercut banks, aquatic vegetation and woody debris. Overall, the reach provides suboptimal fish and macroinvertebrate habitat, with habitat quality improving with distance downstream. The substrate consists of mostly fine soft sediment, although gravel is present in more turbulent sections of the stream.

*Image 10: Blocked culvert marking the beginning of the permanent stream reach of watercourse three.*

- Removal of the two existing culverts (or replacement which allows for fish access) which are likely to be restricting fish passage.
  - Riparian planting along both intermittent and permanent stream reaches.

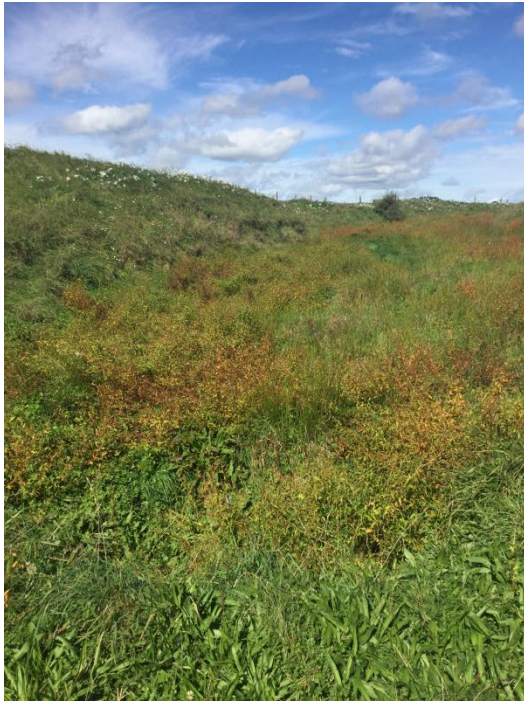
The intermittent waterway channel varied in width from less than 0.2m to 0.6m. Water depth was mostly shallow with some subsurface flows, although some pools were present with 0.5m observed to be the deepest point during the site assessment. The intermittent waterway consisted of suboptimal fish and macroinvertebrate habitat which included riffles, pools, runs and woody debris. The substrate consisted of fine soft sediment in slower flowing areas and gravel habitat in faster flowing reaches. Established riparian vegetation was present along the intermittent reach and stock were also excluded. Culverts were present along the watercourse. Images 11 and 12 show watercourse four.

*Image 11: Wet area containing pasture species and willow weed immediately upstream of the intermittent reach of watercourse four.*

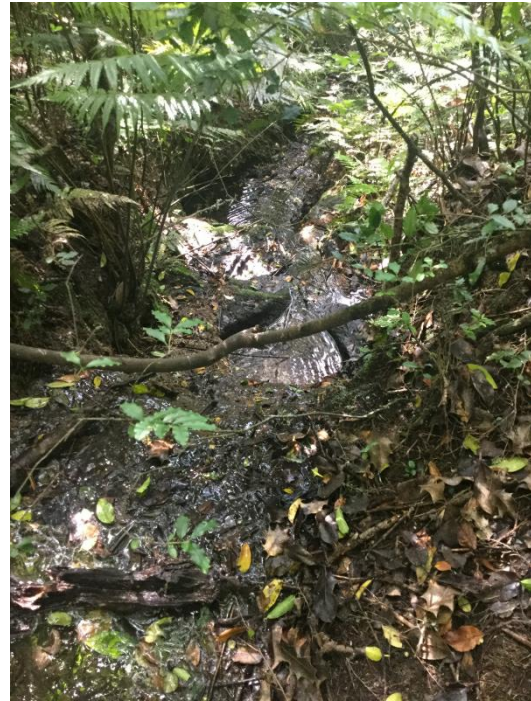
*Image 12: Intermittent stream reach of watercourse four with established riparian cover.*

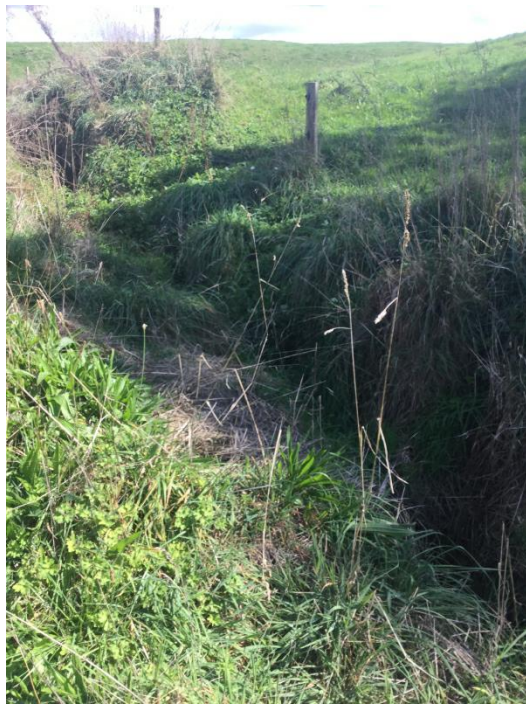
The intermittent waterway channel varied in width from less than 0.2m to 0.4m. Water depth was mostly shallow although some pools were present with 0.4m observed to be the deepest point during the site assessment. The intermittent waterway consists of suboptimal fish and macroinvertebrate habitat which included riffles, pools, runs and woody debris present (excluding the farm drain habitat). The substrate consisted of fine soft sediment in slower flowing areas and gravel habitat in faster flowing reaches. Established riparian vegetation was present along the downstream intermittent reach and stock were also excluded. Images 13 and 14 show watercourse five.

Image 13: Farm drain with intermittent water flow along watercourse five.

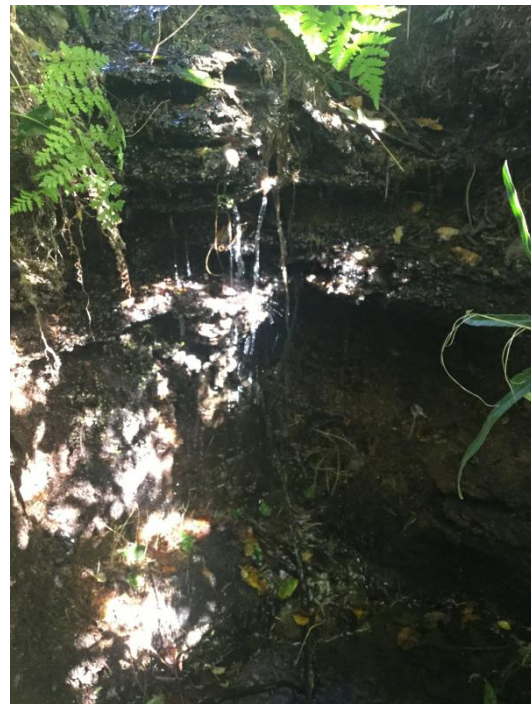
Image 14: Small waterfall towards the downstream extent of watercourse five.

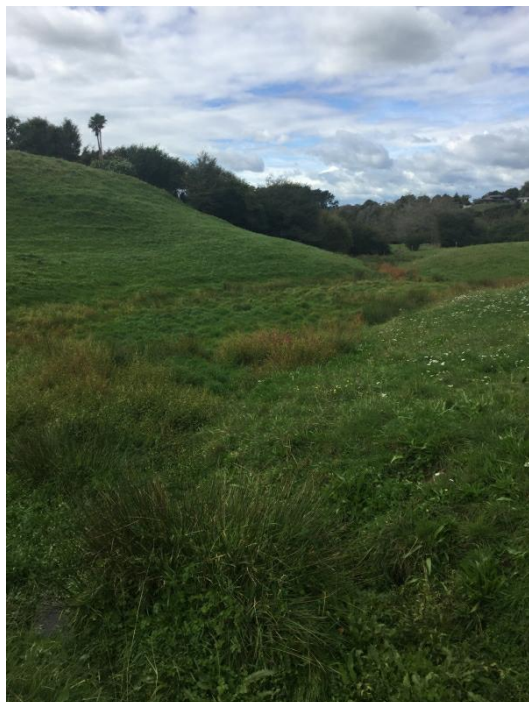
Downstream of the confluence of the two branches, the waterway becomes incised before flowing over numerous waterfalls and chutes, one of which is approximately 5m in height, and discharging into the Waikato River. The stream channel is approximately 0.5m wide with variable depth including the presence of pools and riffles. The stream bed consisted predominantly of fine soft sediment as well as gravel and sections of harder substrate. The waterway consists of suboptimal fish and macroinvertebrate habitat which included riffles, pools, runs and woody debris. Established riparian vegetation was present along the downstream reach consisting of shrubs and small trees and stock were also excluded. Images 15 and 16 show watercourse six.

*Image 15: Wetted area within watercourse six with no defined stream channel.*

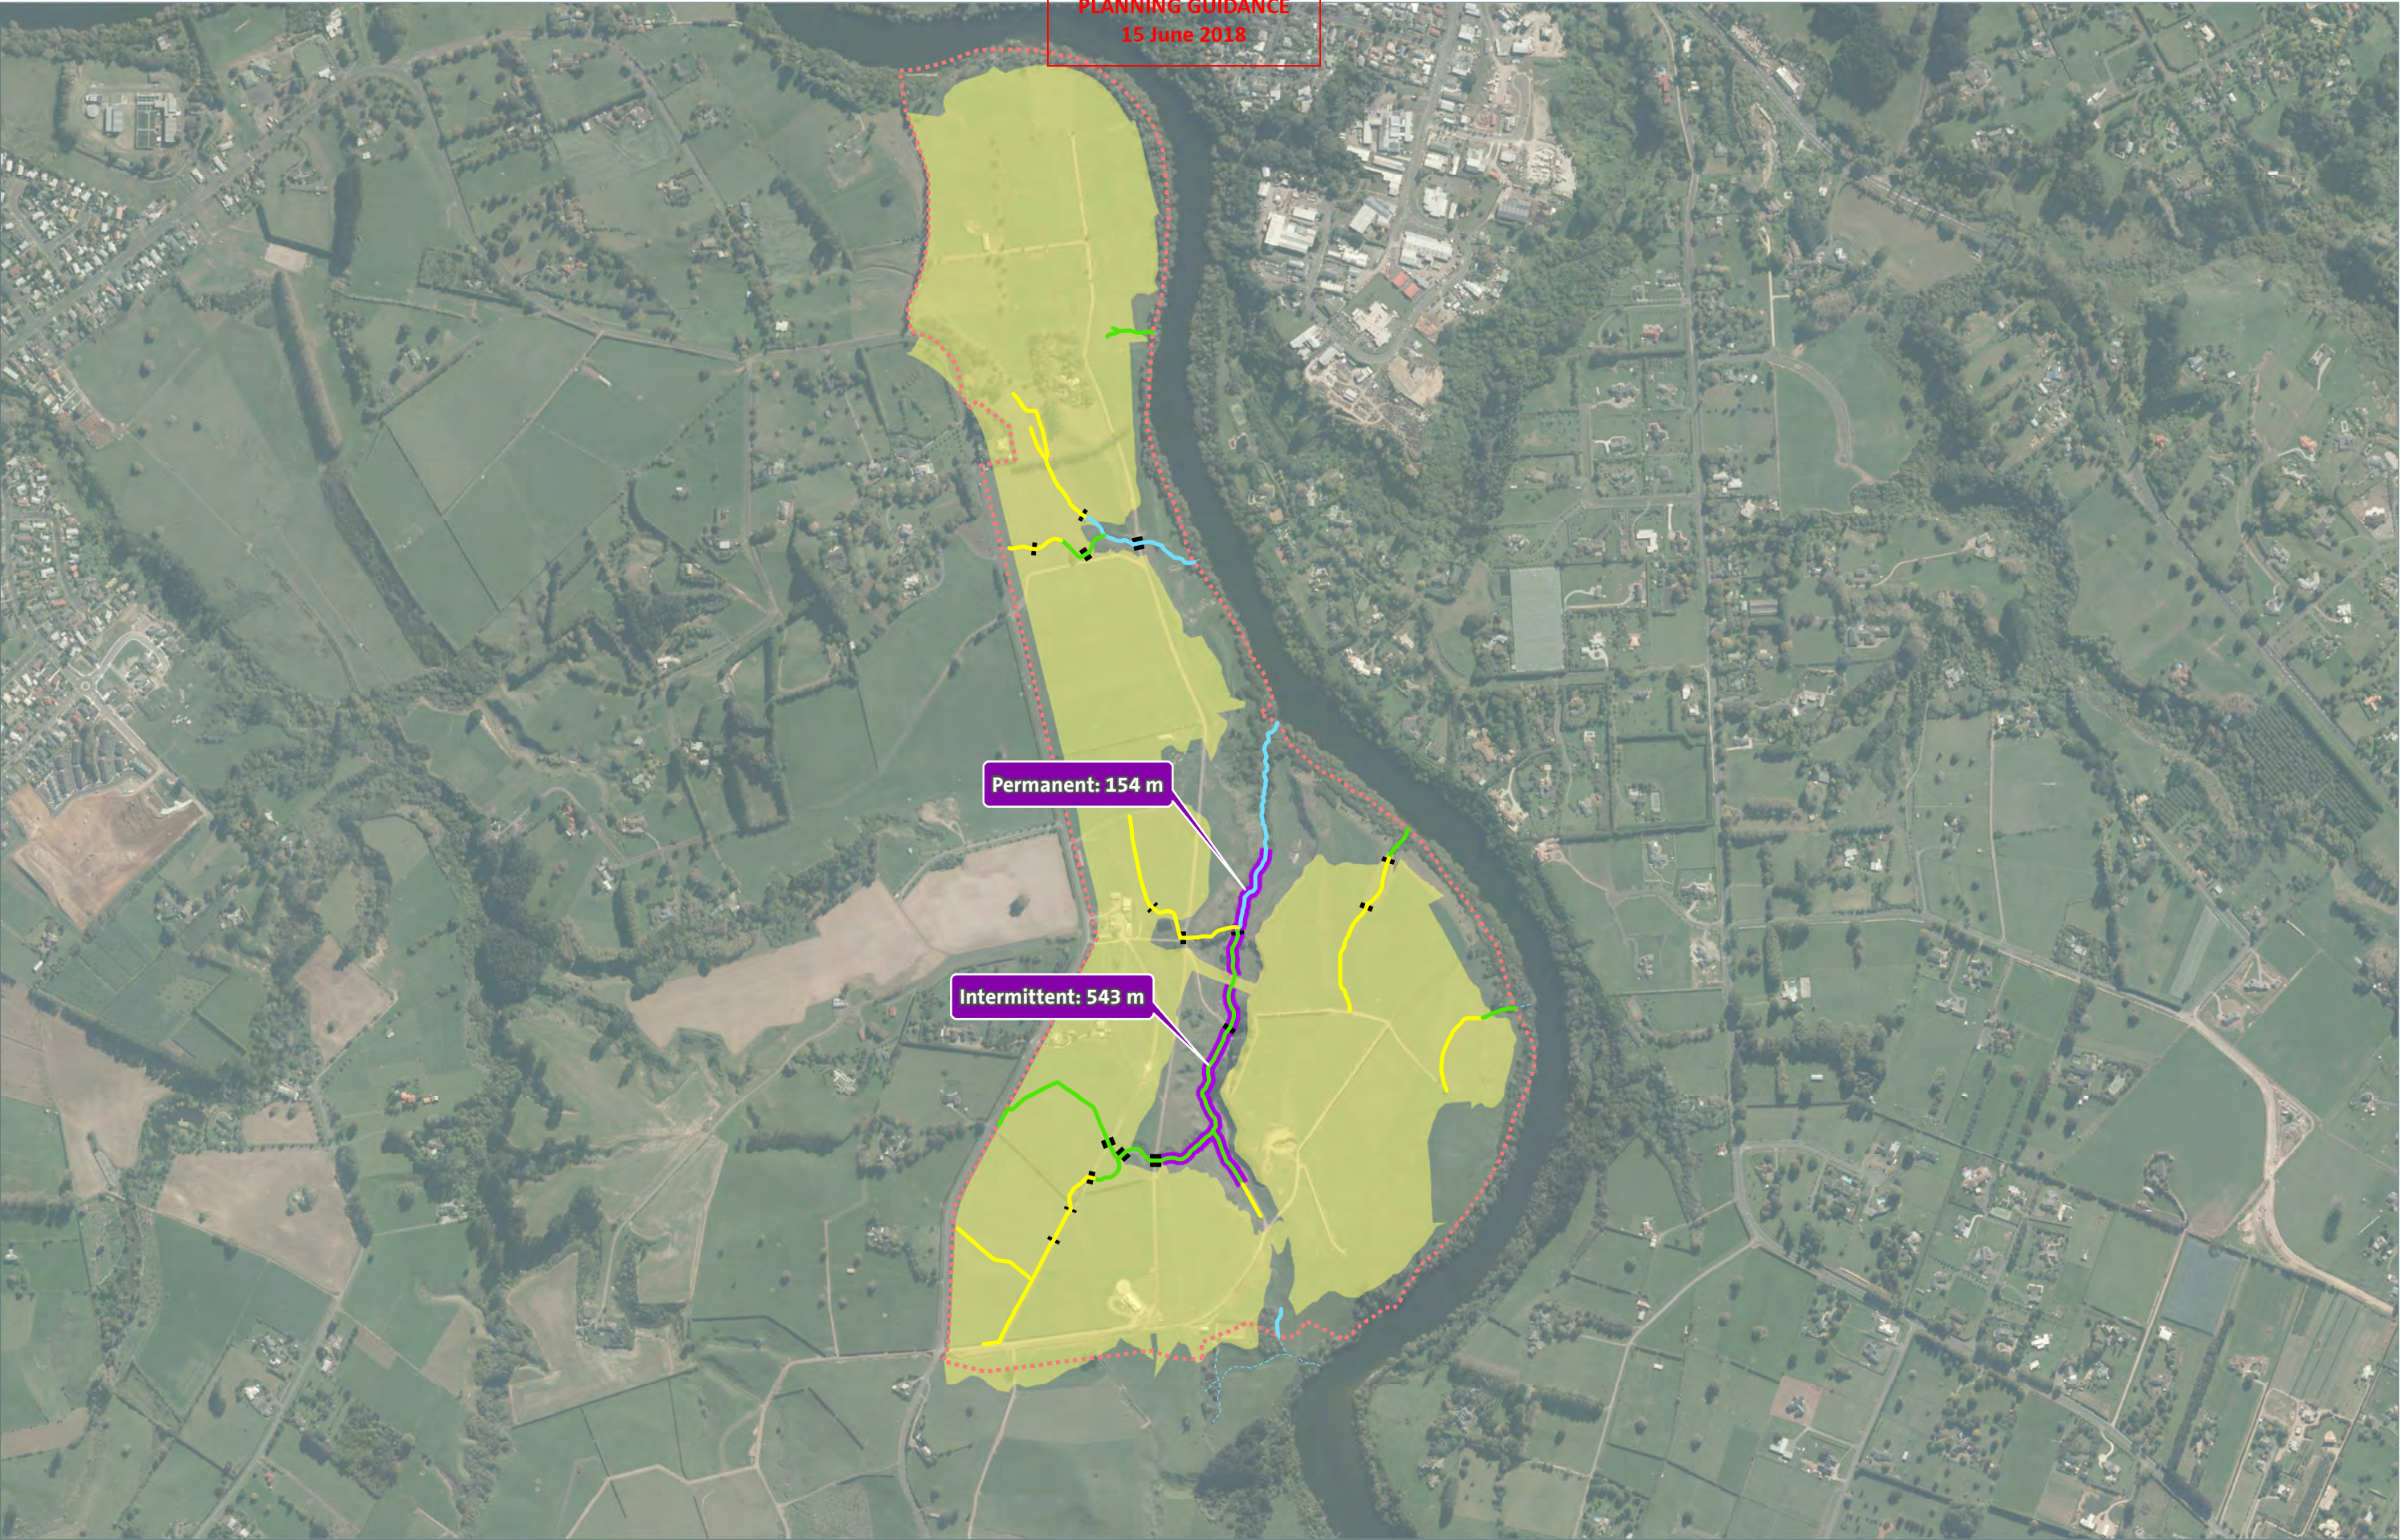
Figure 2

The proposed development will result in the removal of ephemeral, intermittent and permanent waterways across the site. Figure 2, Appendix 1, shows the development extent over the site in relation to the waterways present, while Table 6 provides an overview of the flow types and lengths of waterway loss across the six watercourses.

- Figure 1: Watercourse locations and types
- Figure 2: Development extent and watercourse loss
- Figure 3: Proposed freshwater mitigation

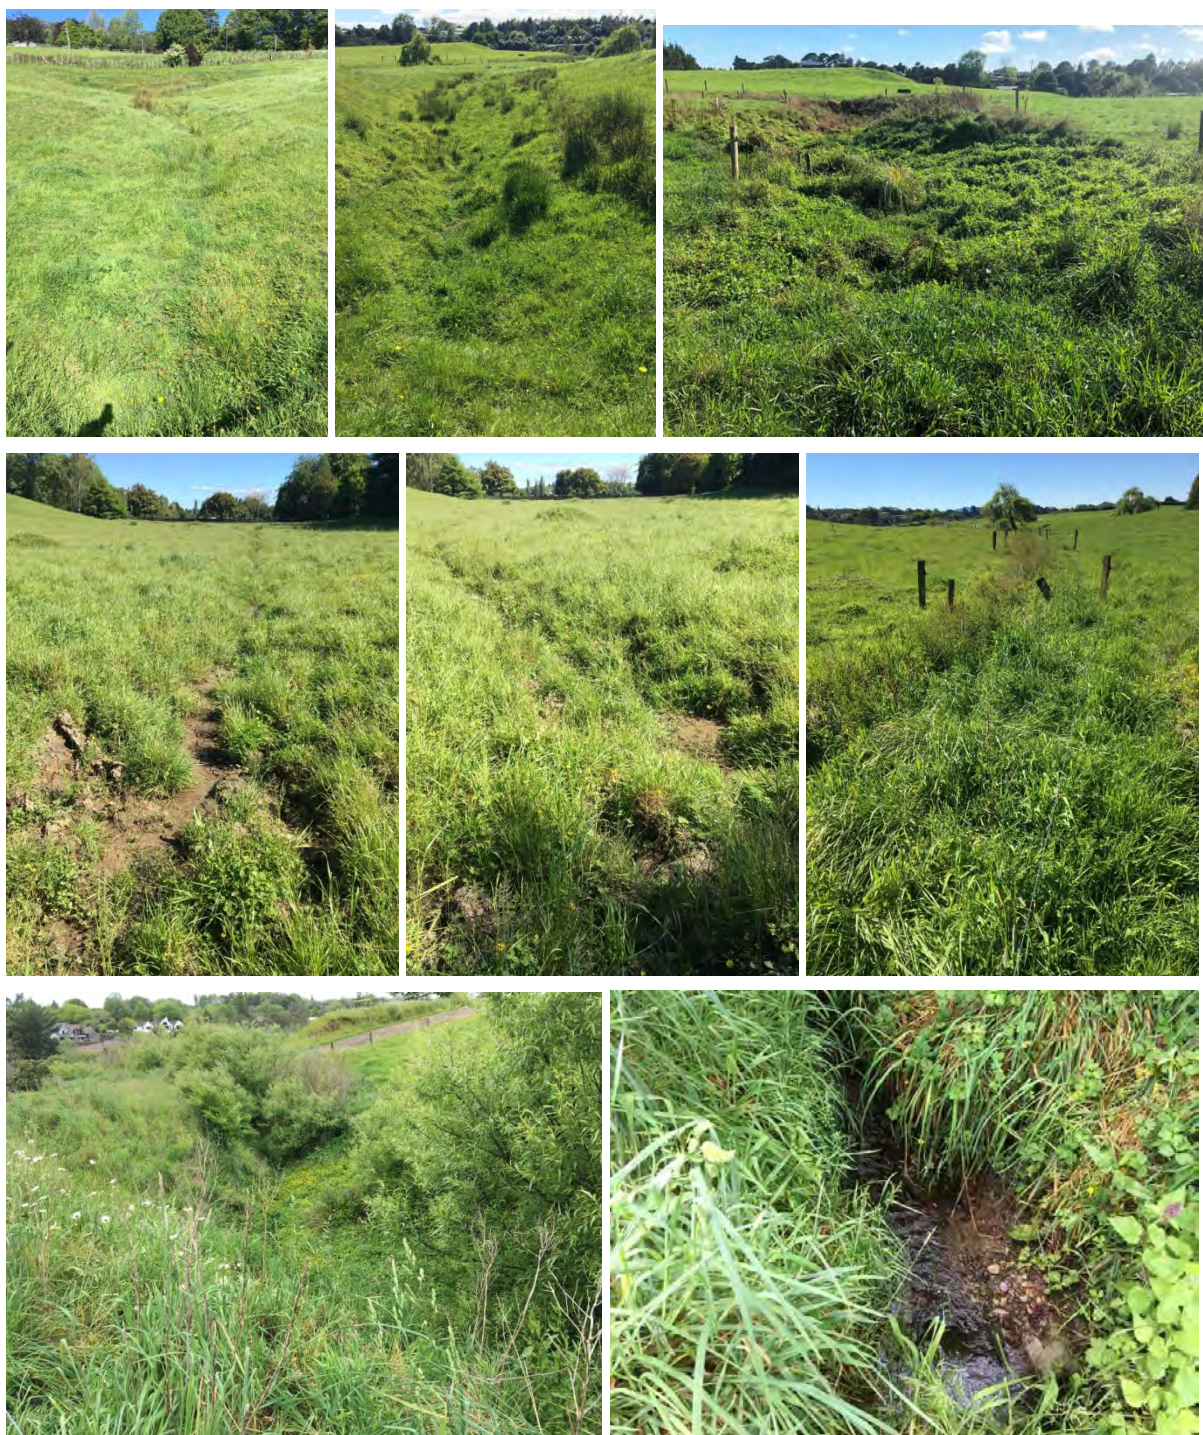
Watercourse S7b has two branches: the 'western' branch originates east of Peacockes Road; and the 'northern' branch in the paddock south of several farmhouses where they are ephemeral in nature. The 'western' branch (a 1<sup>st</sup> order stream) is ephemeral for approximately 115m up to the point where it meets a small intersecting drain on account of the rooted terrestrial vegetation (i.e., grass) present across the entire channel width. The streambed substrate is silt and weathered clay providing unstable benthic habitat for invertebrates. Plate 2 provides images of Watercourse S7b.

**Plate 2: Watercourse S7B ‘western’ branch ephemeral (upper left) and intermittent channel (upper middle & right); northern branch ephemeral (middle left & middle) and fenced farm drain (middle right); and lower permanent reach (bottom left) and substrate (bottom right).**

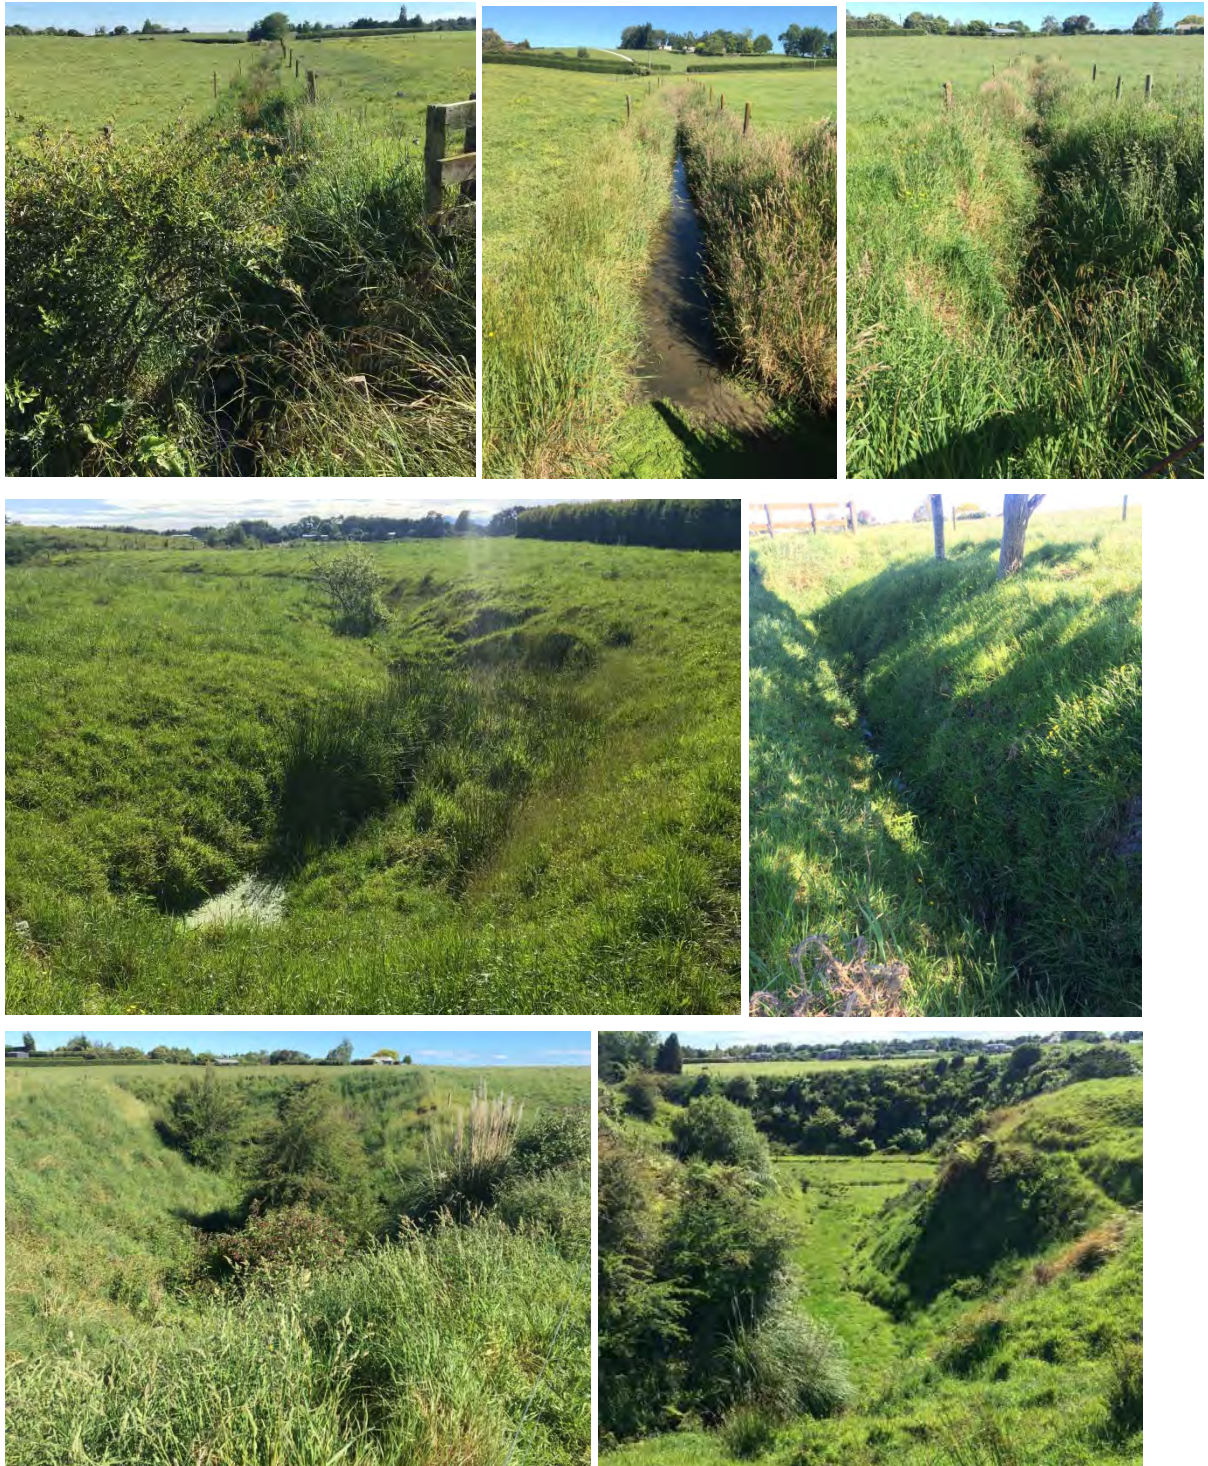
**Plate 3: Watercourse S11 'south eastern' branch (upper left & middle) and north western branch (top right) farm drains; and intermittent channel 1<sup>st</sup> order (middle) and 2<sup>nd</sup> order (bottom) channels.**

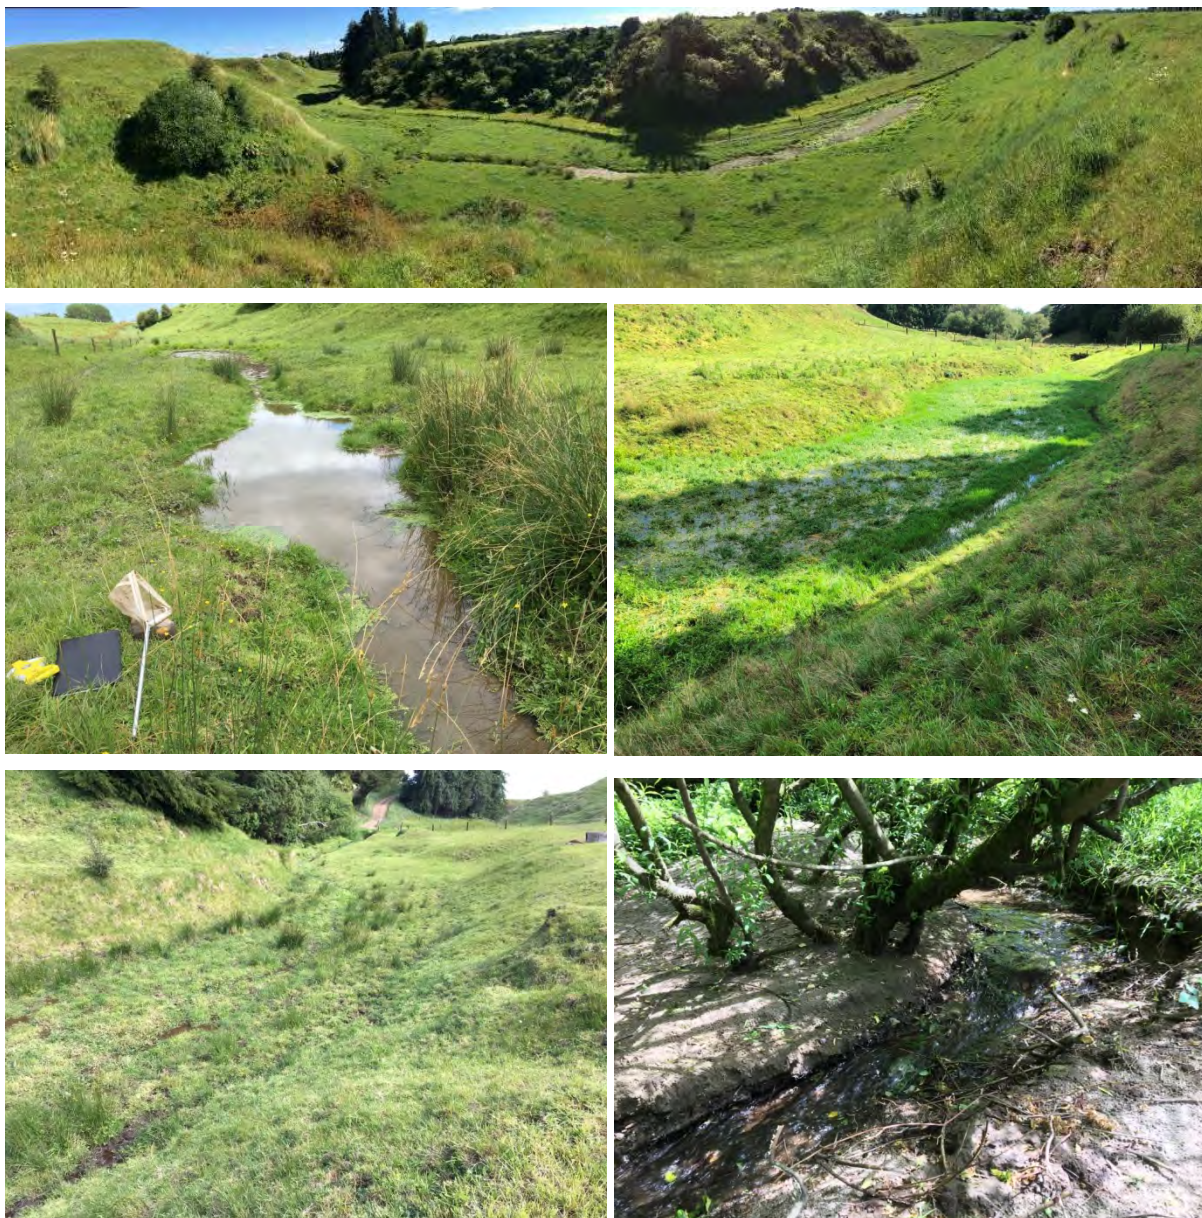
A third farm drain (the 'western branch') is located behind a perched culvert which discharges into an ephemeral watercourse (approximately 170m long) and into the permanent watercourse in the gully (see Plate 4).

**Plate 4: Watercourse S11 'southern' branch intermittent/ephemeral channel (upper & middle left); intermittent pond (middle right); and permanent watercourse downstream of pond (bottom left) and prior to discharge to the Waikato River (bottom right).**

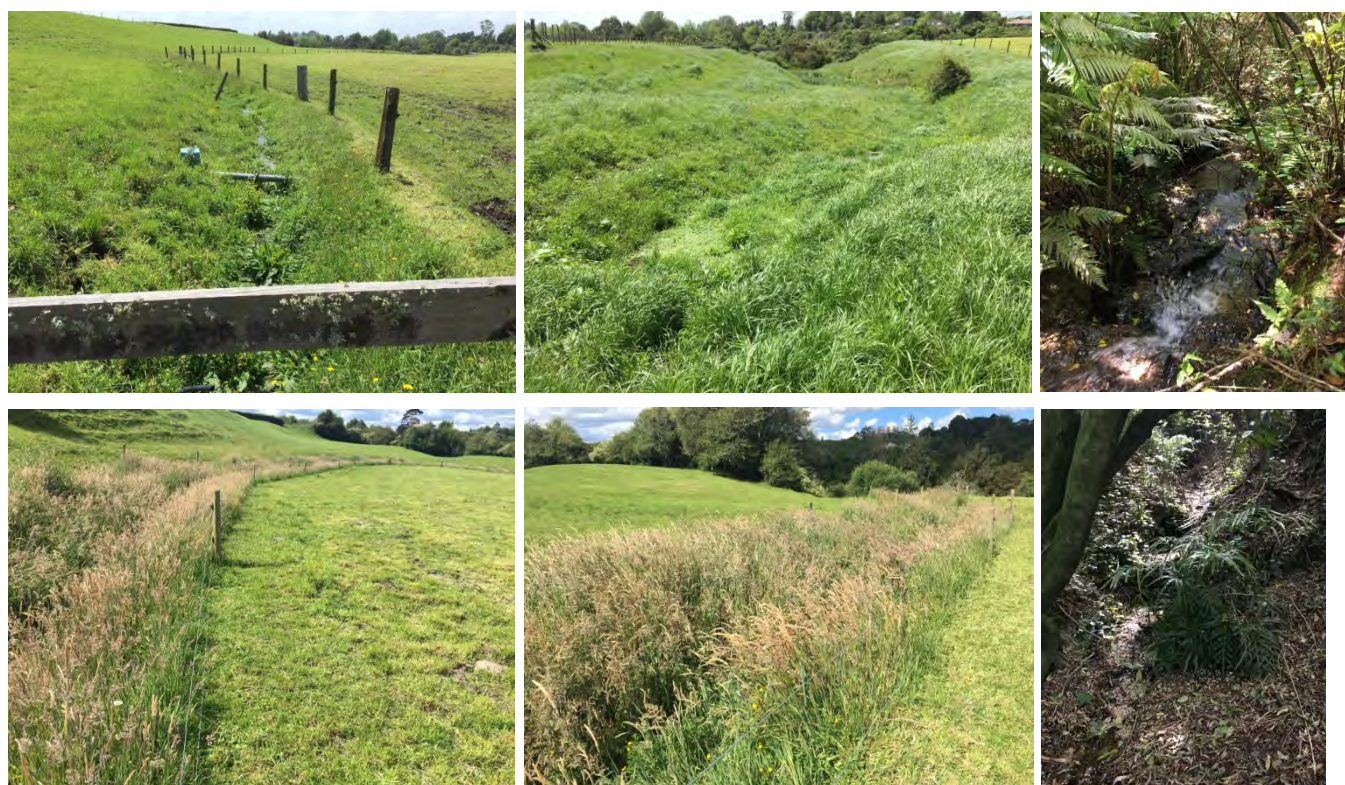
**Plate 5: Watercourse S10 farm drain (upper left); ephemeral (upper middle) and intermittent (upper right) reaches and Watercourse S12 farm drain (lower left & middle); and ephemeral reach (lower right).**
