**Adare Stage 2A  
Peacocke Farm  
Hamilton**

**PRELIMINARY  
FRESHWATER  
ECOLOGICAL RESOURCE  
ASSESSMENT**

**Report prepared by  
Argo Environmental Ltd**

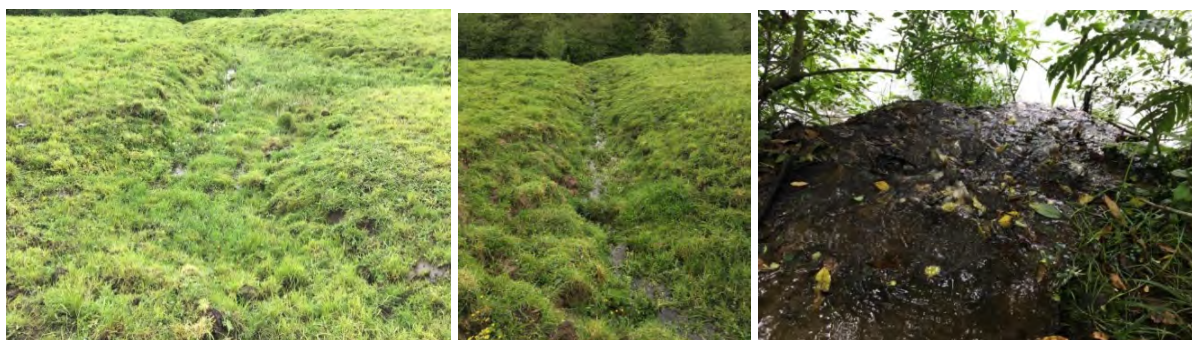
**Plate 1: Watercourse 5 channel (left and middle) and perched outfall to the River (right).**

Further downstream the channel is better defined (ranging from 0.4 to 1.3m) (Plate 1). The watercourse is approximately 75m long. The substrate in the lower section provides better quality habitat for macroinvertebrates with a greater proportion of gravel material. The end of the watercourse, located in the riparian vegetation, is perched with a 5m drop to the River below which severely restricts upstream fish migration.

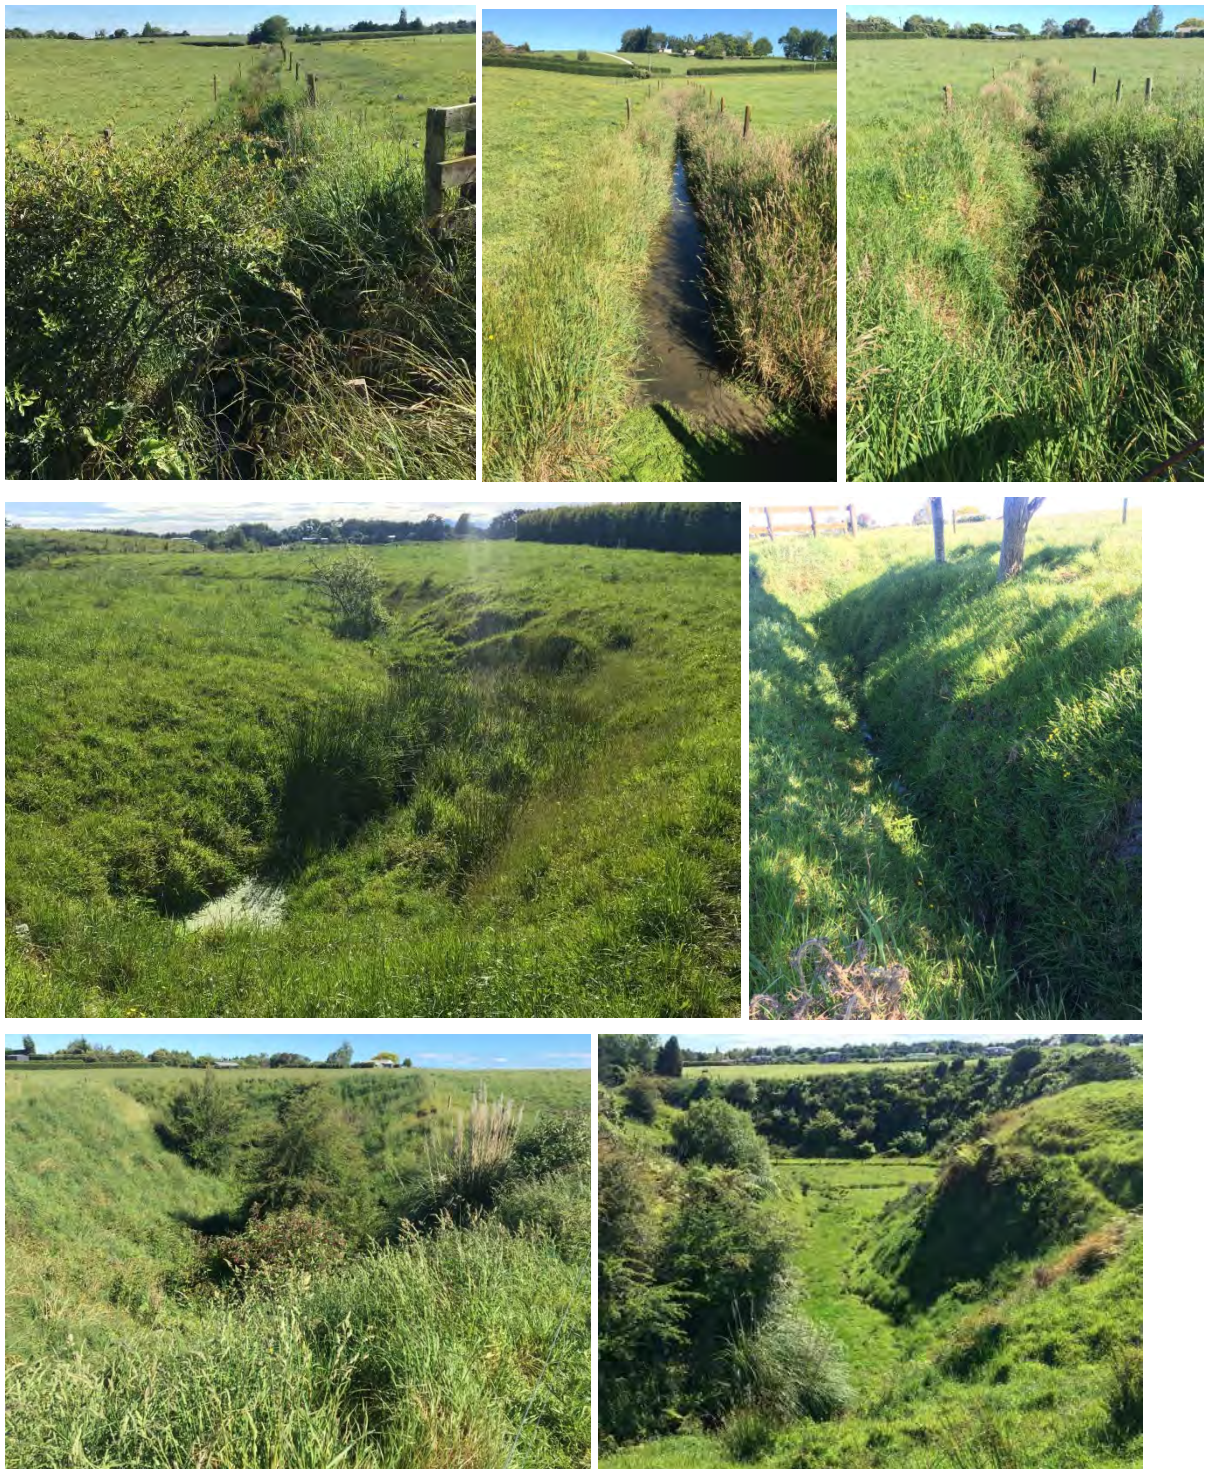
**Plate 3: Watercourse S11 'south eastern' branch (upper left & middle) and north western branch (top right) farm drains; and intermittent channel 1<sup>st</sup> order (middle) and 2<sup>nd</sup> order (bottom) channels.**

Watercourse S11 originates from three areas drained by farm drains in paddocks adjacent to Peacockes Road (totalling 782m in length) (see Plate 3). Beyond the 'north western' and 'south eastern' farm drains are two 1<sup>st</sup> order intermittent watercourses (approximately 67 & 23 m in length respectively), accessible by stock, which contain mud and silt which provides poor quality habitat for macroinvertebrates.

These two 1<sup>st</sup> order watercourses join prior to a large crossing and culvert to create a more incised and fenced 2<sup>nd</sup> order intermittent stream for approximately 54 m up to the main race crossing and culvert. Although a deeply incised channel in parts, a better quality macroinvertebrate habitat (gravels, etc) is present in this section of stream.

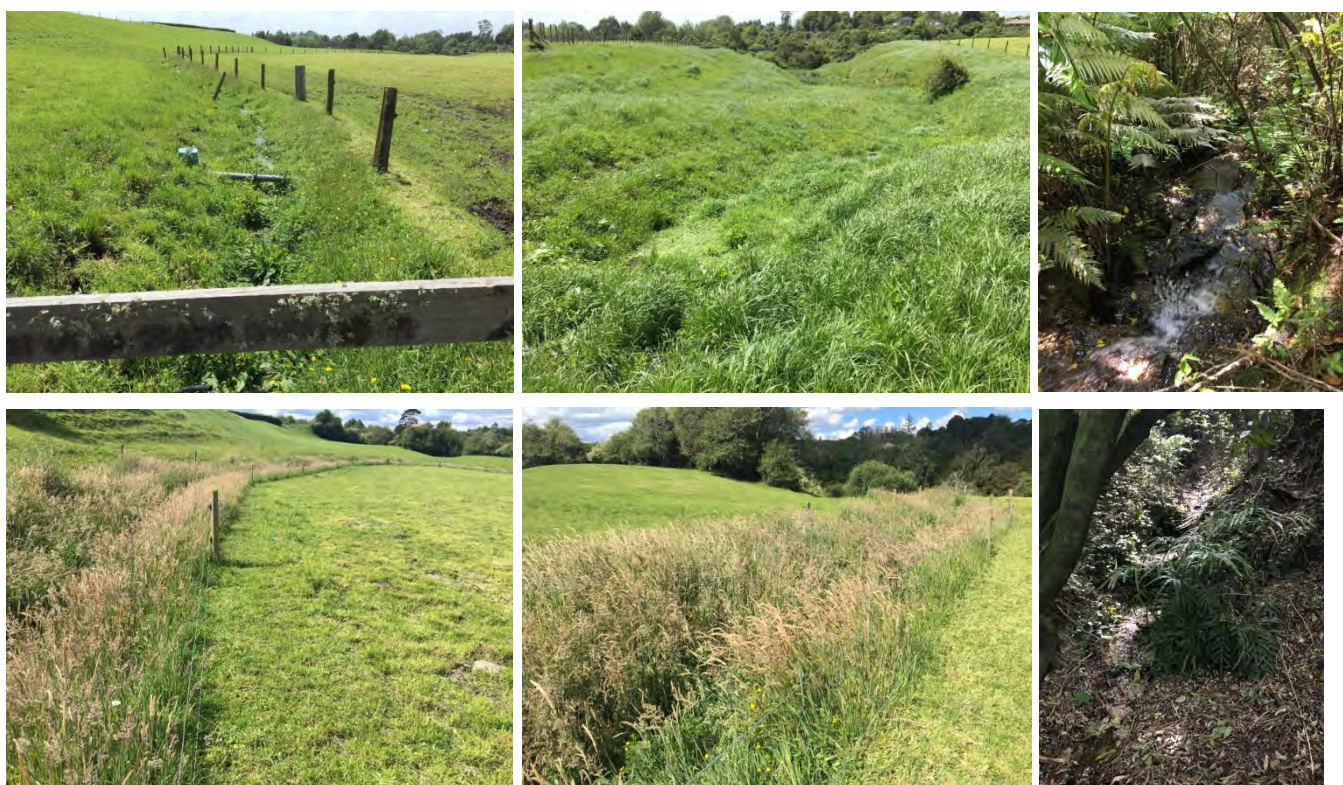
**Plate 5: Watercourse S10 farm drain (upper left); ephemeral (upper middle) and intermittent (upper right) reaches and Watercourse S12 farm drain (lower left & middle); and ephemeral reach (lower right).**

Watercourse S10 consists of farm drain (375m), ephemeral watercourse (80 m) and intermittent (62m) watercourse located within the riparian vegetation adjacent to the Waikato River (see Plate 5).

Watercourse S12 consists of farm drain (186m) and ephemeral watercourse (39m) located within the riparian vegetation adjacent to the Waikato River. The proposed development footprint will require reclamation of the farm drain. The ephemeral reach will be unaffected by reclamation.
