# Geotechnical Investigation Report

Amberfield Development

Peacockes Road

16.05.2018  
14280.000.000\_19

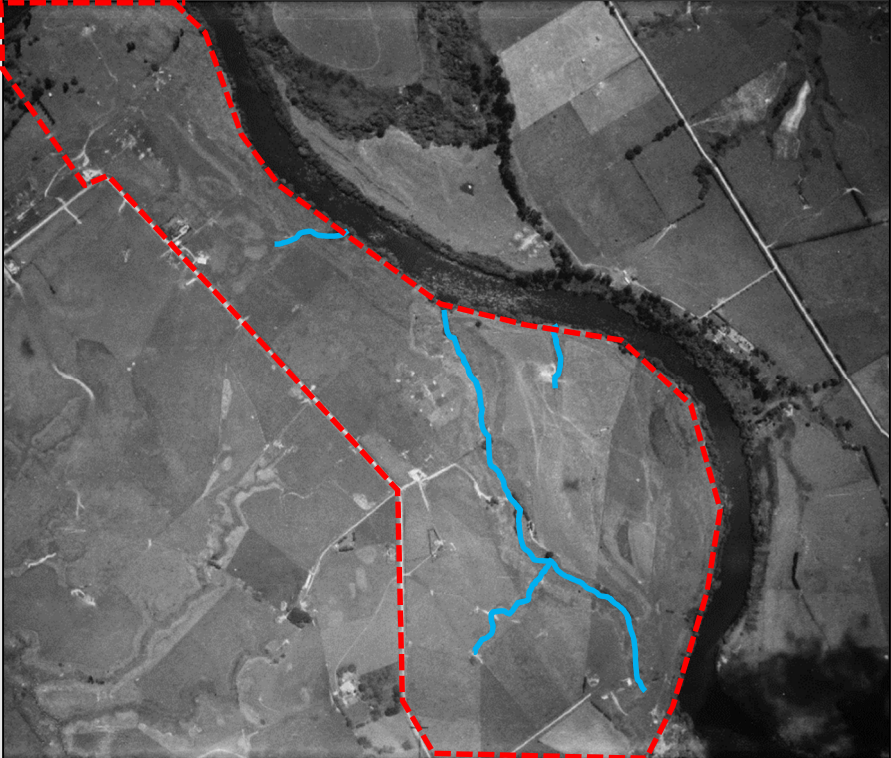
| Source<br>(year) [reference] | Summary |
|---|---|
| Retrolens<br>(1938) [SN107] | <p>The site is largely grassed with more mature vegetation (bushes, shrubs and trees) adjacent to the Waikato River. It should be noted that the vegetation cover on this slope may conceal signs of ongoing instability.</p> <p>There are a number of incised valleys and gullies which feed into the Waikato River (highlighted in blue below).</p> <p>The entire site appears to be used for farming purposes with a number of residential buildings and sheds located across the site.</p> <p>The surrounding area is predominantly rural residential and grazing land.</p> |

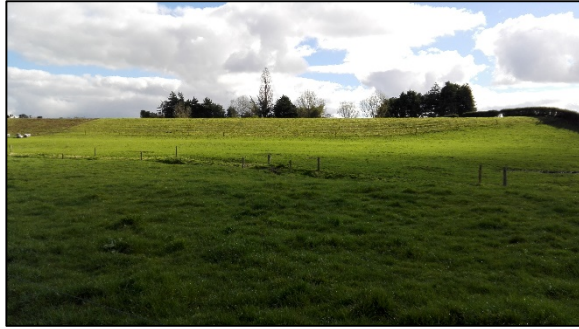
Photo 1: Example of terrace with over steepened back slope.

- Specifically designed remedial earthworks, primarily cutting and regrading of the over-steepened terrace slopes and the hills in the south of the site to reduce the risk of soil creep and shallow soil failure. This also has the benefit of generating a larger number of lots with shallower slope gradients. Site drainage may be implemented at this time, particularly if development is proposed within areas of marshy ground or if fills are being placed proximal to sloping ground; and

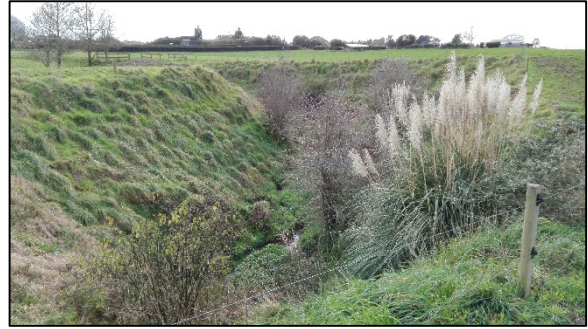
Photo 2: Internal waterway west of Central Valley.

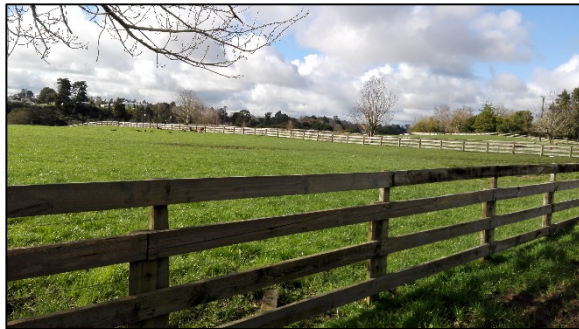
Photo 3: Near level land in the northern portion of the site.

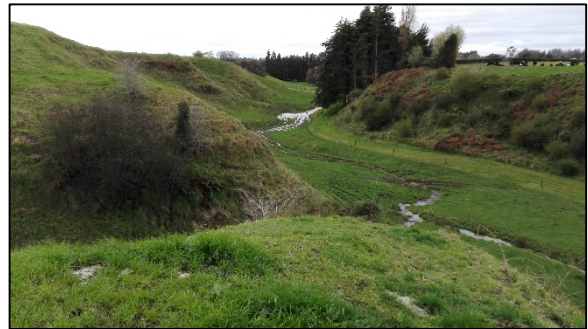
Photo 4: View across northern and Central Valley.

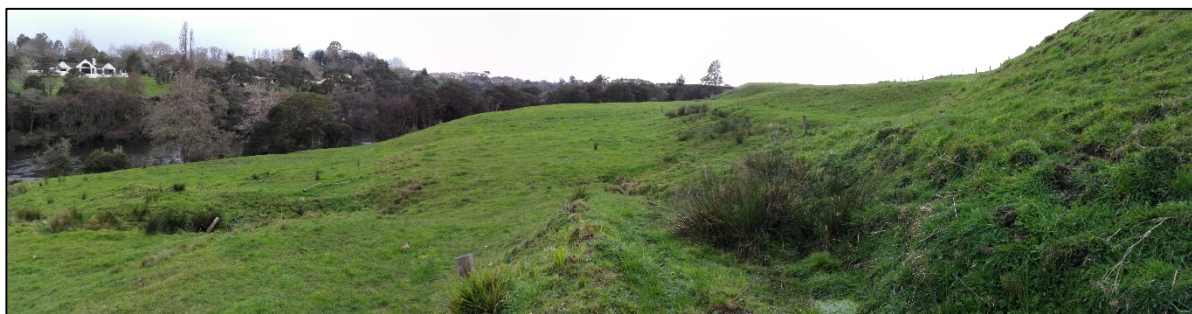
Photo 5: View south along slope terraces, landslide debris and swampy ground adjacent to the Waikato River in the central to northern portion of the site.

As described in Section 8, widespread evidence of soil creep and shallow soil failure was observed within the site, primarily along terrace back-slopes, free faces above the Waikato River and the flanks of the Central Valley.

We consider that soil creep and slope terrace soil failures are likely to continue to occur in the foreseeable future as natural gully regression and erosion processes continue within the site. We consider that larger scale soil failures are likely to be driven by external triggering mechanisms such as seismic loading.
